## ACCIDENT

<b>Aircraft Type and Registration:</b>	Boeing 737-600, 7T-VJT
<b>No &amp; Type of Engines:</b>	2 CFM 56-7B20 turbofan engines
<b>Year of Manufacture:</b>	2002
<b>Date &amp; Time (UTC):</b>	31 May 2006 at 1200 hrs
<b>Location:</b>	London Gatwick Airport
<b>Type of Flight:</b>	Commercial Air Transport (Passenger)
<b>Persons on Board:</b>	Crew - 6                      Passengers - 18
<b>Injuries:</b>	Crew - None                      Passengers - None
<b>Nature of Damage:</b>	Damage to engine and engine outer casing
<b>Commander's Licence:</b>	Airline Transport Pilot's Licence
<b>Commander's Age:</b>	54 years
<b>Commander's Flying Experience:</b>	10,868 hours (of which 700 were on type) Last 90 days - 195 hours Last 28 days - 45 hours
<b>Information Source:</b>	AAIB Field Investigation

## Synopsis

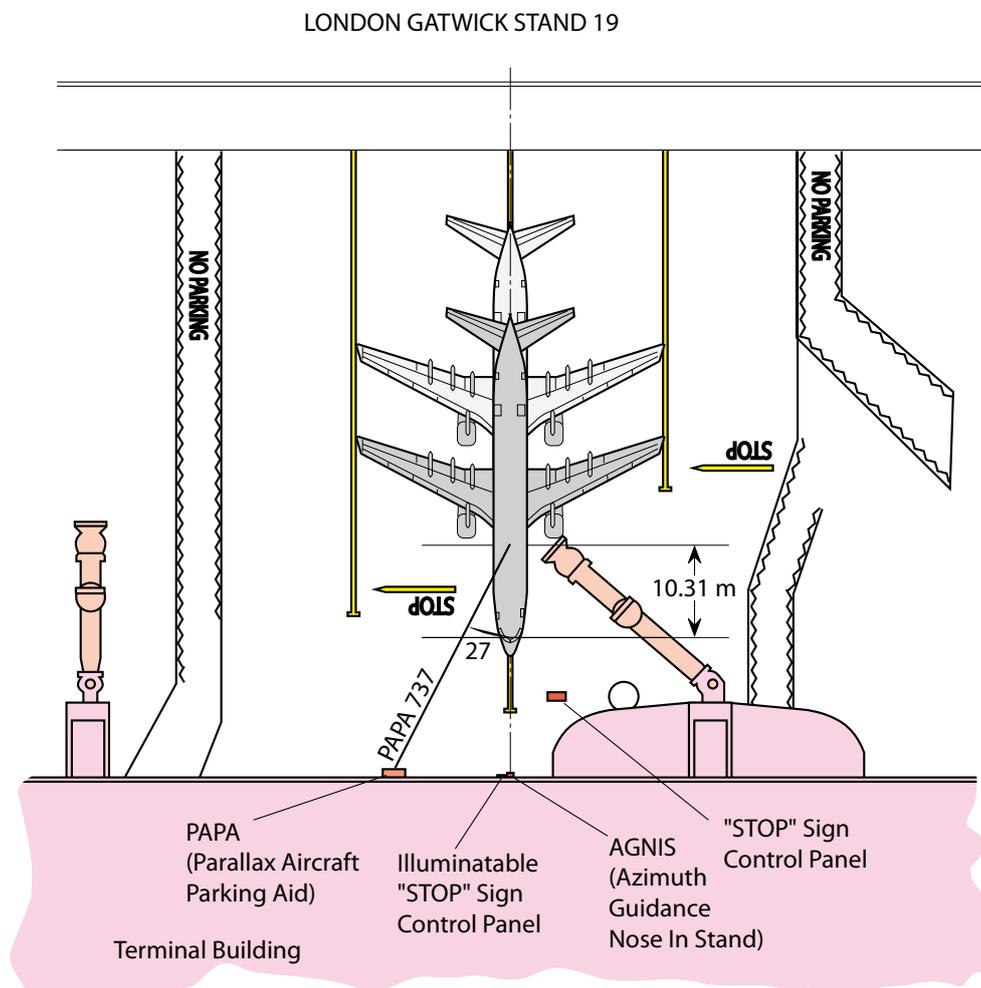
Examination showed that part of the stand mechanism had contacted the cowling, resulting in a three inch diameter hole in the intake lip. The stand mechanism had been slightly deformed. The aircraft had overrun its correct stopping point by 10.3 m.

Layout of Stand 19, illustrating normal stopping position and stopped position of 7T-VJT

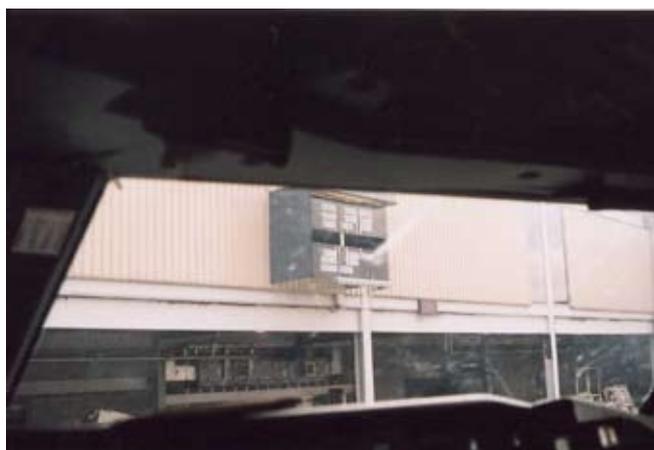
**Figure 3**  
Stand 19 PAPA viewed from commander's seat<sup>4</sup>

On Stand 19, the PAPA, Figure 2, was installed approximately 13 m to the right of the stand centreline but designed for use from the left pilot position. Consequently, it was necessary for the commander to look across the cockpit in order to view it as shown in Figure 3.

The PAPA for Stand 19 was serviceable and would have provided correct stopping guidance to the commander of the aircraft whilst tracking the stand centreline. The commander reported after the incident that, because of its location, it was not apparent that this PAPA referred to Stand 19.

It is recommended that the CAA should use all measures that it can to encourage airport operators to expedite their compliance with international standards for visual docking guidance systems as specified in ICAO Annex 14, Chapter 5, section 5.3.24

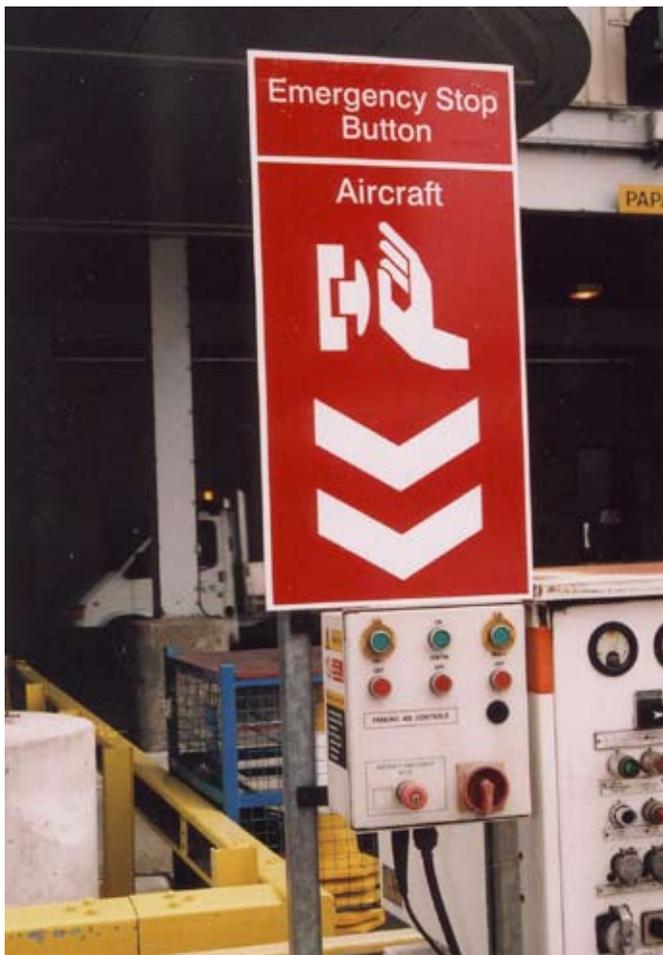
**Figure 4**

Stand guidance control box (ground)

The emergency STOP sign could be activated by pressing a button on the stand guidance control box, located at the head of the stand (nearest the terminal building) to the left of the stand centreline, Figure 4. It could also be operated by a button on an identical control box mounted above the steering controls in the cab of the airbridge, on the left side of the airbridge head (nearest the aircraft), Figure 5. The Traffic Officer was not aware of this, believing that it was located beside the door to the airbridge steps, on the other side of the airbridge head and, consequently, out of reach.

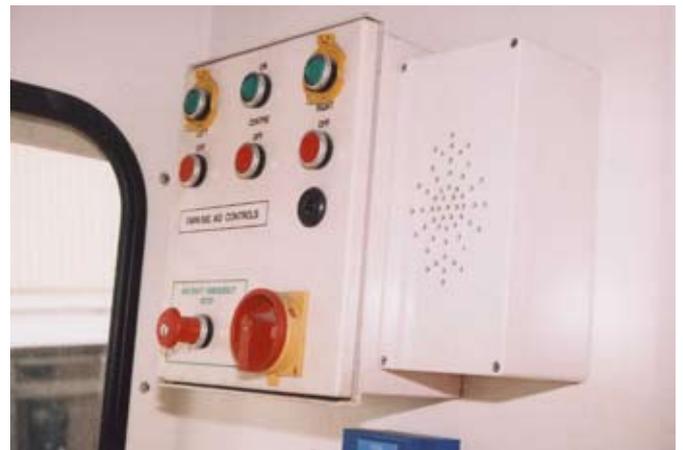
**Figure 5**

Stand guidance control box (airbridge)

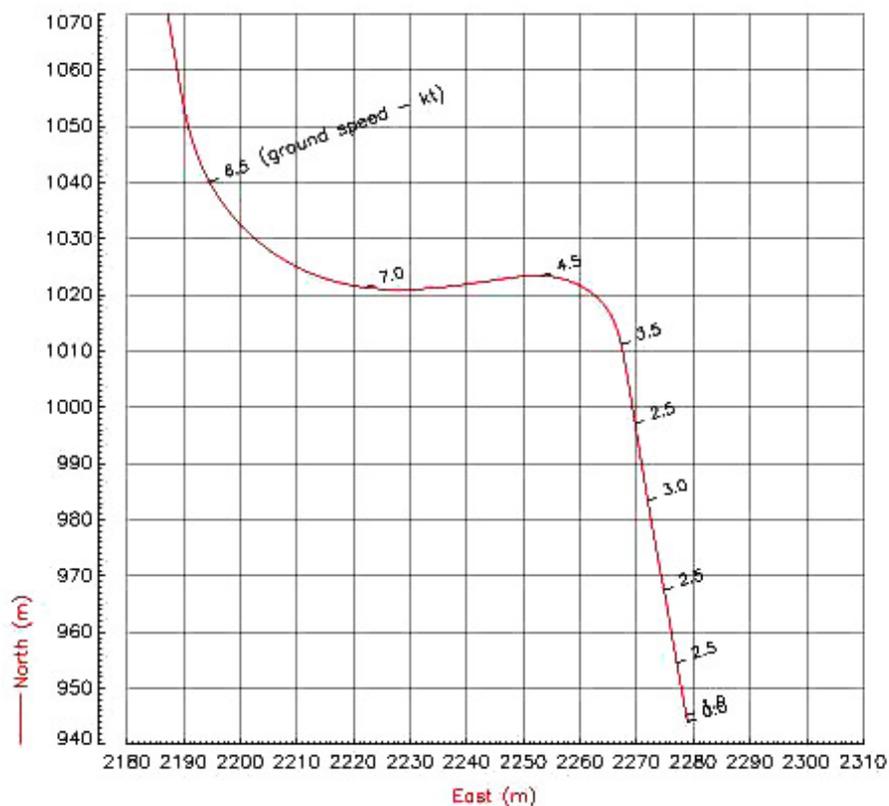
**Figure 6**

The ground track of 7T-VJT as it taxied towards the stand was calculated using ground speed and heading data taken from the FDR. Figure 6 shows the track of the aircraft as it manoeuvred onto the stand, with ground speed in knots and distances in metres. The points are one second apart.

When lined up with the stand, ground speed was between 2.5 and 3.0 kt. The aircraft then decelerated to a stop within two seconds.

Ground track of 7T-VJT onto stand
