ACCIDENT

Aircraft Type and Registration:	Piper PA-28R-200 Cherokee Arrow II, G-BKFZ	
No & Type of Engines:	1 Lycoming IO-360-C1C piston engine	
Year of Manufacture:	1976	
Date & Time (UTC):	13 February 2008 at 1535 hrs	
Location:	North-eastern edge of Rutland Water, near Empingham, Leicestershire	
Type of Flight:	Private	
Persons on Board:	Crew - 1	Passengers - None
Injuries:	Crew - 1 (Fatal)	Passengers - N/A
Nature of Damage:	Aircraft destroyed	
Commander's Licence:	Private Pilot's Licence	
Commander's Age:	85 years	
Commander's Flying Experience:	972 hours (of which 850 were on type) Last 90 days - 2 hours Last 28 days - 0 hours	
Information Source:	AAIB Field Investigation

Synopsis

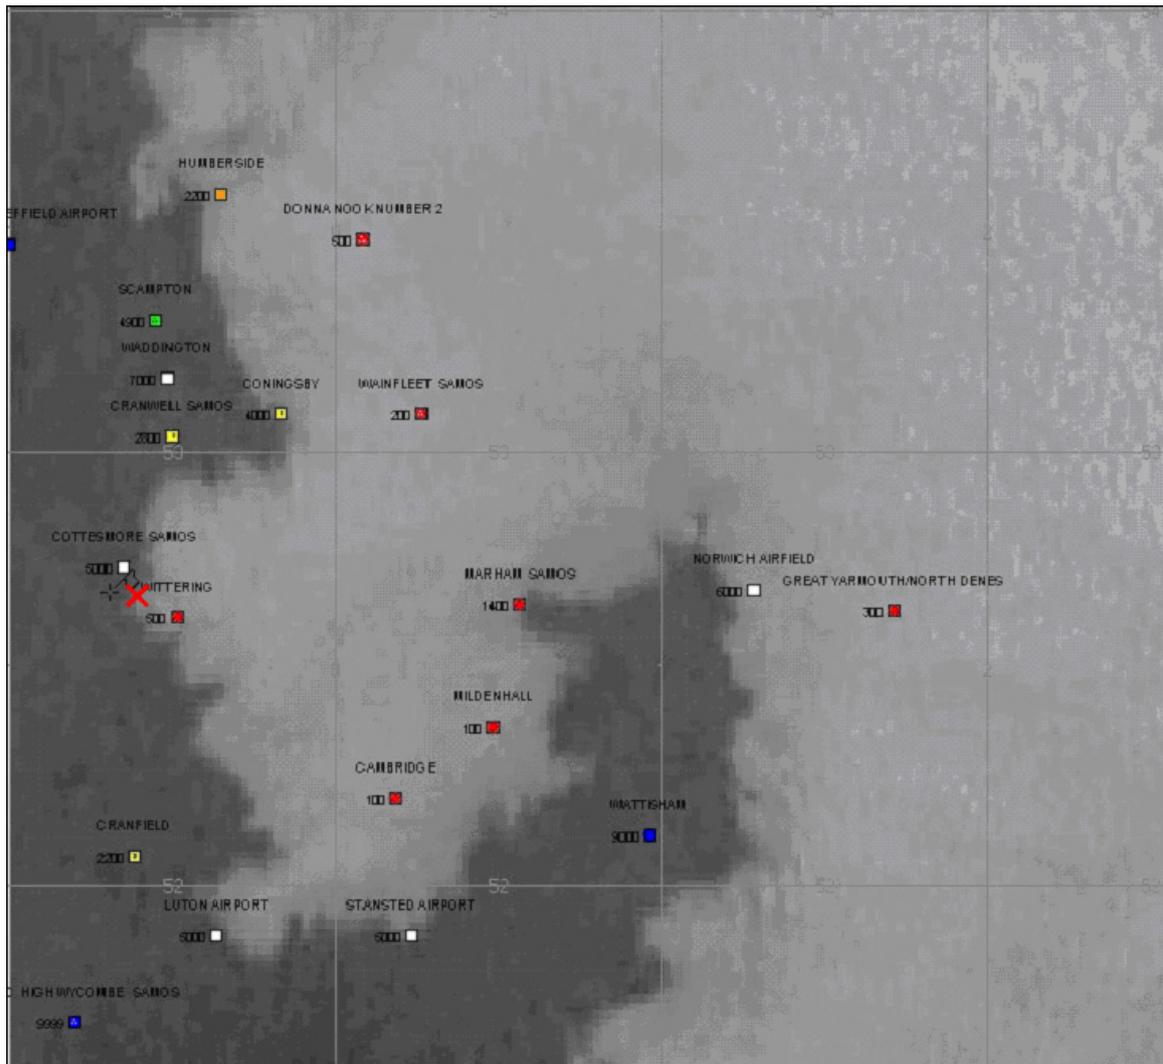
Figure 2

The Met Office provided a high resolution visible cloud satellite image taken at 1530 hrs on the day of the accident, Figure 2. It clearly showed the area of fog across eastern England and the North Sea. The accident

site, marked with a red X was between RAF Cottesmore and RAF Wittering.

Visible cloud satellite image taken at 1530 hrs on 13 February 2008, five minutes before the accident. The approximate location of the accident site is marked X

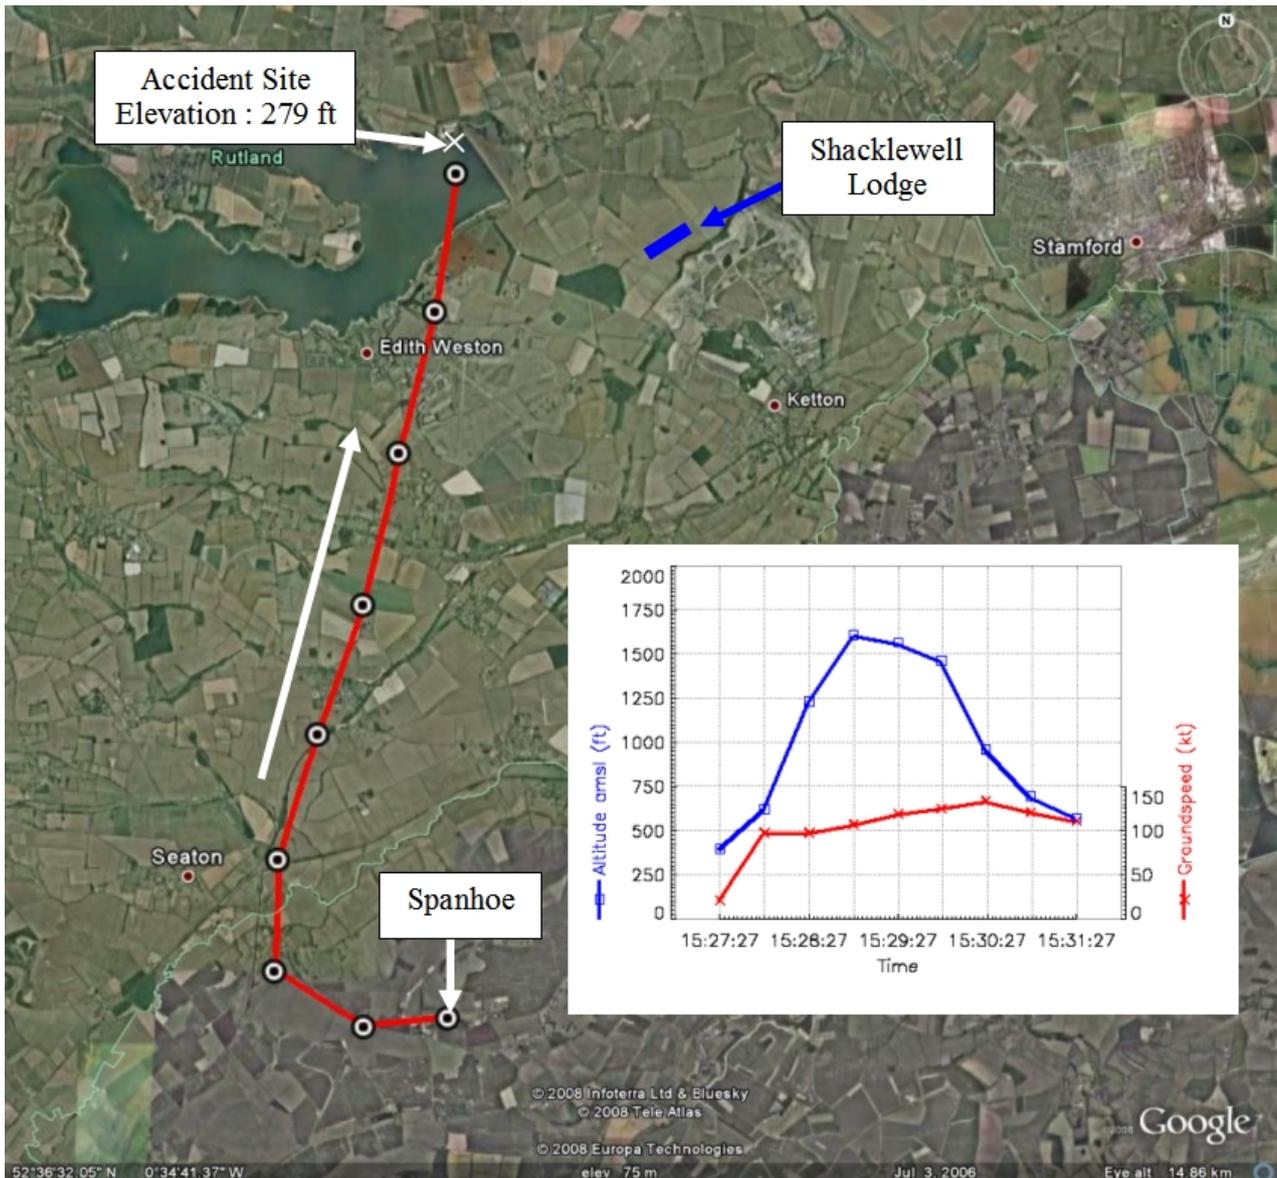
Figure 3

G-BKFZ ground track and altitude from GPS data

1,607 ft amsl, after which a descent commenced of about 150 ft/min which lasted for about one minute. Thereafter, it increased to about 1,000 ft/min. Between the penultimate and final GPS recorded position, the aircraft descended from 696 ft to 572 ft in 31 seconds; a descent rate of 240 ft/min. The total distance covered between these positions was 1 nm, which suggests a descent slope of around 1:50.

The final recorded position of the aircraft was at 1531:27 hrs, at an altitude of 572 ft amsl, at an instantaneous groundspeed of 111 kt and an instantaneous track of 000°. Using the 500 ft aftercast wind of 060° at 11 kt, this represented an airspeed of around 117 kt. This position was approximately 440 m from the accident site where the terrain elevation was 279 ft. Extrapolating from the last GPS point to the accident site gives a final average descent slope of about 1:5 and an

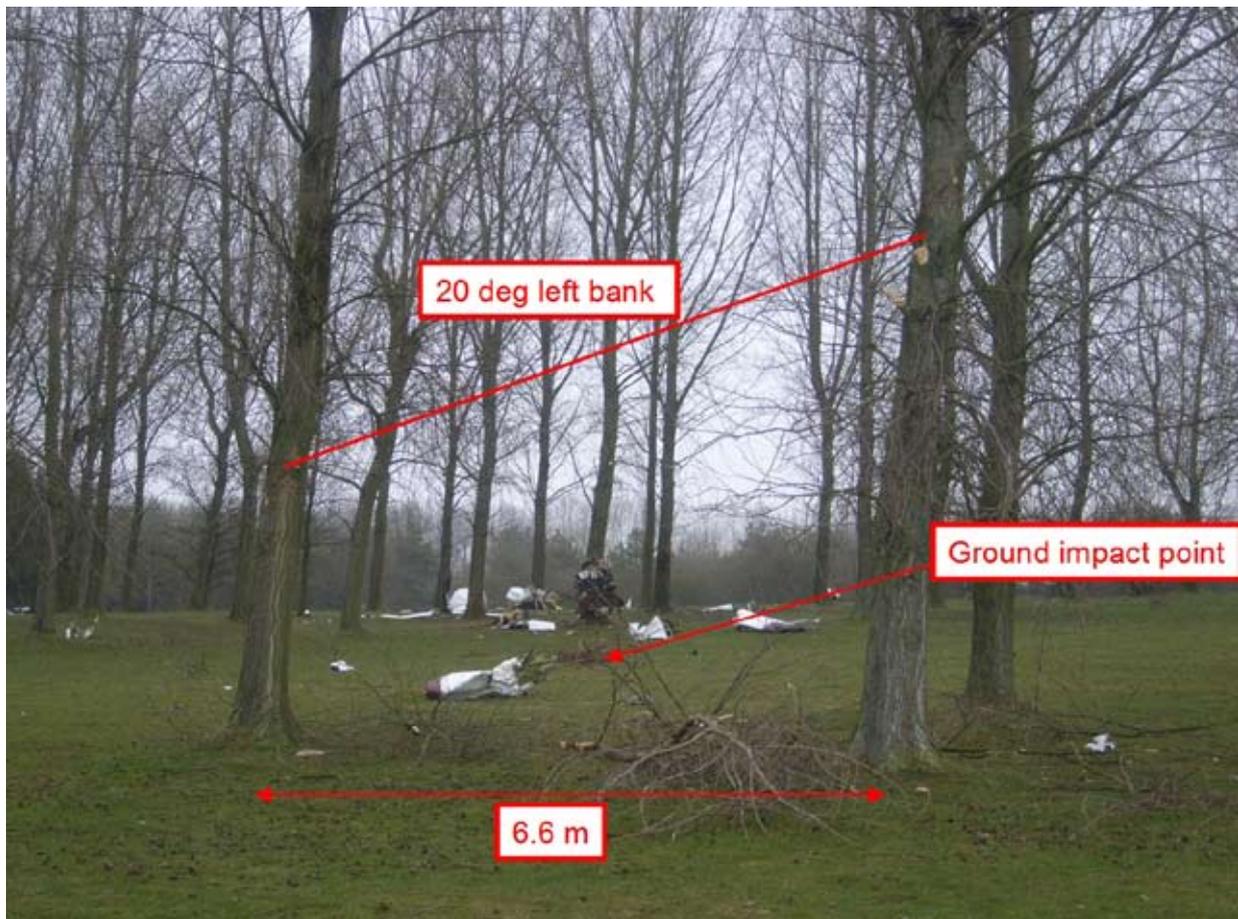
Figure 4

The accident site was located among trees in a park on the north-eastern edge of Rutland Water and was 279 ft amsl. The aircraft's initial impact was with two trees, 6.6 m apart, whilst in a bank to the left of approximately 20° and about 12 ft above the ground,

Figure 4. The impact removed the aircraft's left and right wing outer sections; it continued and struck the ground 15.5 m from the trees whilst on a track of 342°(M). The aircraft's final trajectory from the trees to the ground was calculated at between 10° and 14° below the horizon⁴. After striking the ground, the fuselage bounced and hit another tree head-on, causing the aircraft to break up into multiple sections. The furthest item of wreckage was the battery, which had travelled 127 m from the initial impact point. There were three propeller slash marks at the ground impact point spaced 40 cm apart.

Accident site, viewed in the direction of flight, showing initial impact with trees and ground impact point

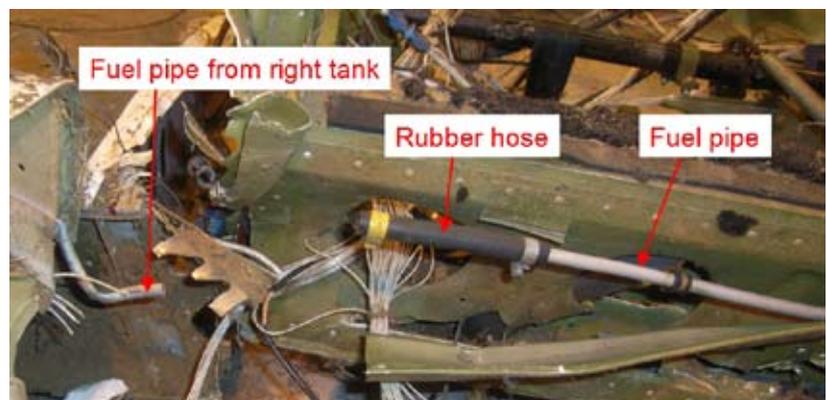
Figure 5

The fuel lines from the fuel tanks to the fuel selector were continuous apart from a separation at the right wing-to-body join. In this separated location, where the centre fuselage fuel pipe joined the right wing fuel pipe, it was apparent that a repair had been made, Figure 5. The two plain-ended pipes had been connected with a 12 cm long rubber hose held in place with a single jubilee clip at each end. According to the aircraft manufacturer, this was not an approved method of repair and there should have been a metal threaded union connecting the two pipes in this location. It was determined that the overlap that would have existed between the fuel pipe from the right tank and the rubber hose was approximately 1 cm.

Rubber hose repair to fuel pipe

Sometime between 7 February 2008 and the accident date, 13 February 2008, the engineer from Spanhoe flew G-BKFZ back to Spanhoe. The Star Annual maintenance check included an inspection of all the fuel pipes and fuel hoses in the aircraft, and should have revealed the presence of the non-approved fuel pipe repair in the right wing to fuselage join area. However, the engineer at Spanhoe stated that he thought the rubber hose had been installed as an anti-chafing device and did not realise that there would normally be a union in this position.

The airframe logbooks, dating back to 1994, contained no entries for a fuel pipe repair. The Service Bulletins and Airworthiness Directives with their relevant compliance due dates were recorded in the pink sheets of G-BKFZ's engine logbook, but these had not been recorded in the airframe logbook following the aircraft's Annual Inspection.
