ACCIDENT

Aircraft Type and Registration:	Diamond HK 36 TC, G-OSFA	
No & Type of Engines:	1 Rotax 912-A3 piston engine	
Year of Manufacture:	1999	
Date & Time (UTC):	12 June 2006 at 1030 hrs	
Location:	Enstone Airfield, Oxfordshire	
Type of Flight:	Training	
Persons on Board:	Crew - 2	Passengers - Nil
Injuries:	Crew - None	Passengers - None
Nature of Damage:	Damaged propeller, nose landing gear leg and nosewheel fork	
Commander's Licence:	National Private Pilot's Licence	
Commander's Age:	60 years	
Commander's Flying Experience:	89 hours (of which 80 were on type) Last 90 days - 3.6 hours Last 28 days - 0 hours	
Information Source:	AAIB Field Investigation

Synopsis

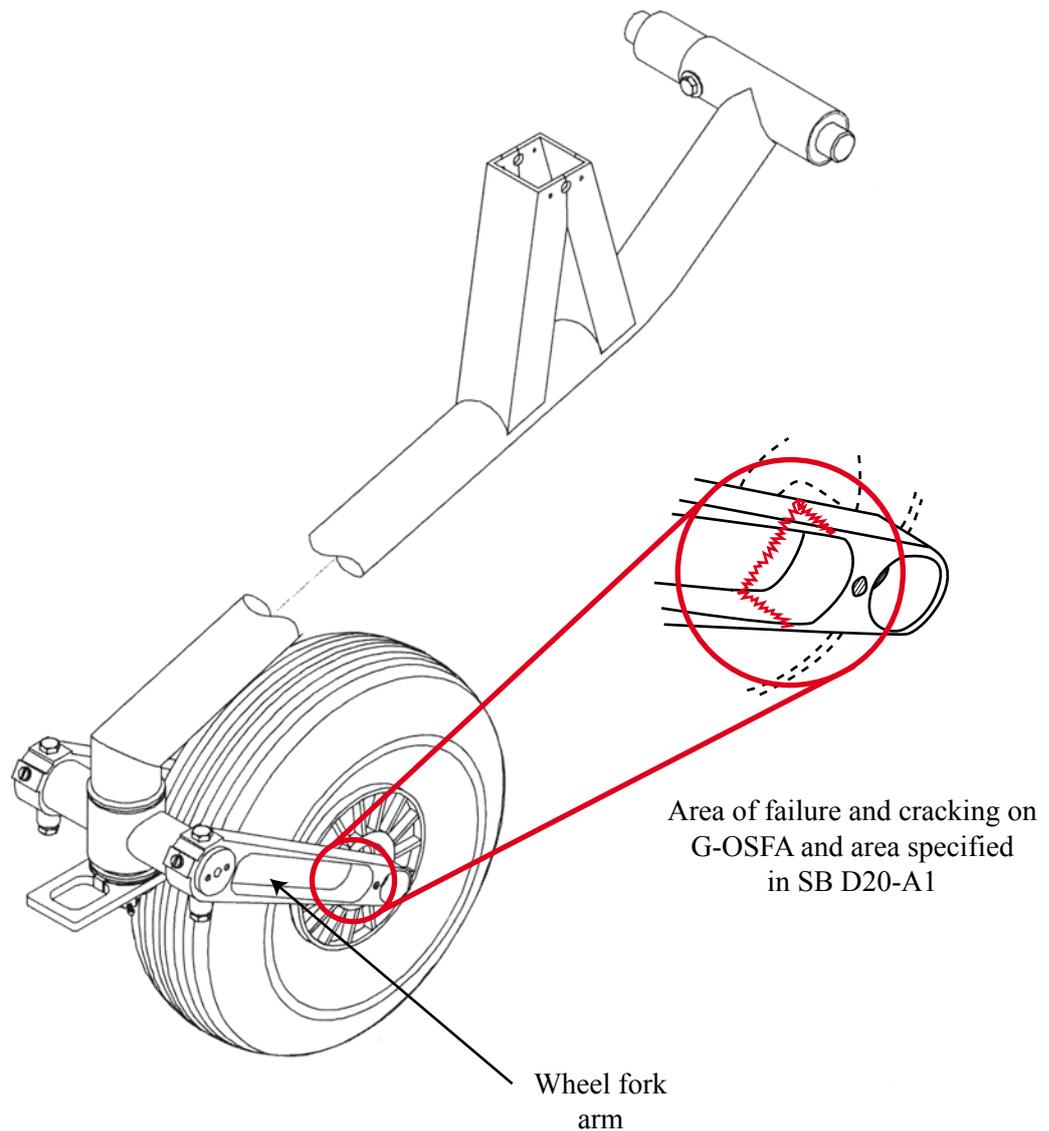
Figure 1 *Adapted from manufacturer's drawing*

Initial examination showed that the nosewheel fork had failed at both sides approximately 45 mm forward of the wheel's axle hole in the fork (Figure 1). Metallurgical

examination showed that both fork arms had failed in simple upward bending overload with a small amount of torsion in the right fork arm. This suggested that the left arm failed first, placing a twisting load on the unfailed portion of the right arm. Evidence from the failure surfaces indicated that a crack initiation had occurred from an event prior to that which resulted in the final failure. It was not possible to determine what the two events were or the time between them. There were no pre-existing material defects or damage to either of the fork arms. It was seen from the general appearance of the material surfaces that the fork arms had been sulphuric acid anodised. This could have adversely affected their resistance to surface crack initiation and propagation.

It was noted during the examination of the fork arms that there had been heavy contact between the insides of the arms and the sidewalls of the nosewheel tyre. It was also seen that the nosewheel tyre that was fitted was of a larger size (5.00-4) than that specified (4.00-4). With a

5.00-4 tyre fitted there is a 10 mm clearance between the tyre sidewall and the inside of the nosewheel fork arm whereas with a 4.00-4 tyre there is a 15 mm clearance.

the operator and were made available to the AAIB, who submitted them for metallurgical examination. Initial examination showed that both fork arms had cracked approximately 45 mm forward of the wheel's axle hole in the fork (Figure 1). Detailed examination showed that both fork arms had cracked in simple upward bending overload. Both fork arm cracks contained fretting products and debris indicating that the cracks had been present for a considerable time and that they had been subjected to a large number of upward cyclic bending loads. These cyclic bending loads had progressed the crack in the right fork arm. There were no pre-existing material defects or damage to either of the fork arms. It was seen from the general appearance of the material surfaces that the fork arms had been sulphuric acid anodised.

It is recommended that Diamond Aircraft Industries, the aircraft manufacturer, issue a service bulletin for HK36-TC aircraft requiring immediate and recurring inspections for cracking of the nose landing gear wheel fork arms.

It is recommended that Diamond Aircraft Industries, the aircraft manufacturer, fully appraise the sulphuric acid anodising of the nose landing gear wheel fork arms that are fitted to HK36-TC aircraft for its effect on fatigue crack resistance.

It is recommended that the European Air Safety Agency (EASA) review the design, manufacturing and material specifications for Diamond HK36-TC nose landing gear wheel fork arms for their suitability for continued airworthiness.
