AAIB Bulletin No: 12/93

Ref: EW/G93/08/18

Aircraft Type and Registration: Avid Speed Wing Mk 4 Avid Flyer, G-BUFV

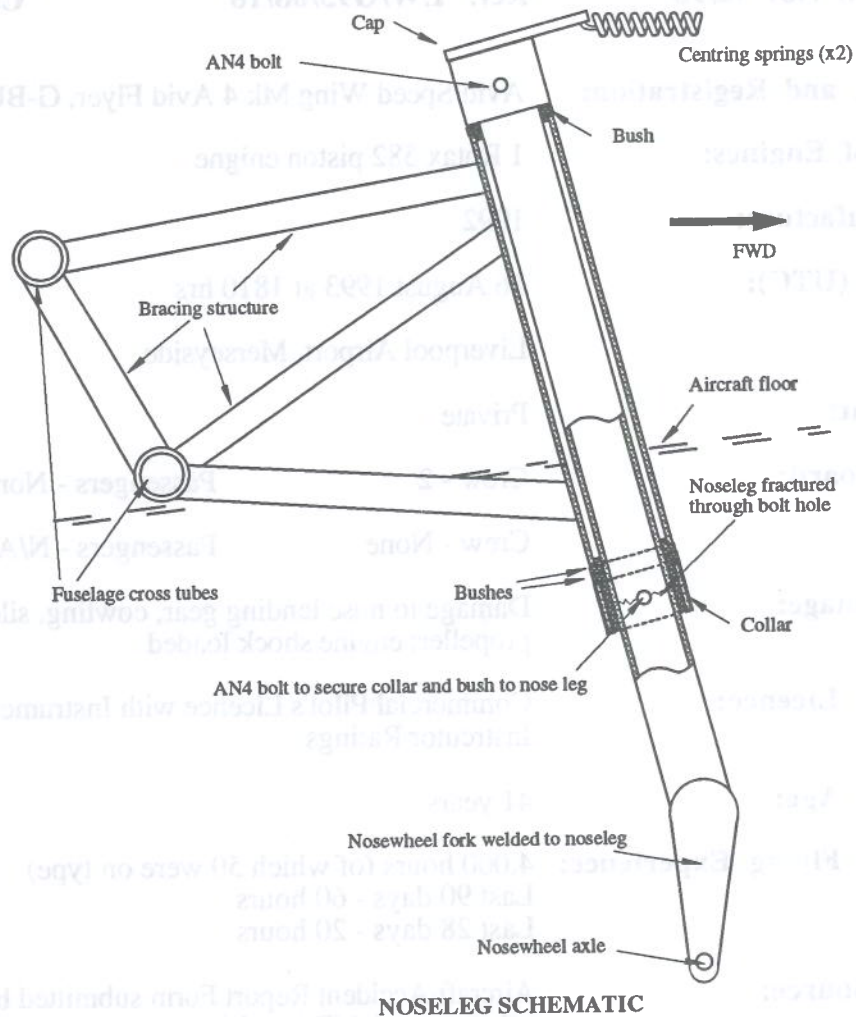
The nose landing gear consisted of a nosewheel fork welded to a steel tube which was inserted into a support tube in the fuselage. A bushed collar, attached via an AN4 bolt, located the lower leg axially within the support tube, as shown in the attached sketch. It was found that the leg had failed through the associated bolt hole.

The failed components were returned to the UK importer of the aircraft, which forwarded them to the manufacturer in the United States. The fracture faces were reportedly indicative of an overload failure which, according to the manufacturer, was likely to have been the result of a nosewheel 'shimmy' problem commonly encountered on this type of aircraft. In addition, the results of a stress analysis commissioned in the UK indicated an inadequate reserve factor on the nose leg. One other instance of nose leg failure is known to have occurred on this type.

New aircraft kits are being supplied with the nose leg tube wall thickness increased from 0.054 inches to 0.108 inches. A modification is available for in-service aircraft which consists of a reinforcing tube inserted inside the existing nose leg. The Popular Flying Association require that either this modification be embodied or the nose leg be replaced with the strengthened version, by the next renewal of the Permit to Fly.
