INCIDENT

Aircraft Type and Registration:	Boeing 767-31K, G-DAJC
No & Type of Engines:	2 General Electric Co CF6-80C2B7F turbofan engines
Year of Manufacture:	1994
Date & Time (UTC):	15 August 2010 at 0750 hrs
Location:	Gatwick Airport, West Sussex
Type of Flight:	Commercial Air Transport (Passenger)
Persons on Board:	Crew - 11 Passengers - 324
Injuries:	Crew - None Passengers - None
Nature of Damage:	Electrical overheating of an oven controller module
Commander's Licence:	Airline Transport Pilot's Licence
Commander's Age:	51 years
Commander's Flying Experience:	13,650 hours (of which 8,630 were on type) Last 90 days - 155 hours Last 28 days - 34 hours
Information Source:	Aircraft Accident Report Form submitted by the aircraft commander

Synopsis

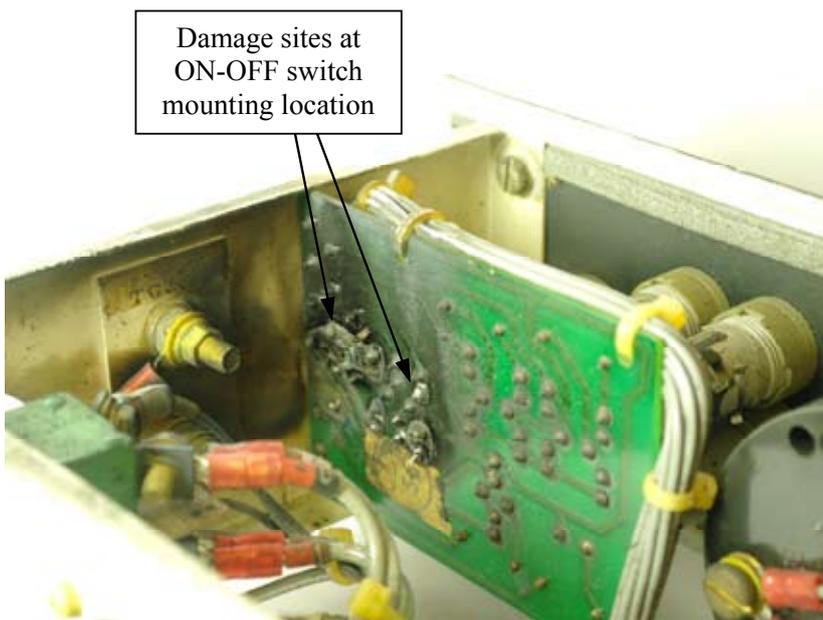
Figure 2

Following the incident, both forward galley ovens were removed from the aircraft by the operator's maintenance engineers. Whilst the left oven was undamaged, inspection of the right oven revealed that an electrical short circuit had occurred within the oven's controller module, and the controller's 5 amp circuit breaker had tripped. The controller's printed circuit board (PCB) assembly exhibited electrical overheat damage where the ON-OFF switch was mounted to the PCB, as shown in Figure 2. Localised burning of the PCB copper tracks and soldered connections at the ON-OFF switch location prevented examination of pre-existing defects in this area of the PCB.

Electrical overheating damage to the oven controller PCB

The damage to the oven controller's PCB indicates that an electrical short circuit occurred at the connection between the PCB and the oven controller's ON-OFF switch. The nature of the damage to the soldered connections and copper PCB

tracks at this location prevented further investigation into the cause of the short circuit. The oven controller's 5 amp circuit breaker, which was operating within its design specification, tripped and prevented further current from flowing and intensifying the electrical overheating.

The overheating damage was limited to the oven controller's PCB and was contained within the controller enclosure. Smoke caused by the overheating circuit board escaped from the controller enclosure and circulated around the forward galley ovens, causing confusion regarding its source.

A review of the maintenance history of the oven controller module did not reveal any defects that may have contributed to the initiation of an electrical short circuit, which is the most likely cause of the electrical overheating damage to the oven controller's PCB.
