**ACCIDENT**

<b>Aircraft Type and Registration:</b>	DA40D, G-CCLB	
<b>No &amp; Type of Engines:</b>	1 Thielert TAE 125-01 piston engine	
<b>Year of Manufacture:</b>	2004	
<b>Date &amp; Time (UTC):</b>	20 October 2005 at 1430 hrs	
<b>Location:</b>	Rochester Airport, Kent	
<b>Type of Flight:</b>	Training	
<b>Persons on Board:</b>	Crew - 2	Passengers - None
<b>Injuries:</b>	Crew - None	Passengers - N/A
<b>Nature of Damage:</b>	Nose gear, propeller and engine shock loaded	
<b>Commander's Licence:</b>	Commercial Pilot's Licence	
<b>Commander's Age:</b>	58 years	
<b>Commander's Flying Experience:</b>	6,692 hours (of which 420 were on type) Last 90 days - 125 hours Last 28 days - 31 hours	
<b>Information Source:</b>	AAIB Field Investigation

**Synopsis**

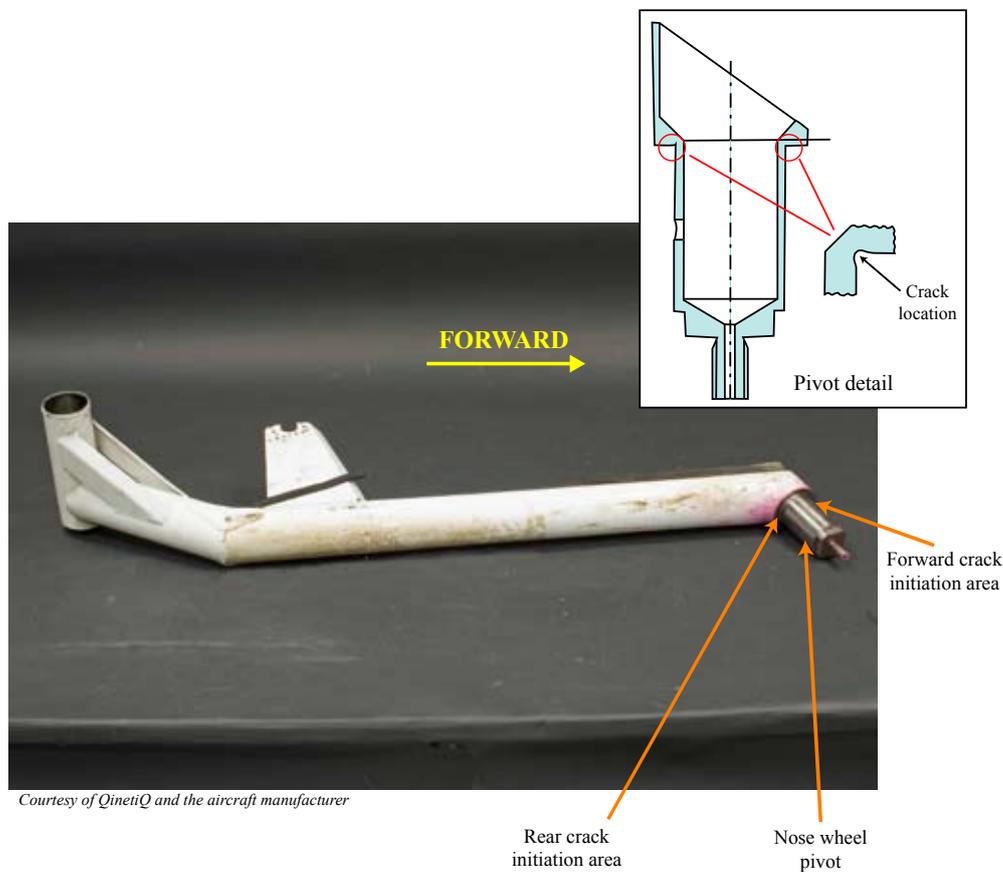
Figure 1

The manufacture of the nose landing gear (NLG) strut, Figure 1, is sub-contracted by the aircraft manufacturer to a metal fabrication organisation. This organisation manufactures the NLG from two different types of steel, 1.3477.4 sheet steel and SAE 4130 steel for the main structure, which includes the pivot. Post manufacture, a hardness test is carried out with the intention of ensuring that the assembly has been correctly heat treated and has achieved the required combination of strength and toughness. The NLG struts are not individually serial numbered, and only feature a manufacturer’s batch number, printed on a label attached to the inside of a section of the leg. Once the NLG is mounted on an aircraft it is difficult to access and view this label.

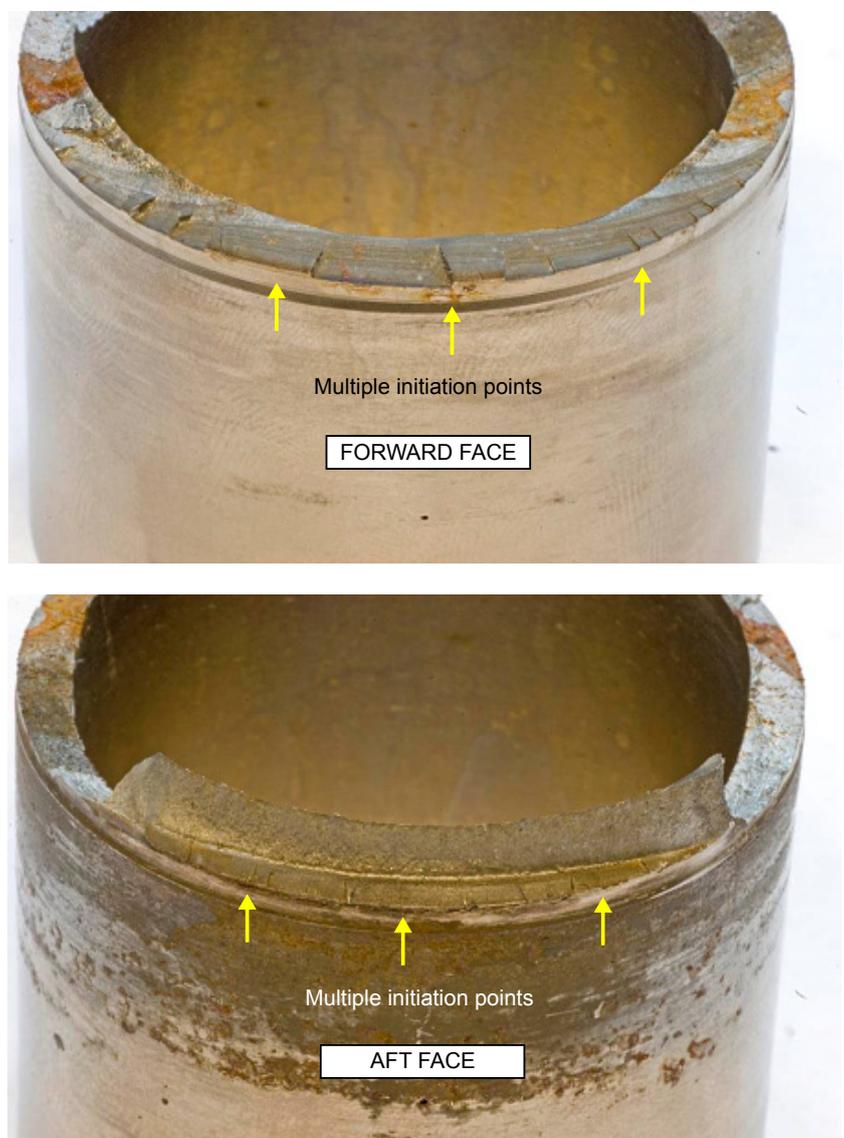
**Figure 2**

The NLGs from both aircraft were sent to AAIB for a detailed examination, which was carried out in conjunction with the Materials Centre at Qinetiq, Farnborough. The results of this showed that fatigue cracking had occurred at the top of both nose wheel swivel/castoring pivots in an undercut/ radius adjacent to an abutment shoulder, Figure 1. In both cases the fatigue cracks had initiated at multiple points in the radius at the forward and rear sides of the pivots, Figures 2 and 3. The cracks in the pivot from ‘LB had propagated around the majority of the circumference before the final overload failure occurred. The cracks in the pivot from ‘US were very similar to those found on ‘LB, albeit at an earlier stage of development and, as such, would almost certainly have eventually propagated to final failure in a similar manner.

Detailed examination of the fracture surfaces showed evidence of corrosion which had removed a large area of the fine fatigue striation detail. However, the fracture topography was typical of the propagation of a fatigue crack in steel. The area of the overload failure of the pivot from ‘LB showed evidence of ductile dimples typical of an overload failure. There was no evidence of any material defects or machining abuse which could have influenced the initiation of fatigue cracks, although there was evidence of corrosion on

Forward and aft face of the fractures pivot from G-CCLB

232 HV10, equivalent to a minimum ultimate tensile strength (UTS) of 734 MPa, and that of the pivot from 'US was 236 HV10, equivalent to a minimum UTS of 746 MPa. The specified minimum hardness on the aircraft manufacturer's drawing for the pivot is 320 HV, ie, a required minimum UTS of 1080 MPa, and thus both pivots were below the specified minimum strength required. A material composition check was carried out on both pivots, which showed that they had been manufactured from Society of Automotive Engineers (SAE) 4130 low alloy steel, the correct material as specified in the aircraft manufacturer's drawing. It was noted that the manganese and sulphur levels of their composition appeared to be slightly higher than those specified in SAE Aerospace Material Specifications (AMS) 6374 for this material, but this was not considered to have influenced the initiation or propagation of the fatigue cracking.

On 11 November 2005 the aircraft manufacturer issued a Mandatory Service Bulletin (SB) DAI MSB40-046 which requires that a visual inspection of the upper shoulder radius of the nose landing gear swivel/

The aircraft manufacturer is exploring the possibility of increasing the strength of the nose landing gear wheel swivel/castoring pivot with a view to modifying or removing the requirement for the heat treatment process during manufacturing.

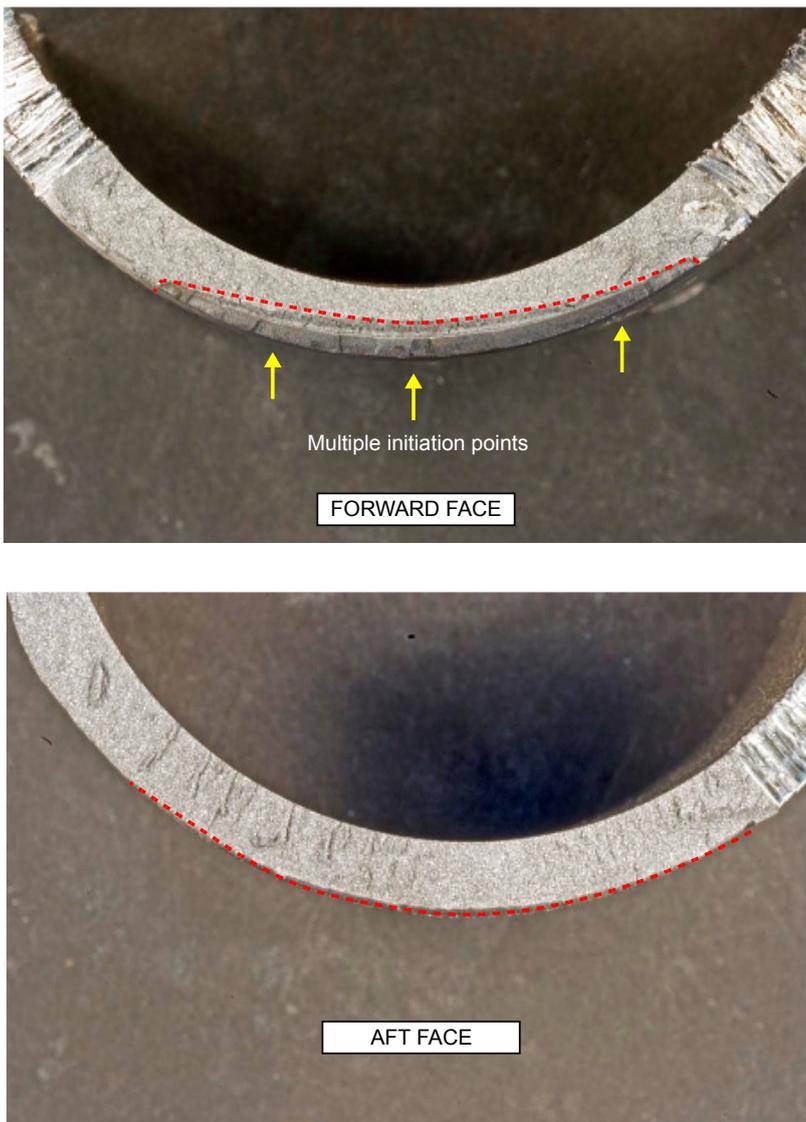
**Figure 3**

Initial visual examination of the failure area by a local aircraft engineer revealed what appeared to be a region of long term ‘staining’ on the failure surface, which indicated to him that there may have been a crack present for a period of time prior to the failure. This led the engineer to inspect the NLG of the other DA40D operated by the flight training school, G-CCUS (‘US), where he found evidence of a crack in the same area where the failure had occurred on G-CCLB (‘LB).

Forward and aft face of the fractures pivot from G-CCUS

However, when detected, the cracks in the pivot from 'US were considerably less well developed than to those associated with 'LB. If it is assumed that landing and taxiing loads are primarily responsible for crack propagation, then the minimum time/cycles for an incipient crack to propagate to failure would be around 308 landings/152 flights. It should be noted that these figures are only an estimate for crack growth and assume that the pivot material characteristics are identical, the fatigue cracks in both aircraft would initiate after the same time in service and that both would experience identical loading spectra. In reality this is unlikely to be the case.
