INCIDENT

Aircraft Type and Registration:	Boeing 737-800, TC-JGR	
No & Type of Engines:	2 CFMI CFM56-7B26 turbofan engines	
Year of Manufacture:	2006	
Date & Time (UTC):	16 October 2006 at 1101 hrs	
Location:	On departure from London Stansted Airport, Essex	
Type of Flight:	Commercial Air Transport (Passenger)	
Persons on Board:	Crew - 6	Passengers - 93
Injuries:	Crew - None	Passengers - None
Nature of Damage:	None	
Commander's Licence:	Airline Transport Pilot's Licence	
Commander's Age:	44 years	
Commander's Flying Experience:	10,500 hours (of which 7,000 were on type) Last 90 days - 230 hours Last 28 days - 82 hours	
Information Source:	AAIB Field Investigation

Synopsis

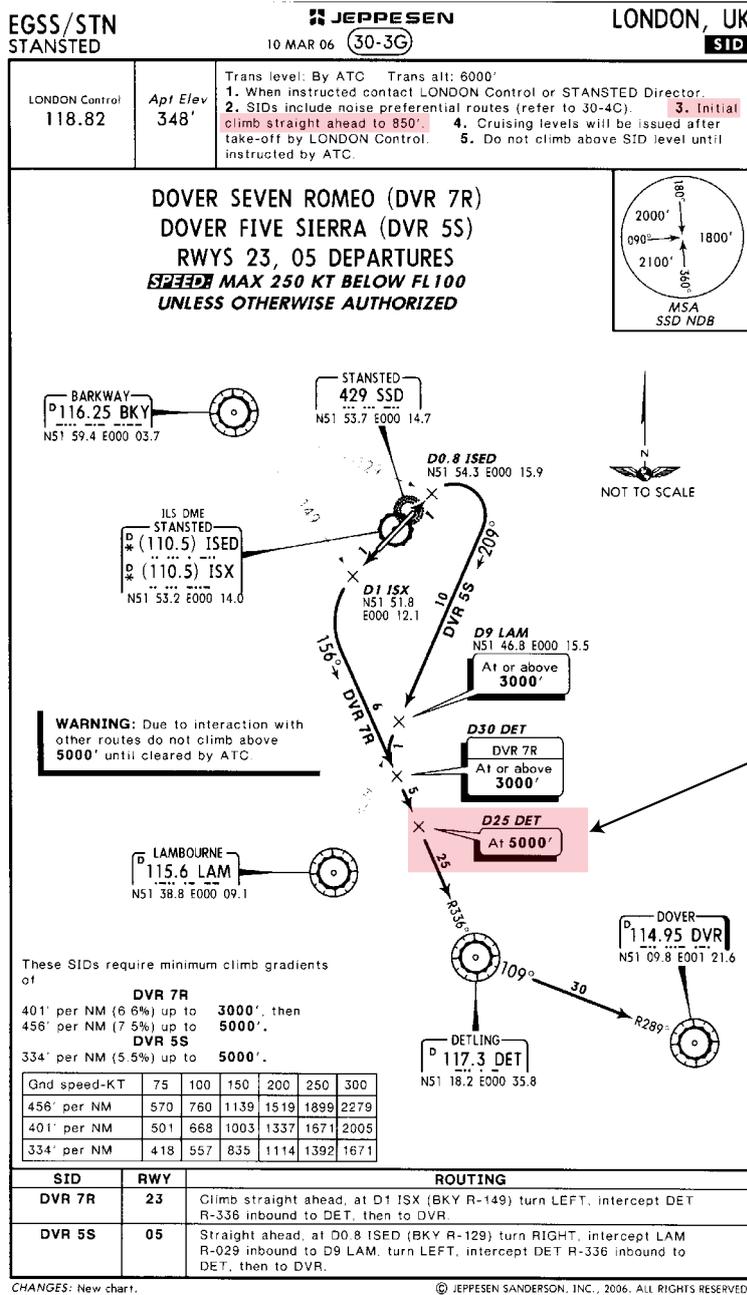
Figure 1

DVR 5S SID plate used by the crew

After the incident the commander realised that he and the co-pilot had not registered the exact meaning of the ‘Initial climb’ note on the SID plate and thought this might have been due to a language issue. He added that the format of the plate was also “unsuitable” compared to those of the other major European airports into which he operates, where the initial level-off altitude is displayed more conspicuously.

The commander commented that there might be a language issue with the *'Initial climb'* note on the plate. His initial doubt, during the co-pilot's brief, should have alerted him to seek clarification from ATC before takeoff. As he had operated out of other major UK airports before on "numerous occasions", he either interpreted the meaning of the note correctly or failed to notice it on the previous departures.

As a result of a misunderstanding of the notes on a SID plate and a breakdown in CRM, the crew did not comply with the prescribed altitudes on the SID and flew for several miles below the MSA. Had the MSA been more critical, this could have led to a more serious outcome.

To ensure the safety of the aircraft, the crew must ensure that they fully understand the meaning of all notes on any airport plate. If there is any doubt, clarification must be sought.

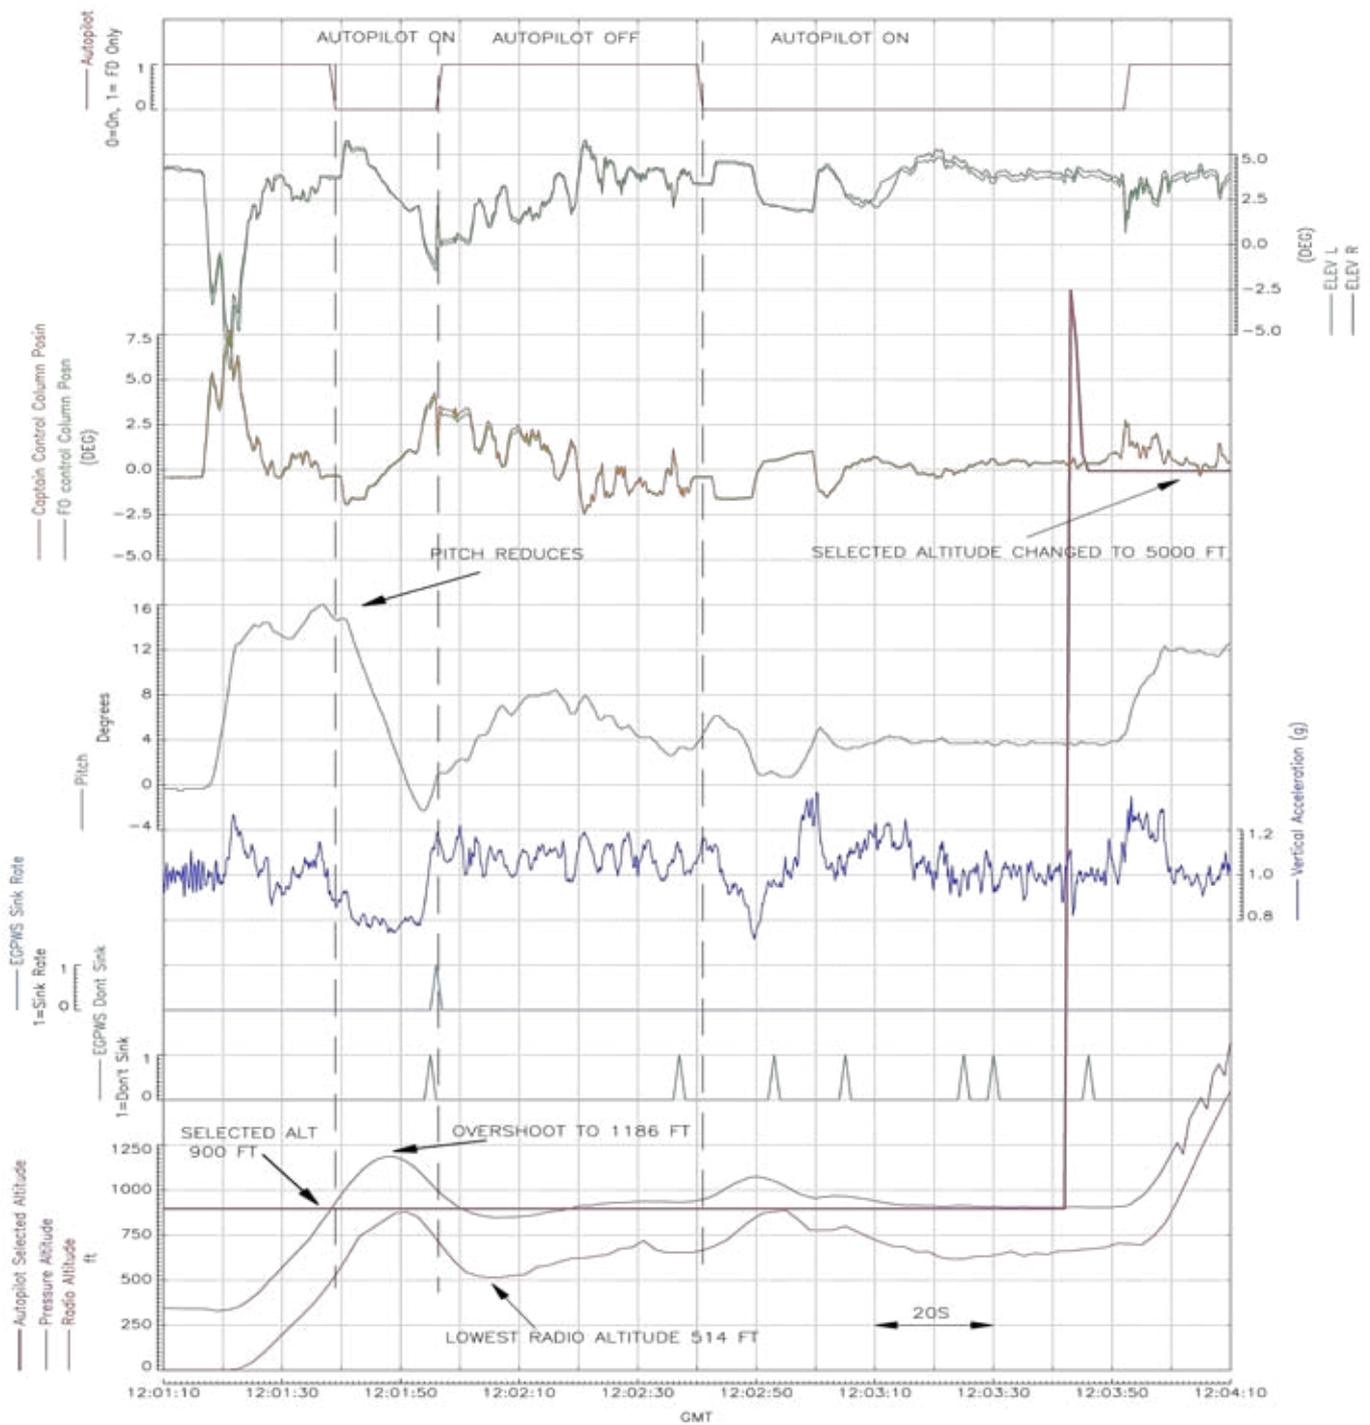
Figure 3
Flight data recorder (FDR) - TC-JGR

The FDR contained data covering just over 26 hours of operation. Takeoff occurred at 11:01:23 and around 16 seconds later, at a pressure altitude of around 882 ft, the autopilot was selected ON (see Figure 3). The autopilot selected altitude was 900 ft and 'Altitude Acquire' was immediately engaged. A pitch-down command was signalled by the autopilot but, due to the rate of climb and late acquire, TC-JGR overshot the selected altitude. It climbed to a maximum of 1,186 ft before descending towards 900 ft. The pilot then commanded a nose-down attitude, selected autopilot OFF and flew the aircraft manually, from around 974 ft.

At this point, the first EGPWS "DON'T SINK" alert was triggered. This alert is triggered when a significant altitude loss is detected with the landing gear or flaps not set in a landing configuration. The alert includes an audio message and EGPWS warning lights. The amount of altitude loss permitted is dependent on the height above the terrain (radio altitude). Data downloaded by the EGPWS manufacturer indicated a recorded altitude of 737 ft radio altitude at the time of the alert. From the FDR, this constitutes a 143 ft altitude decrease from the peak of 880 ft recorded just after takeoff.

One second after the "DON'T SINK" alert, an EGPWS "SINK RATE" alert was triggered. Unlike "DON'T SINK", this alert monitors for excessive descent rates with respect to radio altitude, in all phases of flight. At the time of the alert, the EGPWS recorded a descent rate of 2,029 ft/min at an altitude of 694 ft agl.

After disconnecting the autopilot, the pilot flew the aircraft manually and descended to a minimum altitude

of 514 ft agl. A steady increase in altitude to 719 ft agl (938 ft pressure altitude) ensued, followed by an additional altitude decay, triggering a second “DON’T

SINK” alert at 655 ft agl (932 ft pressure altitude). Pitch attitude was increased to 6° and the aircraft began to climb again.

Following this alert, the autopilot was re-engaged and, following an overshoot to 1,070 ft pressure altitude, the selected altitude of 900 ft was achieved. However, due to this overshoot and subsequent reduction to the selected altitude, five more “DON’T SINK” alerts were recorded by the EGPWS. At 11:03:42, the selected altitude was changed to 5,000 ft and 11 seconds later the aircraft began to climb. The remainder of the flight was uneventful.

The aircraft manufacturer analysed the behaviour of the autopilot system during the events detailed above and concluded that it had performed as expected, with the overshoot to 1,186 ft explained by the ‘late acquire’ by the autopilot just after takeoff. Further simulations indicated that, had the autopilot remained engaged, only a slight undershoot below the selected altitude of 900 ft would have occurred.
