INCIDENT

| Aircraft Type and Registration: | Embraer EMB-145EU, G-EMBT | |
| Date & Time (UTC): | 29 December 2006 at 2001 hrs | |
| Location: | Bristol Airport | |

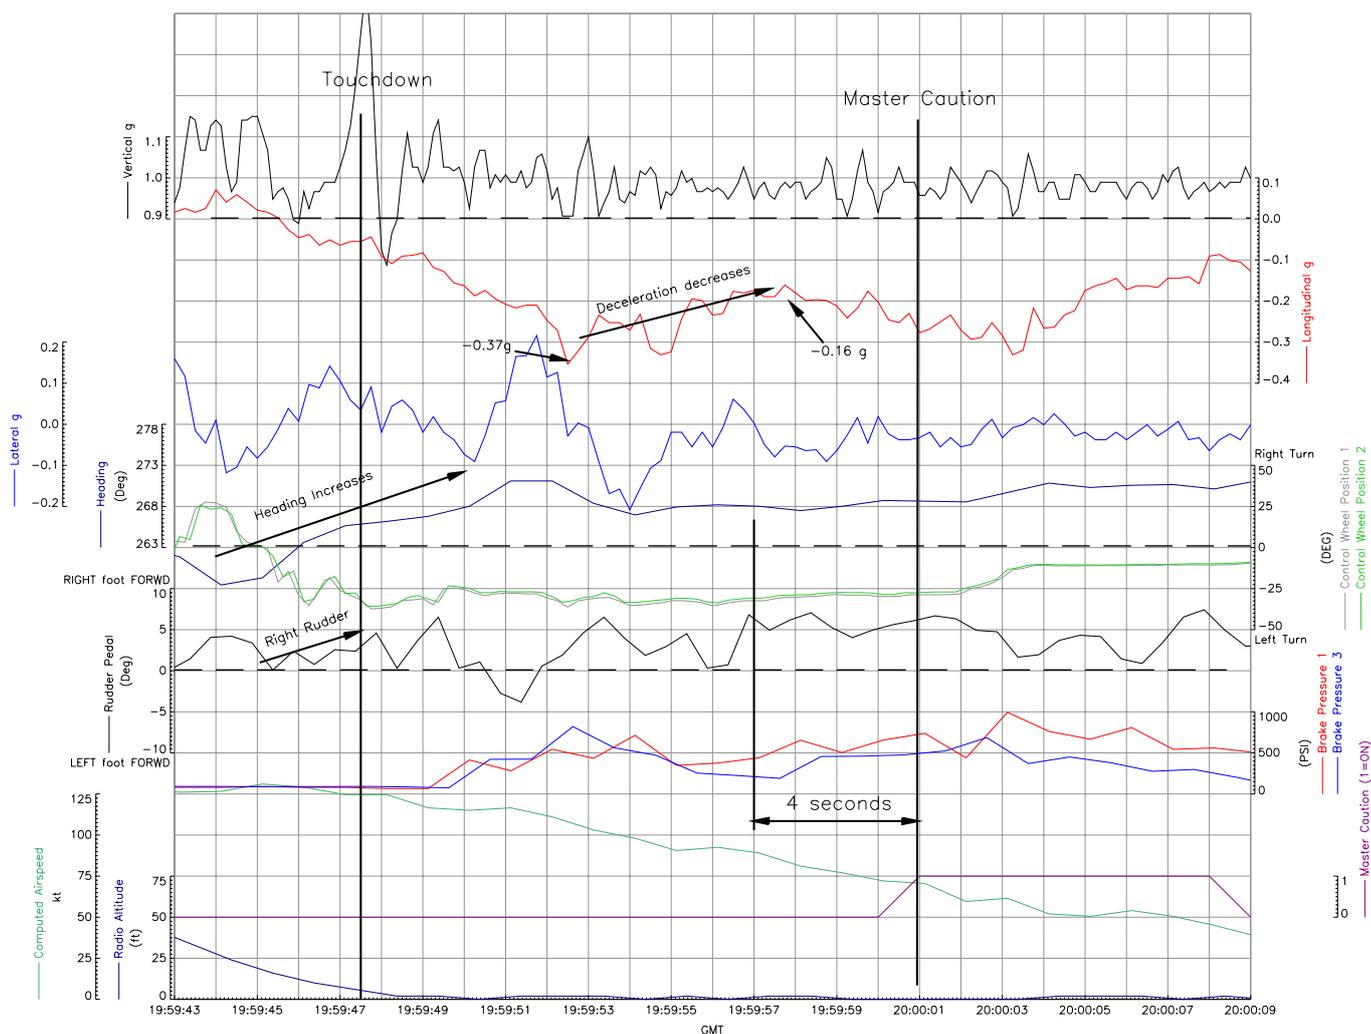
At 20:00:01, a master caution was triggered with the aircraft at a groundspeed of 79 kt. Based on the pilot's report, this master caution was probably triggered by the RHPS. According to the manufacturer, the 'RUDDER SYS 1-2 INOP' message requires a 3 second confirmation time. The message should appear at the same time as the master caution. The master caution is recorded by the FDR every second so, in this case, the event which triggered it would be between three and four seconds before 20:00:01.

Figure 2 confirms that, during this 4 second period, the minimum rudder pedal deflection was 4°, corresponding to 6.7° of right rudder deflection.

G-EMBT FDR Parameters

The Master Caution associated with the RHPS trip occurred at 20:00:01 hrs. According to the aircraft manufacturer there is a 3 to 4 second delay time between RHPS trip and Master Caution trigger. Therefore, the probable time of RHPS activation was between 19:59:57 and 19:59:58. During this period the pedal was deflected by more than 3° to the right, which means that the rudder was deflected by more than 5° to the right. So, during this period the left pedal spring cartridge microswitch probably tripped in order to trigger RHPS. This would normally only occur as a result of a 130 lbf force being applied to the left pedal. It is possible that the pilot was applying a heavy force to both pedals as a result of his attempts
