**INCIDENT**

<b>Aircraft Type and Registration:</b>	Fokker F27-500, EI-SMF	
<b>No &amp; Type of Engines:</b>	2 Rolls-Royce Dart 532-7 turboprop engines	
<b>Category:</b>	1.1	
<b>Year of Manufacture:</b>	1984	
<b>Date &amp; Time (UTC):</b>	8 September 2004 at 0114 hrs	
<b>Location:</b>	Stansted Airport, Essex	
<b>Type of Flight:</b>	Public Transport (Non revenue)	
<b>Persons on Board:</b>	Crew - 2	Passengers - None
<b>Injuries:</b>	Crew - None	Passengers - N/A
<b>Nature of Damage:</b>	Overheat and turbine damage to left engine	
<b>Commander's Licence:</b>	Airline Transport Pilot's Licence	
<b>Commander's Age:</b>	46 years	
<b>Commander's Flying Experience:</b>	2,730 hours (of which 1,700 were on type) Last 90 days - 60 hours Last 28 days - 28 hours	
<b>Information Source:</b>	AAIB Field Investigation

**Synopsis**

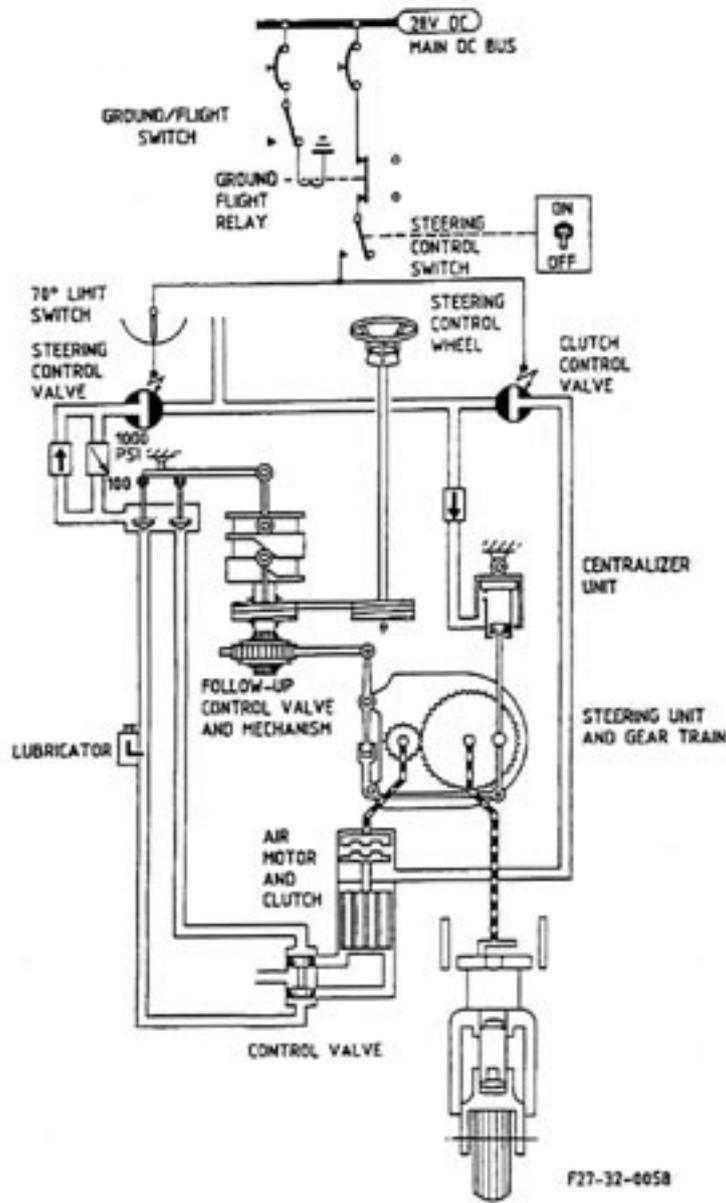
Figure 1

NOSE WHEEL STEERING SYSTEM - OPERATION
