INCIDENT

Aircraft Type and Registration: BAC One-Eleven 518FG, G-OBWD
No & Type of Engines: 2 Rolls-Royce Spey 512-14DW turbofan engines
Year of Manufacture: 1970
Date & Time (UTC): 29 September 1993 at 2302 hrs
Location: Norwich Airport, Norfolk
Type of Flight: Public Transport
Persons on Board: Crew - 6 Passengers - 57
Injuries: Crew - None Passengers - None
Nature of Damage: None
Commander's Licence: Airline Transport Pilot's Licence
Commander's Age: 47 years
Commander's Flying Experience: Approximately 7,500 hours (of which 600 were on type)
Last 28 days - 38 hours
Information Source: AAIB Field Investigation

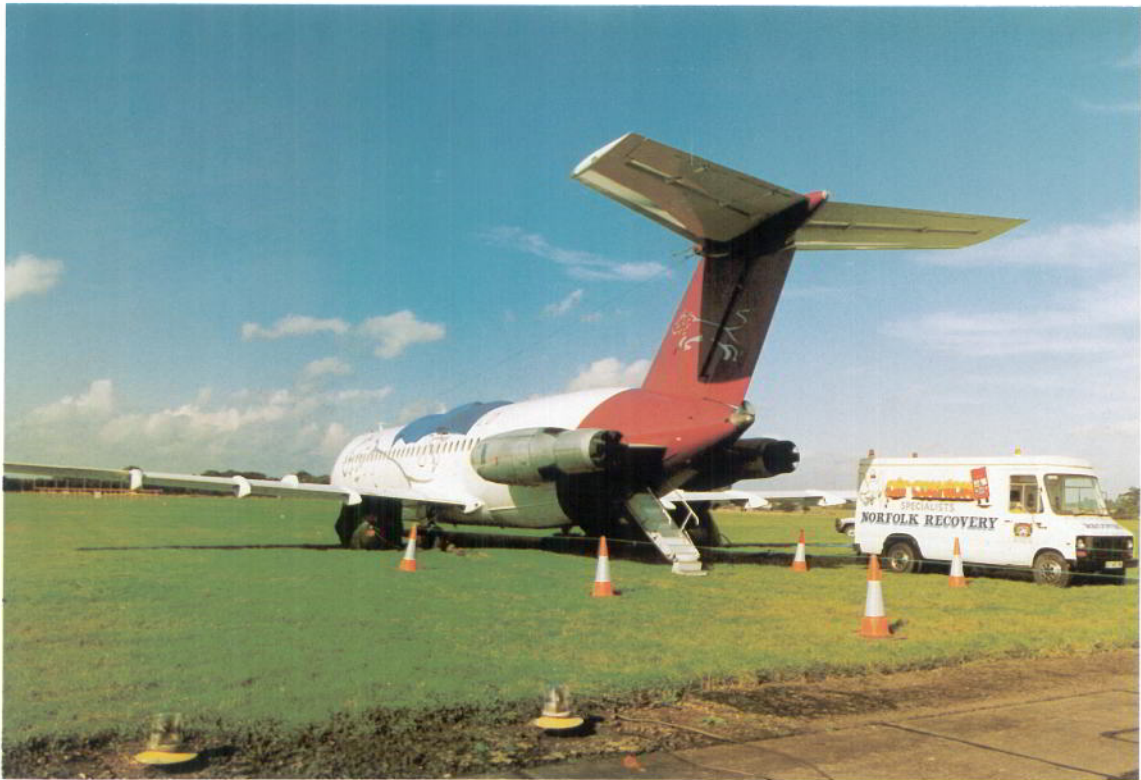
Figure 1

The aircraft had entered the designated stopway area and had come to rest with the mainwheels 20 metres from the end of the paved surface, the nosewheels 33 metres. The aircraft's wheel tracks could clearly be seen in the stopway (Figures 1 and 3). Before the aircraft had come to rest the nose and

Aircraft In Relation To Runway End, Stopway And Localiser Aerial

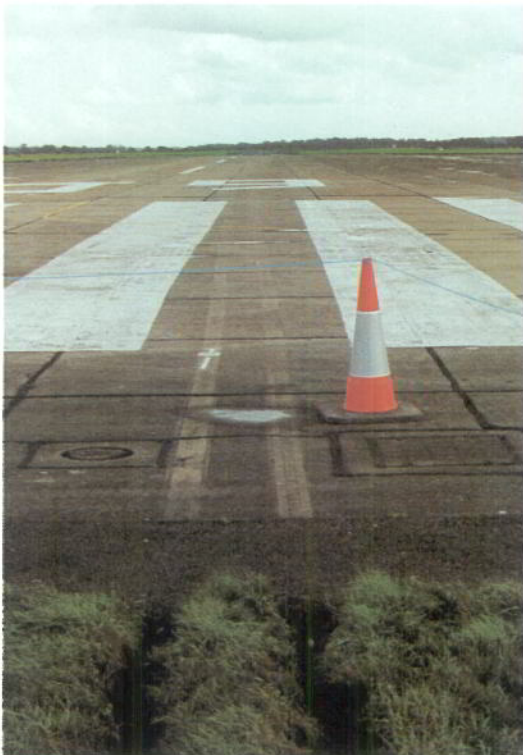
Figure 2

Evidence of wheel marks on the runway from this aircraft could only be positively identified on the concrete surface which formed the last 255 metres of Runway 27. These marks took the form of tyre tracks of a lighter colour than the natural (dirty) surface of the concrete, and were typical of such marks which result from the scouring/cleaning action provoked by water which is abruptly forced out from under the tyre footprint area by high hydrodynamic pressure (Figure 2). Tracks were evident from all four mainwheel tyres and, to a lesser extent, from both nosewheel tyres. There was no evidence from the surface that the tyres had been abraded by, for example, wheel locking. At the time of this examination there was evidence from wet and damp areas on the concrete that water could form shallow puddles on the concrete surface. As the aircraft had passed over the transition line from asphalt to concrete it could be seen that it had been slightly to the right of the centreline but had moved to the left such that the right mainwheels were on the runway centreline by the time the aircraft departed the paved surface.

Left Main Tyres Scouring Marks

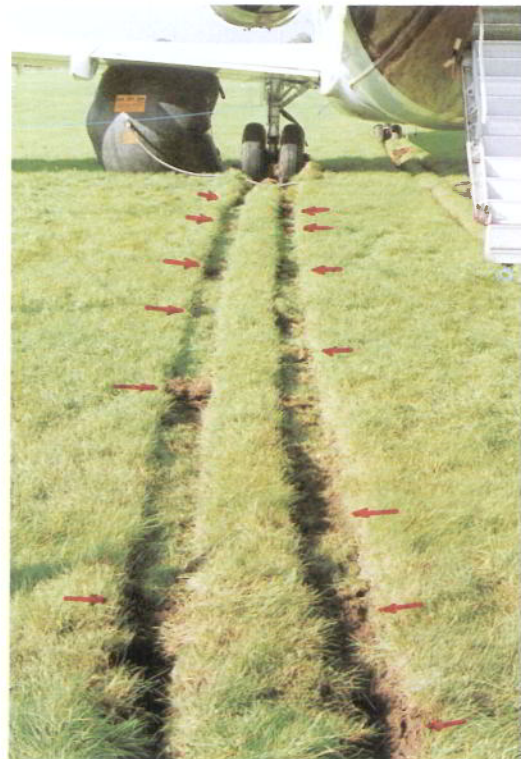
Figure 3

mainwheels had penetrated approximately six inches into the surface but sank deeper, up to the axle positions, in the last few feet of travel. The right main gear had sunk deeper in the ground after the coming to rest, such that the right wingtip was reported to have been approximately three feet above ground level before the aircraft was levelled by the use of airbags. During this period it was reported that fuel was spilt from a vent in the right wingtip. It was apparent that the anti-skid system on the four main wheels had been operating over most of the grass surface, alternate skid and wheel rolling marks being evident.

**Left Main Tyre Tracks Across Stopway
Arrows Indicate Skid Marks**
