ACCIDENT

Aircraft Type and Registration:	Reims Cessna F406 Caravan II, G-TWIG
No & Type of Engines:	2 Pratt & Whitney Canada PT6A-112 turboprop engines
Year of Manufacture:	1987
Date & Time (UTC):	22 October 2004 at 1033 hrs
Location:	37 miles north-west of Inverness
Type of Flight:	Public Transport (non-revenue)
Persons on Board:	Crew - 1 Passengers - None
Injuries:	Crew - 1 (Fatal) Passengers - N/A
Nature of Damage:	Aircraft destroyed
Commander's Licence:	Airline Transport Pilots Licence
Commander's Age:	35 years
Commander's Flying Experience:	2,735 hours (of which 510 were on type) Last 90 days - 170 hours Last 28 days - 48 hours
Information Source:	AAIB Field Investigation

Synopsis

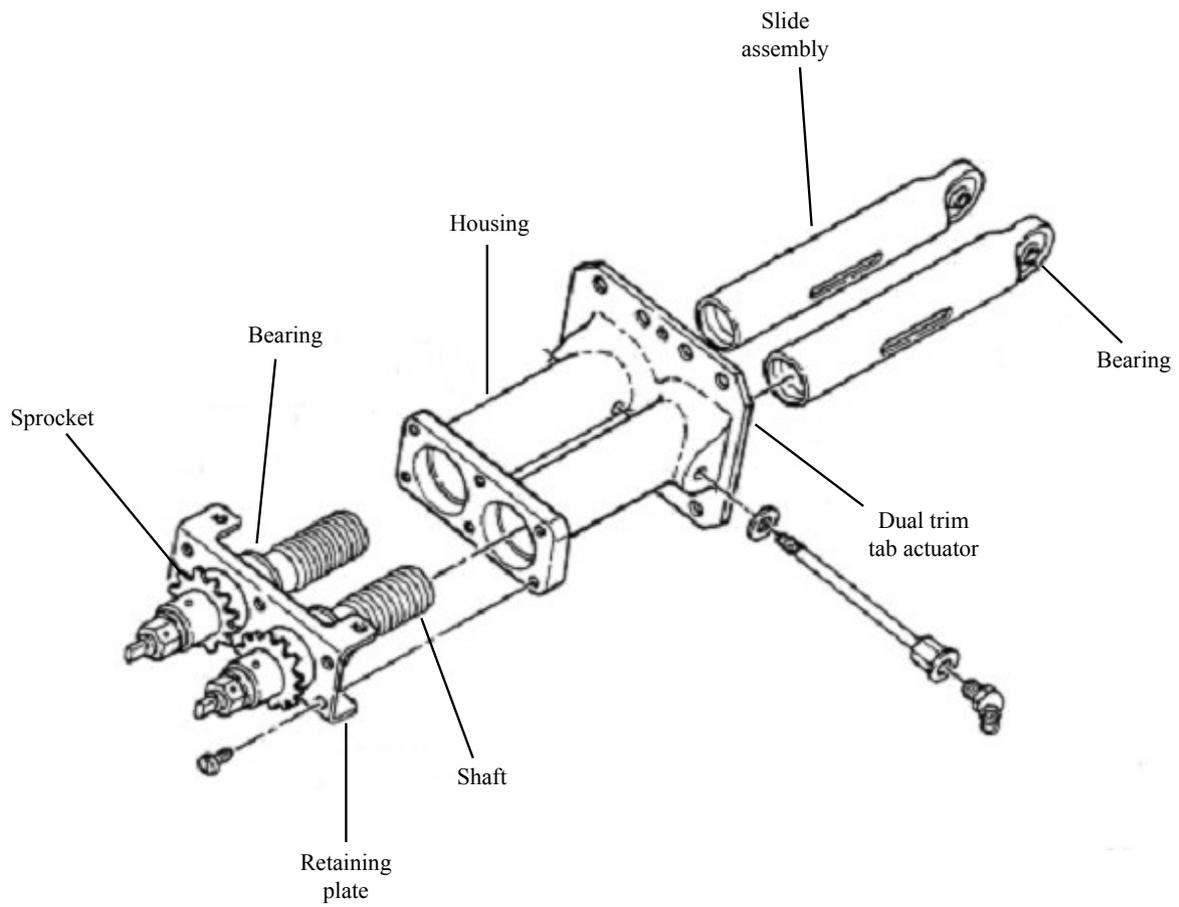
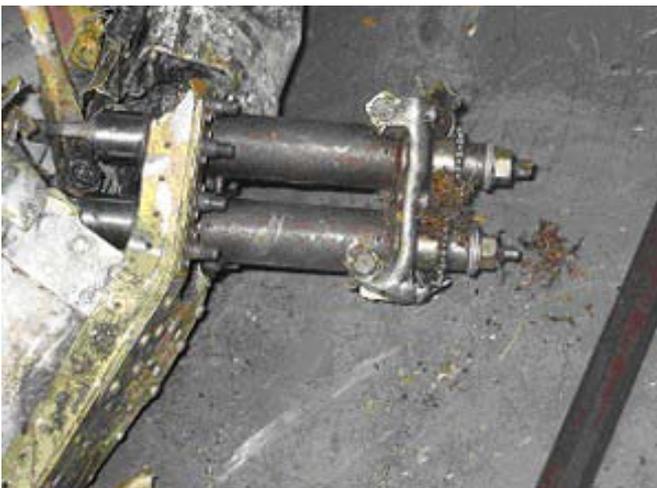
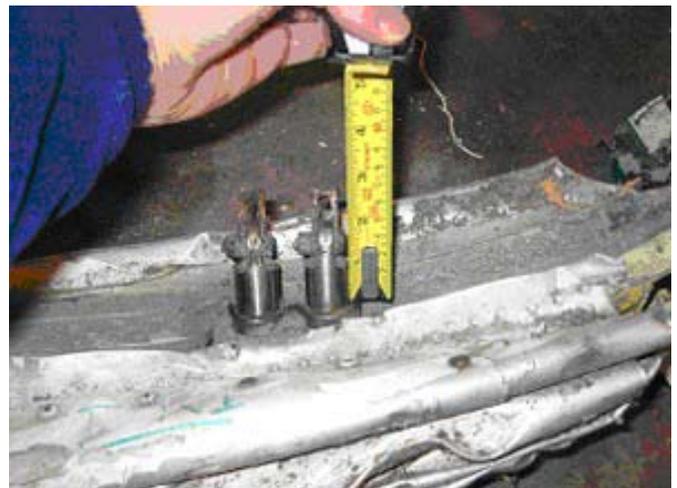
Figure 1
Details of pitch trim jack

There were two elevator trim actuators on this aircraft, operating tabs on both elevators. Both units were present in the wreckage and the linkages to the tabs were intact. Each actuator comprised a 'twin-pack', which consisted of two screw-jacks driven by sprocket assemblies which in turn were operated by chains that formed part of the elevator trim circuit. Operation of the pitch trim system (whether by means of the manual or electric system, or by the autopilot), thus caused all the jack-screw assemblies to move in unison. A diagram of one actuator, together with photographs, is shown at Figure 1. Rotation of the sprockets caused the sliders (which were attached to rods that moved the tabs) to move back and forth: they extended for nose-down trim and retracted for nose-up trim. All the sliders were extended by a similar amount. Comparison with an intact aircraft revealed that the slider positions equated to almost a fully nose-down trim condition.

During the high-speed impact, in which the airframe must have disintegrated extremely quickly, tension in the trim operating cable/chain system would have been lost due to foreshortening of the fuselage. However, as the tail section broke up, there may have been scope for considerable snatch-loads to be applied to localised lengths of cable close to the elevators. Whilst such loads may have moved the trim actuators, the simultaneous distortion that was occurring in the structure and tab linkages would have resisted such movement leading to overload failures in the cable. As a consequence, it is likely that little significant slider movement occurred during the impact. Therefore, the 'as-found' positions of the elevator trim actuators were most probably representative of the pre-impact settings.

Investigation of the pitch trim system revealed that the elevator trim actuators were near their fully nose-down positions whereas the appropriate setting for the weight and balance conditions was 0.125 in from the fully nose-down position. There are only three possible reasons for the as-found positions of the actuators: the commander trimmed to this position; a fault in the electric trim system caused an uncommanded trim input; or there was a fault in the autopilot. There appears to be no logical reason why the commander would trim to such a nose-down setting at the normal airspeed used in a descent. However, the as-found trim setting may have been appropriate to some higher airspeed. It was not possible to discount an electric trim system malfunction although flight tests indicated that the control forces could have been overcome with little difficulty. Similarly, the most serious potential fault in the autopilot, a spurious nose-down input followed by failure to disengage automatically when the pitch angle exceeded 21° nose-down, could not be discounted. If that had happened, the commander would have had to overcome the force of the servo motor in addition to the aerodynamic force. Whilst this force may have been significant, possibly in excess of 40 lbf, the commander would have had the option of switching off the autopilot and manually re-trimming the aircraft. Switching off the autopilot via the electrical master switch might explain why the aircraft's secondary radar return was lost but it does not explain why only one more primary return was received. Moreover, had the commander been combating a run-away trim system, it seems likely that he would also have reduced engine power and rolled the aircraft's wings level to recover from a dive.

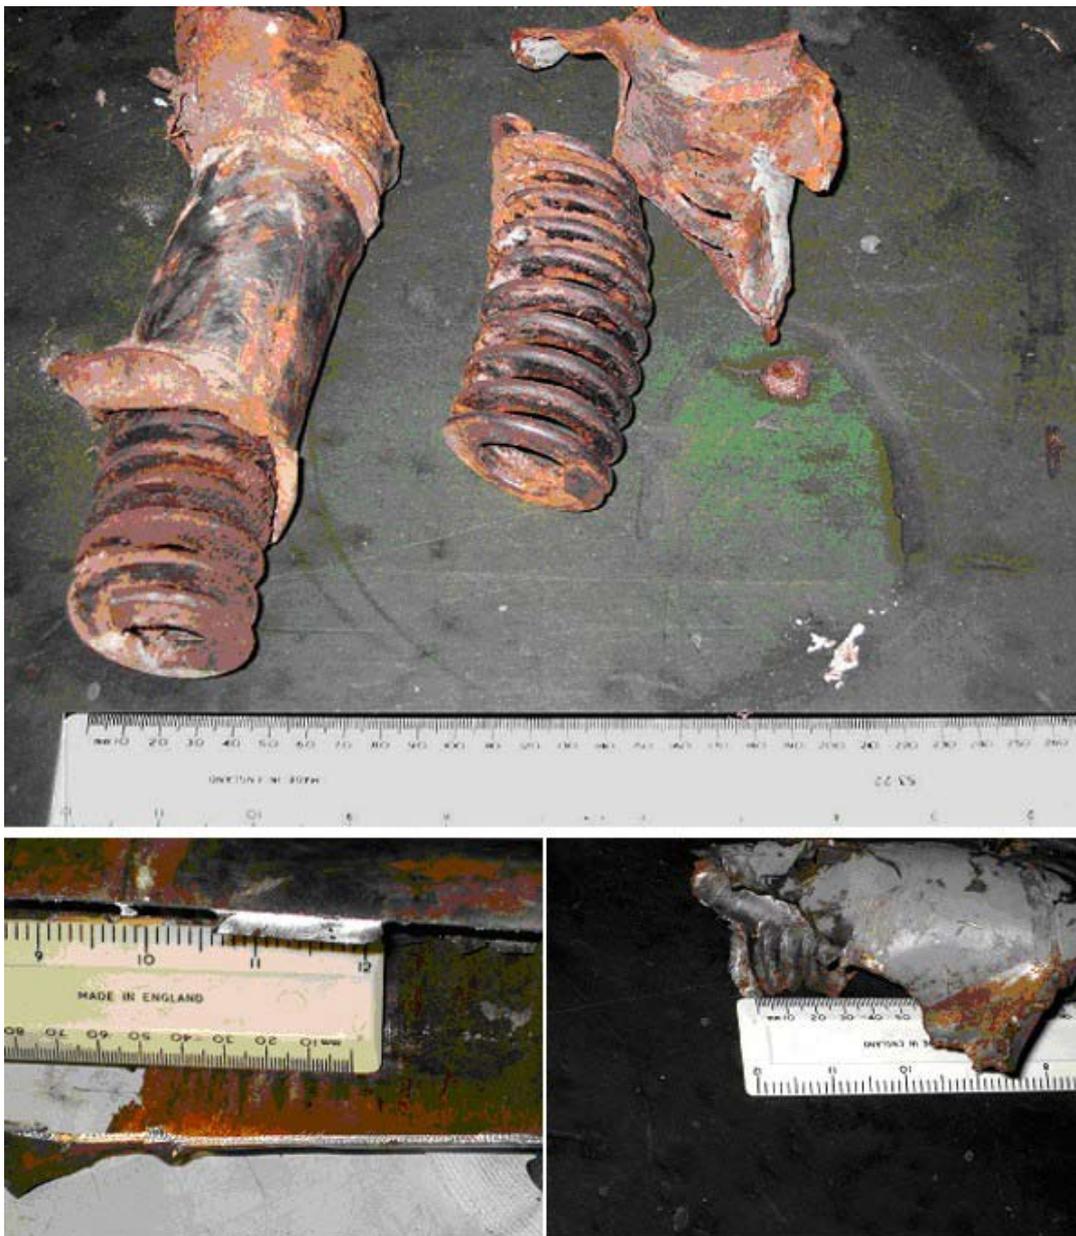
Figure 2

coils during the impact. The average spacing between the coil imprints can vary according to the fore-aft position of the dome, which in turn is a function of the propeller blade angle. The imprints were measured (see Figure 2), which revealed that the spacings were the same for both tubes, indicating that the left and right propeller angles were very similar. Using the measured spacing of 8.33 mm, the propeller manufacturer was asked to determine the corresponding blade angle.

Remains of feathering springs, showing coil imprints on tube bores

The 'as-found' blade angle, for both propellers was 55.2°. It was stated that the blade angle would increase by approximately 2.7° for every 50 kt increase in airspeed, with temperature and altitude changes resulting in comparatively smaller blade angle changes.

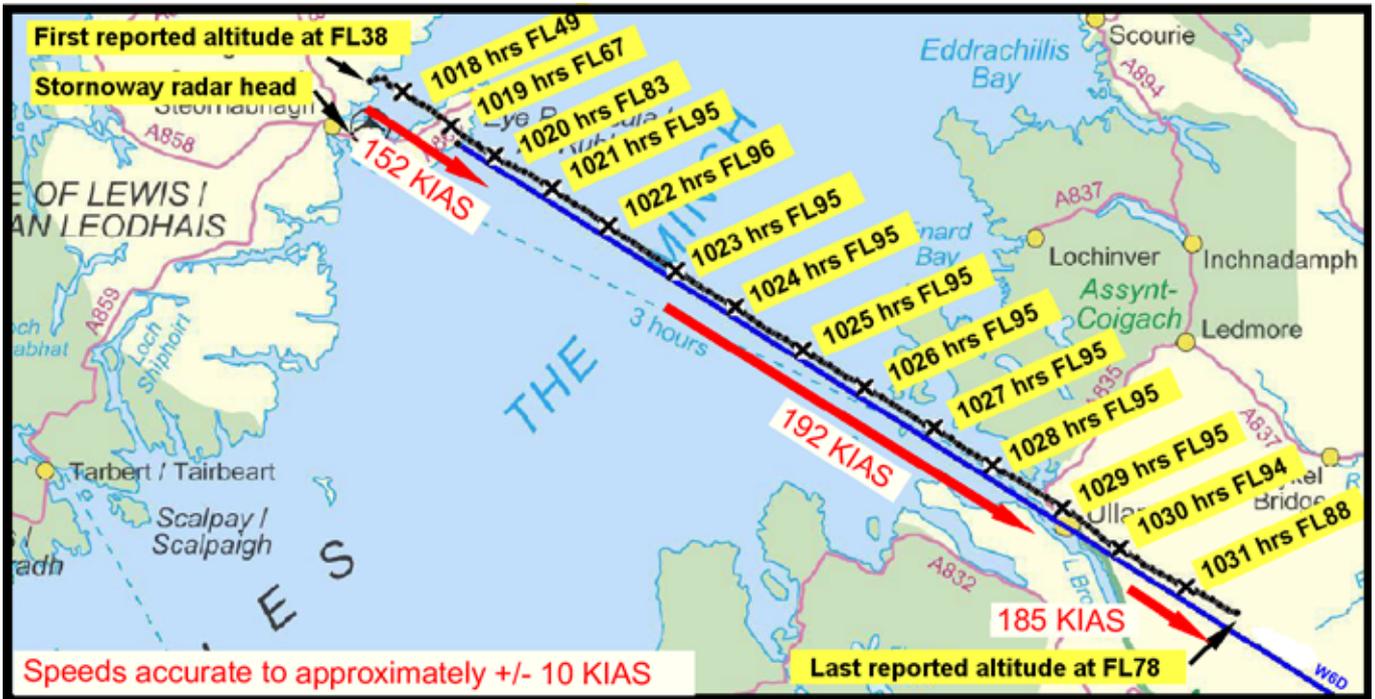
Figure 4a

The Stornoway secondary radar track with reported altitude

750 ft/min until FL88 (approximately 8,200 ft amsl) at which point the descent rate started to fluctuate, approximately 50 seconds before the aircraft track was lost. Due to the coarse nature of the altitude data, it was difficult to determine the flight path between individual radar returns. However, the average descent rate between the last two recorded points was between 1,500 ft/min and 3,000 ft/min. The last radar point was at 1031 hrs with the aircraft at FL78 which was approximately 7,200 ft amsl.

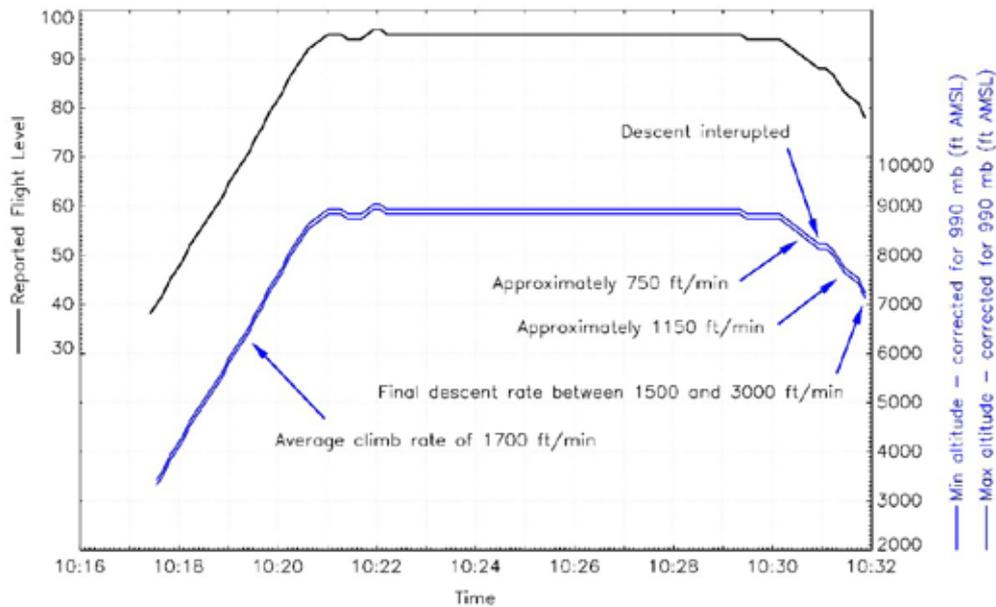
Figure 4b

The Stornoway secondary radar track derived parameters

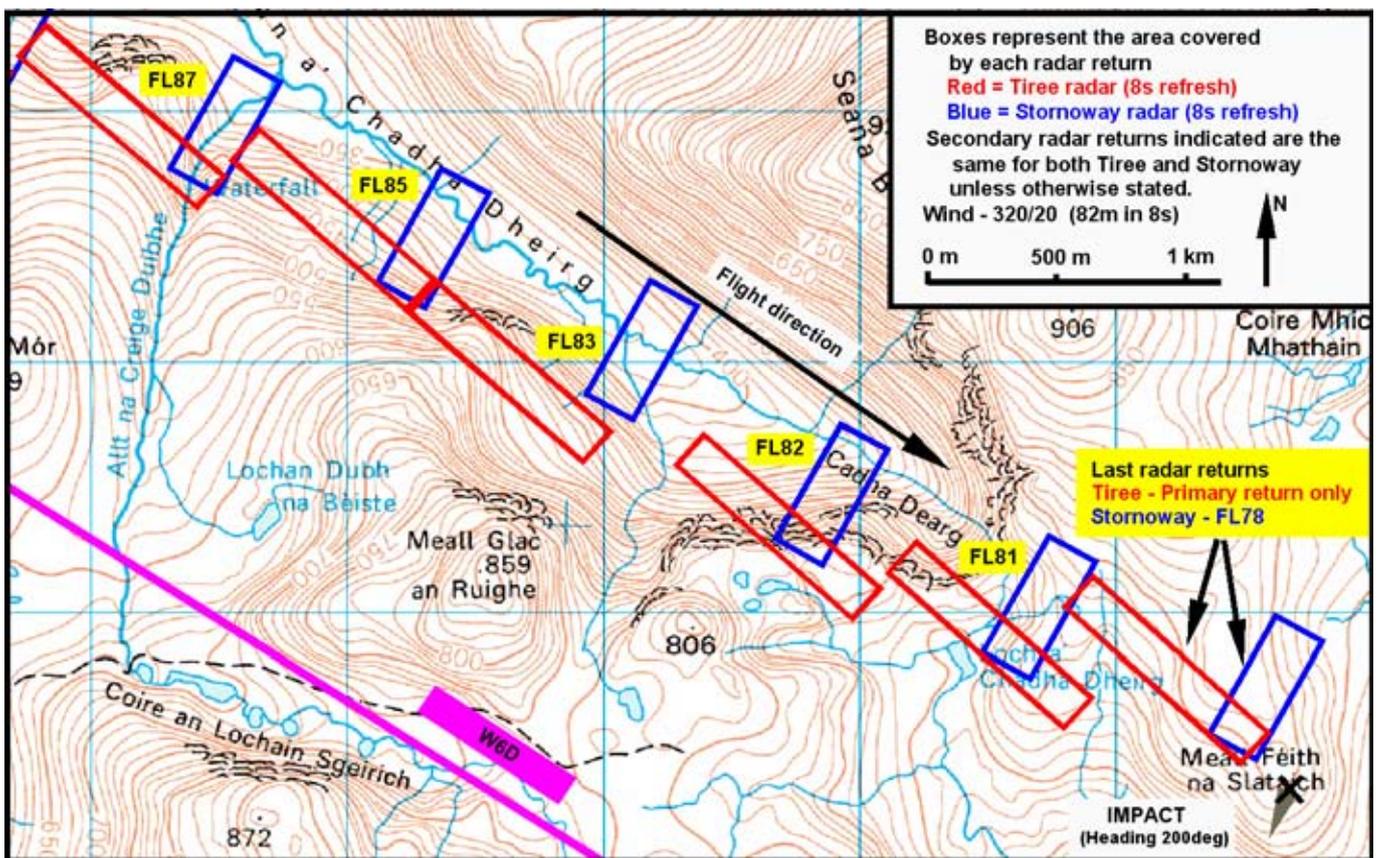
Figure 5

Overview of the final radar track points from Tiree and Stornoway against the impact site, impact orientation and local terrain.

1. Despite being vertically separated by nearly 5,000 ft, the aircraft impact was within a few hundred metres of the final radar return.
2. The aircraft turned left relative to its previous flight path in the last few radar sweeps.
3. Reaching the impact point required a significant change in heading after the relative motion of the last radar points.
4. None of the radar heads recorded, or were observed to display, the aircraft after it descended through FL78 despite having line of sight capabilities significantly below this level.
5. The Tiree secondary radar did not detect the aircraft at FL78 despite Stornoway secondary radar and Tiree primary radar detecting it. Also, the observer of the Kinloss secondary radar did not recall seeing any returns below FL81.

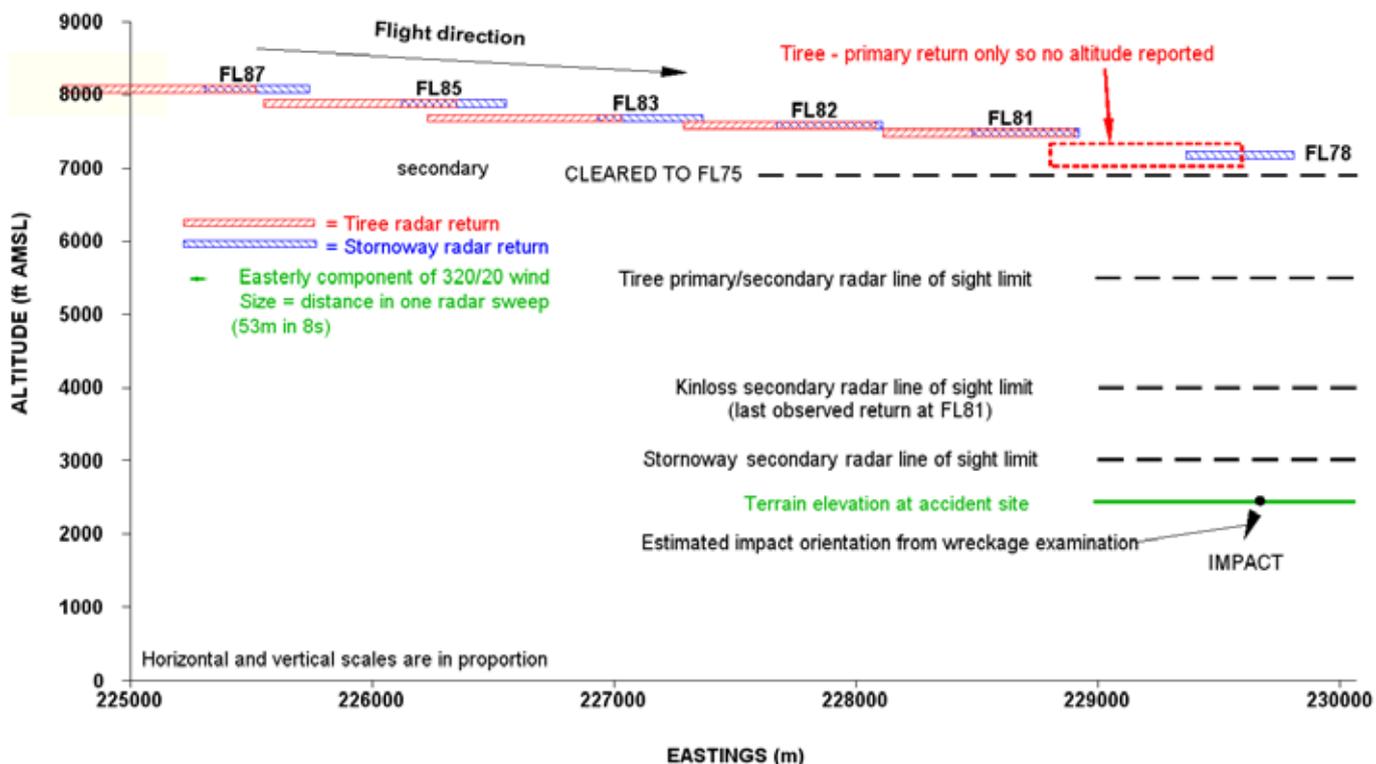
Figure 6

View of the final radar track points from Tiree and Stornoway, as viewed from a point to the South of the accident site
