ACCIDENT

Aircraft Type and Registration:	Savannah VG Jabiru (1) microlight, G-CEGK	
No & Type of Engines:	1 Jabiru Aircraft Pty 2200 piston engine	
Year of Manufacture:	2006	
Date & Time (UTC):	3 May 2008 at 1430 hrs	
Location:	Church Inn Field, approximately 10 miles NW of Chichester, West Sussex	
Type of Flight:	Private	
Persons on Board:	Crew - 1	Passengers - 1
Injuries:	Crew - None	Passengers - None
Nature of Damage:	Damage to landing gear, wingtips and propeller	
Commander's Licence:	Private Pilot's Licence	
Commander's Age:	44 years	
Commander's Flying Experience:	482 hours (of which 70 were on type) Last 90 days - 26 hours Last 28 days - 12 hours	
Information Source:	Aircraft Accident Report Form submitted by the pilot

Synopsis

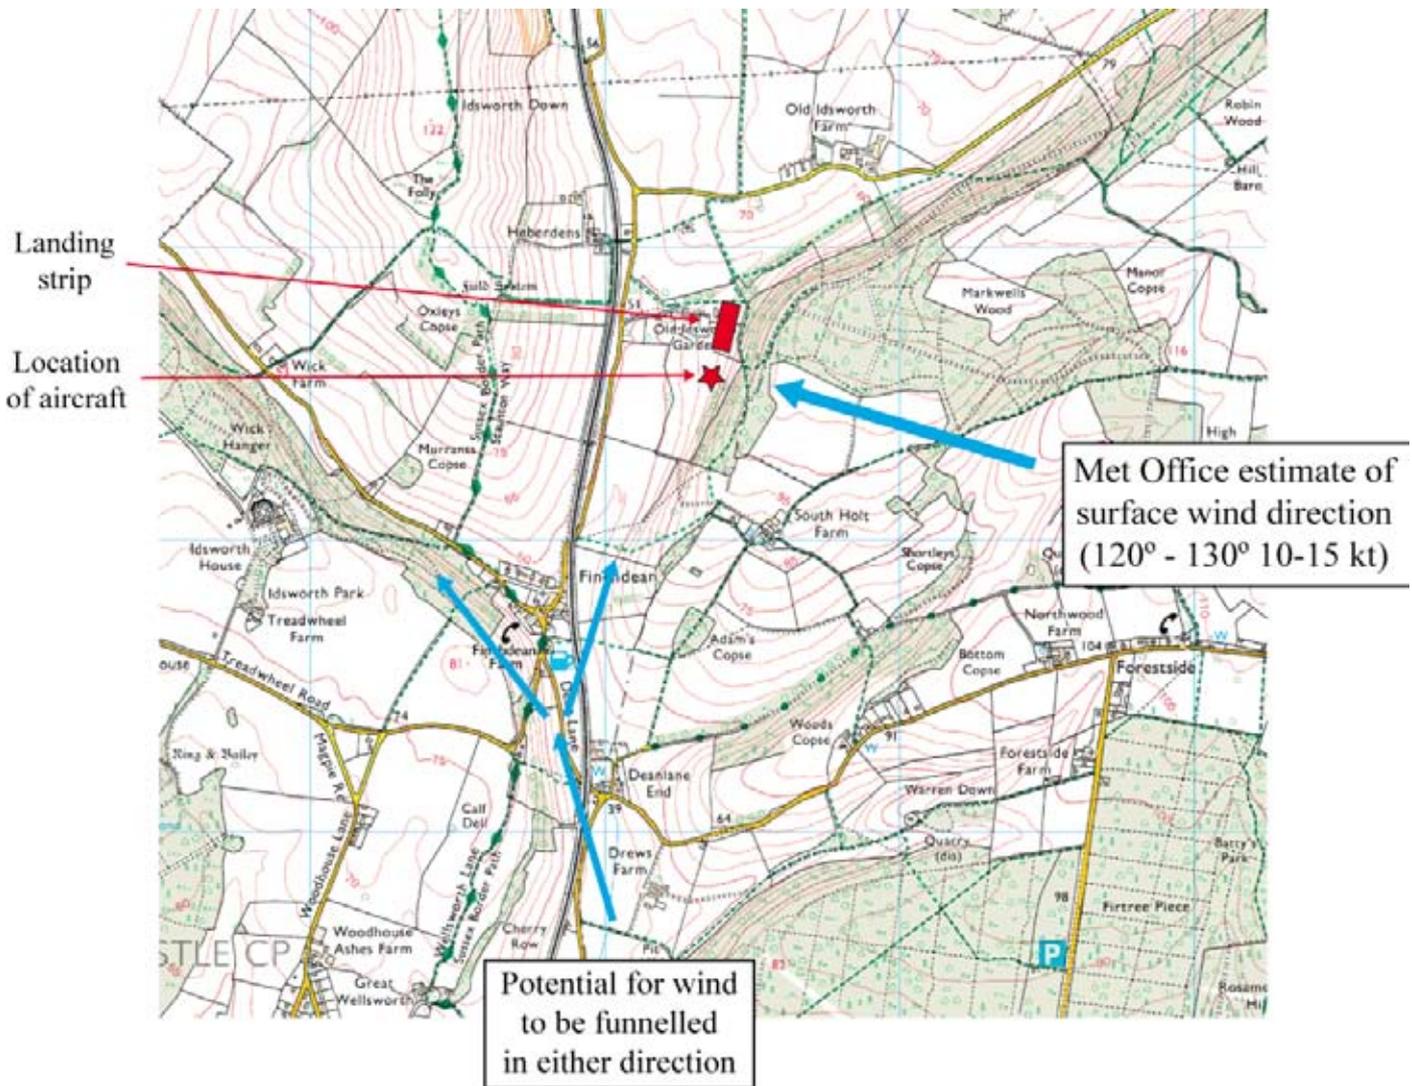
Figure 1

There are ridges to the east and west of the strip, which lies close to the foot of the western ridge (Figure 1). The wind direction at the time would have placed the strip downwind of the ridge and downdraughts and

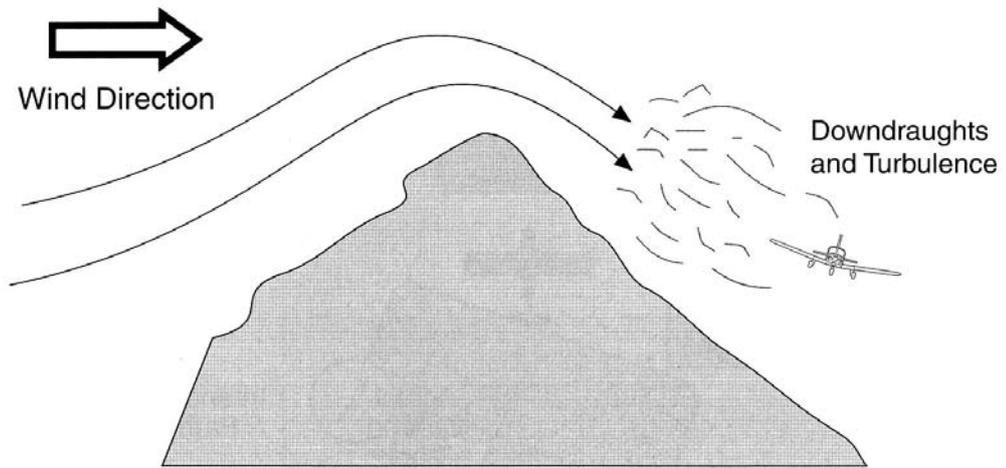
Figure 2

turbulence would be expected at low level (Figure 2). The ridge to the east may also have influenced the local airflow. The combined effect of the two ridges is difficult to assess, although a scenario in which marked changes in vertical and horizontal wind strength for the approach could readily be envisaged.

The pilot attributed the accident to the downdraught created by the adjacent hills. This is a well known phenomenon and pilots are advised against flying at low level downwind of high ground, particularly in strong wind conditions, or in aircraft with low wing loadings that are susceptible to gusts.

Dangers of flying at low level downwind of high ground
(Figure copyright AFE and Jeremy M Pratt)
