<b>Aircraft Type and Registration:</b>	Piper PA-28-161 Cherokee Warrior II, G-BHIL	
<b>No &amp; Type of Engines:</b>	1 Lycoming O-320-D3G piston engine	
<b>Year of Manufacture:</b>	1979	
<b>Date &amp; Time (UTC):</b>	8 February 2005 at 1100 hrs	
<b>Location:</b>	Near Horsmonden, Kent	
<b>Type of Flight:</b>	Private	
<b>Persons on Board:</b>	Crew - 1	Passengers - None
<b>Injuries:</b>	Crew - 1	Passengers - N/A
<b>Nature of Damage:</b>	Aircraft destroyed	
<b>Commander's Licence:</b>	Private Pilot's Licence	
<b>Commander's Age:</b>	52 years	
<b>Commander's Flying Experience:</b>	225 hours (of which 142 were on type) Last 90 days - 5.5 hours Last 28 days - 5.5 hours	
<b>Information Source:</b>	AAIB Field Investigation

## Synopsis

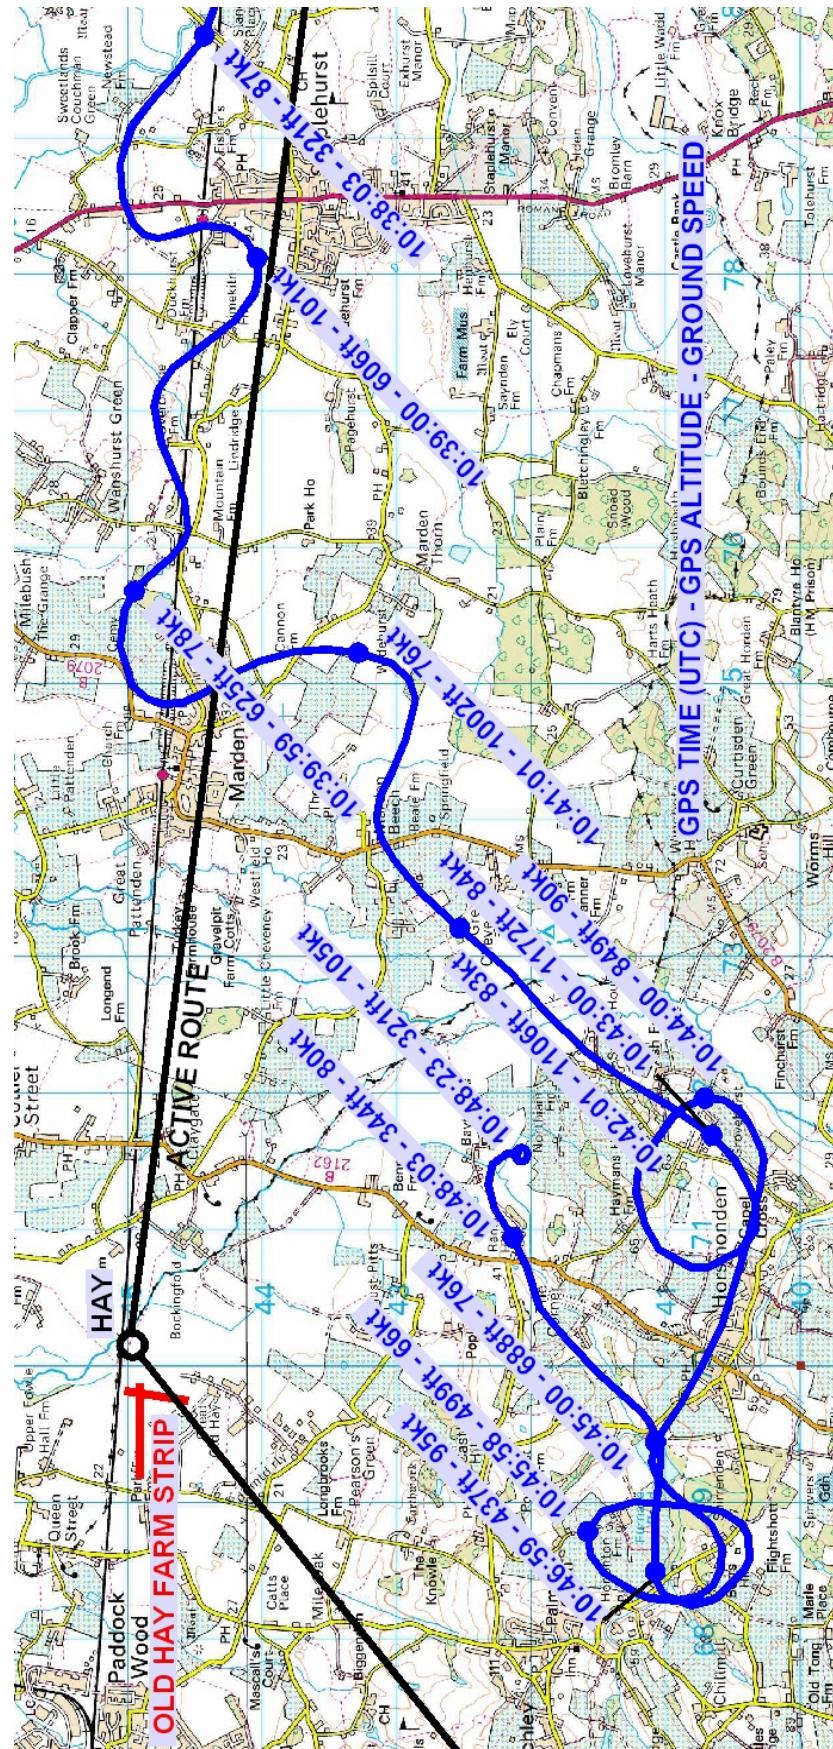
Figure 1 shows the track of the aircraft when over the UK together with plots of groundspeed, terrain elevation and GPS altitude, as well as the position of Old Hay Airfield.<sup>1</sup> Figure 2 focuses on the final part of the flight between Staplehurst and the accident location, where the aircraft's ground speed varied between 66 kt and 101 kt. If the aircraft was being flown with the flaps retracted then there were two data points at which the aircraft was being flown within 5 to 10 kt of its stall speed. If it was being flown with the flaps fully extended then there were six points in this portion of the flight at which the maximum permissible speed with flaps extended was exceeded. One of the data points at which the aircraft is near to the stall speed is less than 10 seconds from one of the points at which the maximum flap extension speed is exceeded.

G-BHIL - GPS Aircraft track and height  
for the last 10minutes of flight

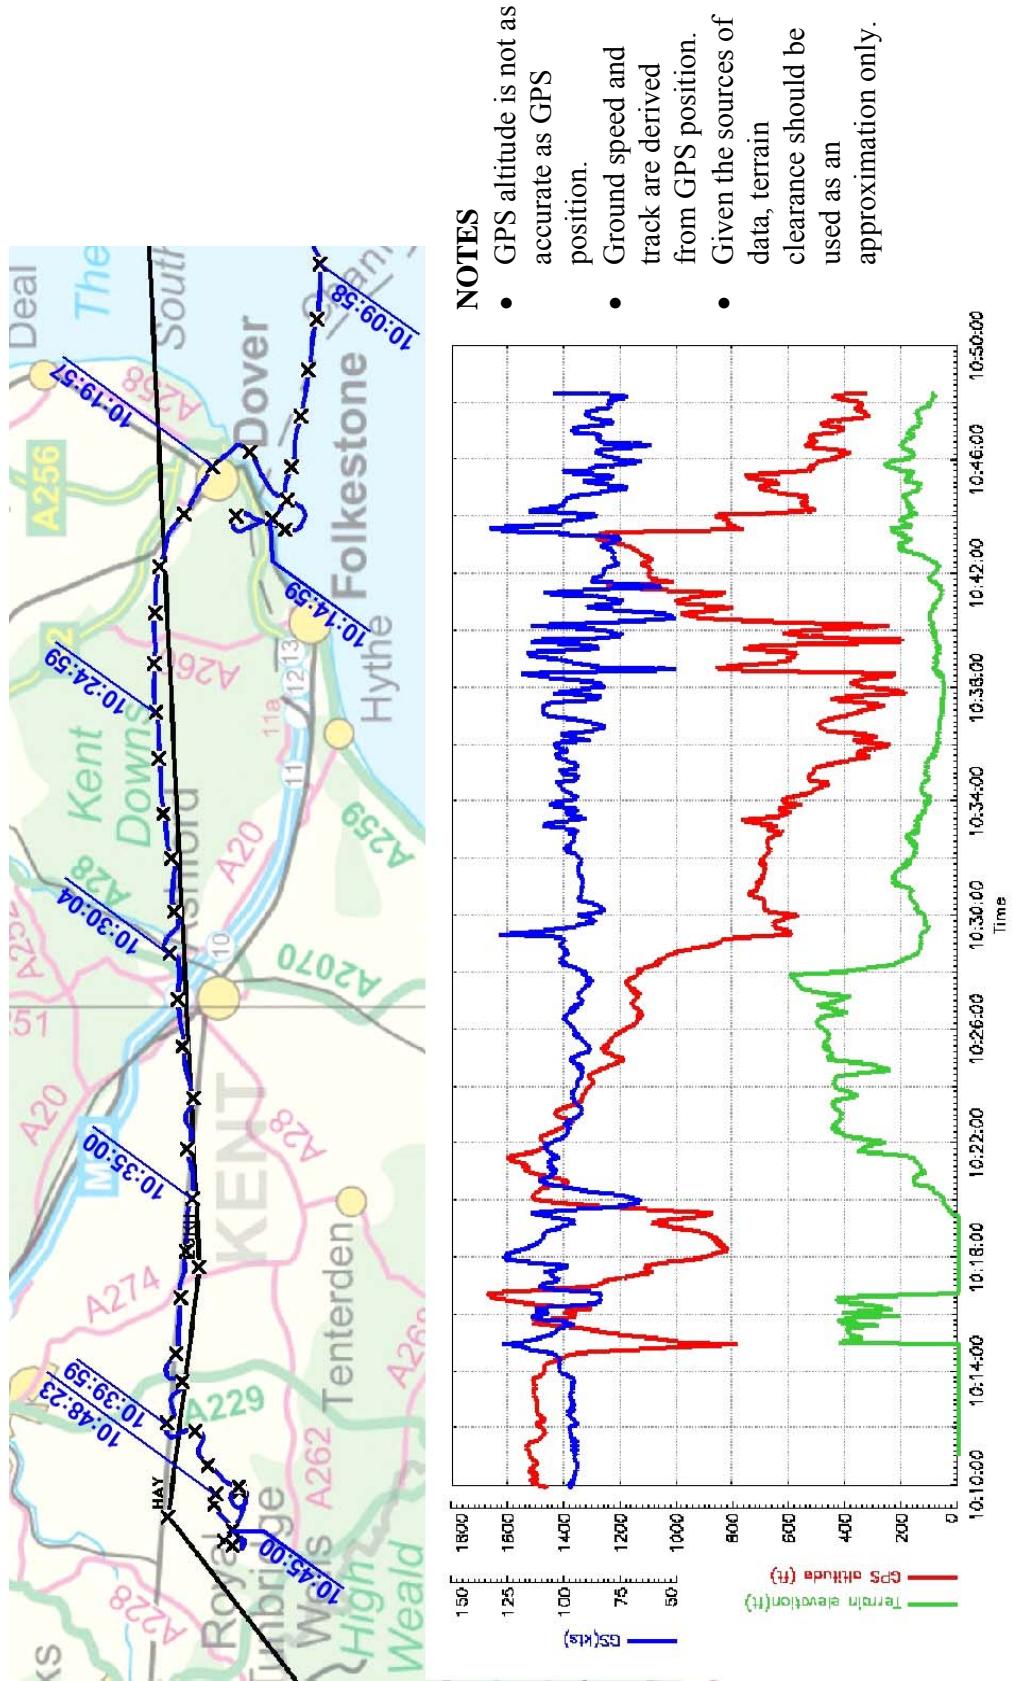
Figure 2

Basic flight parameters and plan view of the accident flight from 10:10 UTC.  
(Accident G-BHIL on 8 February at near Horsmonden, Kent)
