**INCIDENT**

<b>Aircraft Type and Registration:</b>	Boeing 747-236B, G-BDXG	
<b>No &amp; Type of Engines:</b>	4 Rolls-Royce RB211-524D4 turbofan engines	
<b>Year of Manufacture:</b>	1977	
<b>Date &amp; Time (UTC):</b>	24 January 1993 at 1512 hours	
<b>Location:</b>	Over Amboise, France	
<b>Type of Flight:</b>	Scheduled Passenger	
<b>Persons on Board:</b>	Crew - 18	Passengers - 278
<b>Injuries:</b>	Crew - None	Passengers - None
<b>Nature of Damage:</b>	None	
<b>Commander's Licence:</b>	Airline Transport Pilot's Licence	
<b>Commander's Age:</b>	45 years	
<b>Commander's Flying Experience:</b>	12,800 hours (of which 3,000 were on type) Last 28 days - 39 hours	
<b>Information Source:</b>	AAIB Field investigation

BA B747 G-BDXG DOUBLE ENGINE SHUTDOWN OVER AMBOISE, FRANCE ON 24 JANUARY 1993

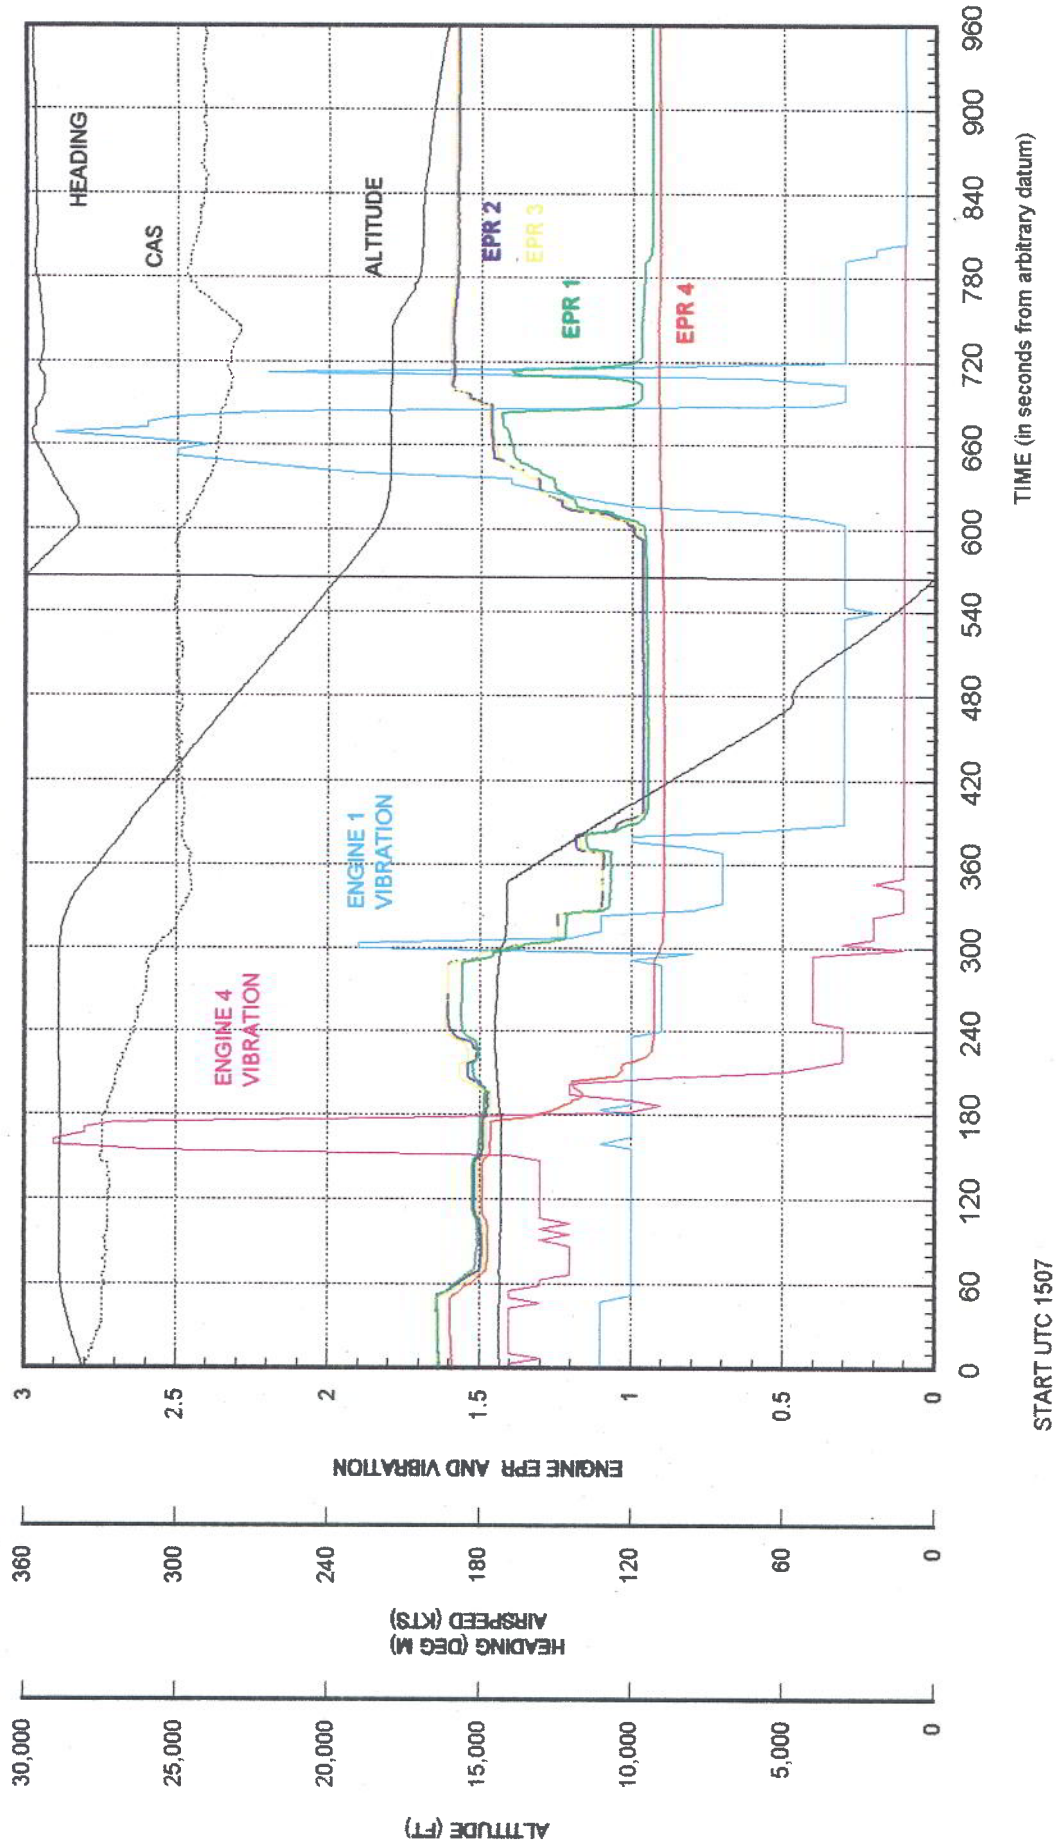
FIGURE 1

Figure 1 shows a plot of some of the recorded parameters from the QAR for the relevant period, beginning as the aircraft climbed to FL 290. The engine vibration is sampled once every four seconds on each engine; only the values for No 1 and No 4 engines are plotted. The warning light illuminates

above a value of 2.5 units of vibration. The engine pressure ratio (EPR) values are plotted for all four engines.

The recorded QAR data indicated that the aircraft levelled at FL290 and the engines were throttled back from around 1.63 EPR. The EPR on No. 4 Engine was slightly lower at 1.59, to around 1.55 EPR at about 55 seconds as given by the time scale in Figure 1. At this power setting the vibration level was 1.1 units on No 1 engine and 1.4 units on No 4 engine; Nos 2 and 3 engines had low vibration levels of 0.7. The vibration on No 4 began to increase, as the EPR again reduced slightly to 1.45 EPR at 150 seconds, to a maximum of 2.9 units over a period of 8 seconds. (Figure 2 shows this in more detail). The EPR on No 4 was then reduced at 176 seconds, and the vibration reduced correspondingly to a value of around 0.4 units, before the engine was shutdown.

The aircraft then levelled at FL180 at 630 seconds as shown in Figure 1, and as the EPR on the three engines rose the vibration on No 1 engine increased from 0.6 to a maximum of 2.9 units over about 60 seconds. The EPR then reduced on No 1 engine, and the vibration reduced correspondingly. The EPRs on No 2 and No 3 engines were increased to around 1.6, and the aircraft descended. The No 1 EPR was increased 20 seconds later, for about 10 seconds, which again produced a vibration increase to a maximum of 2.2 units. The EPR was reduced and the vibration reduced correspondingly. The engine was then shutdown and the vibration reduced to zero.

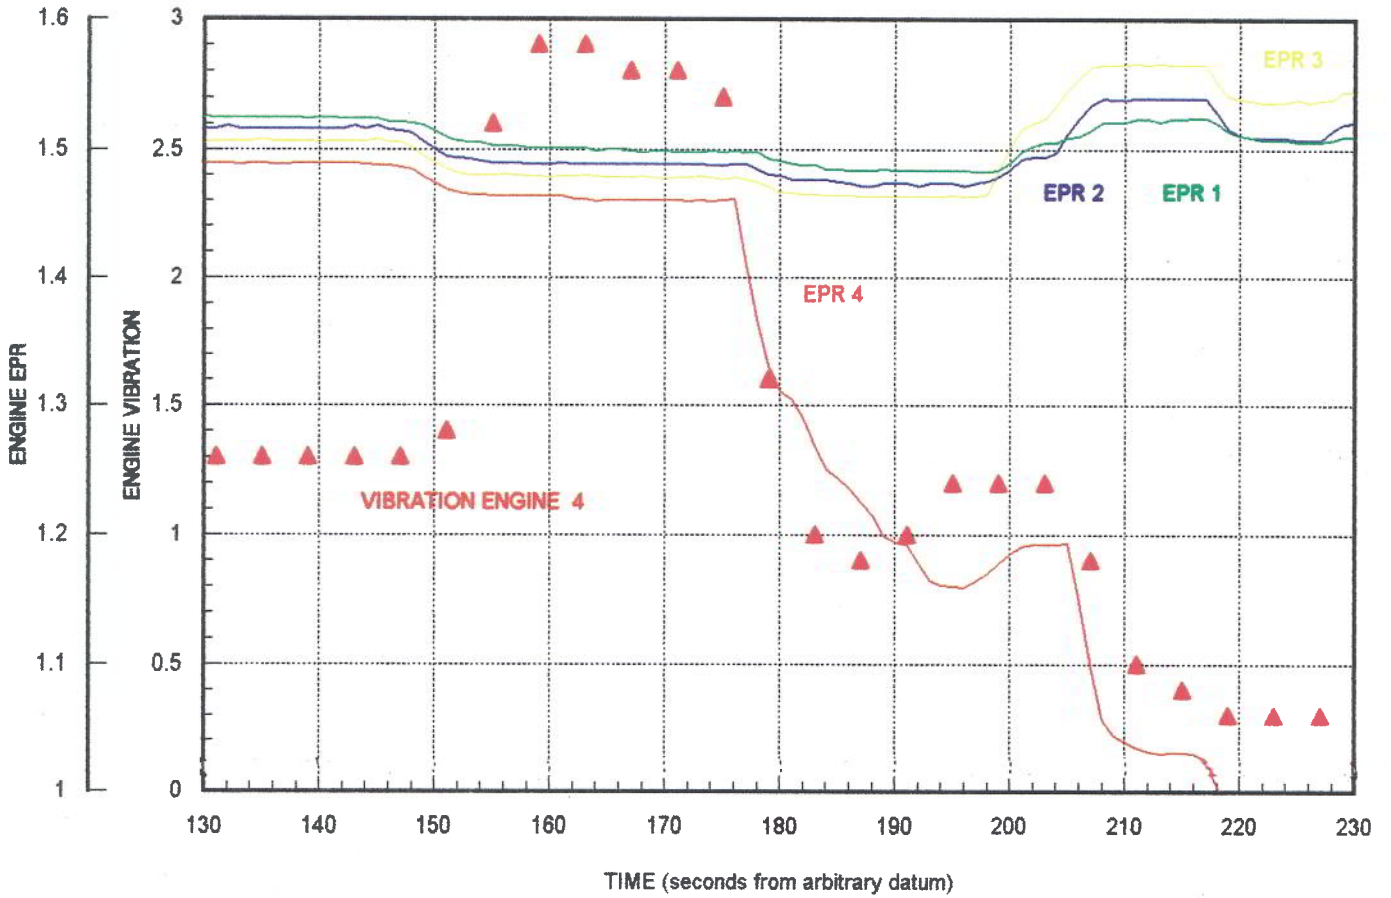
FIGURE 2

G-BDXG NO 4 INITIAL ENGINE VIBRATION

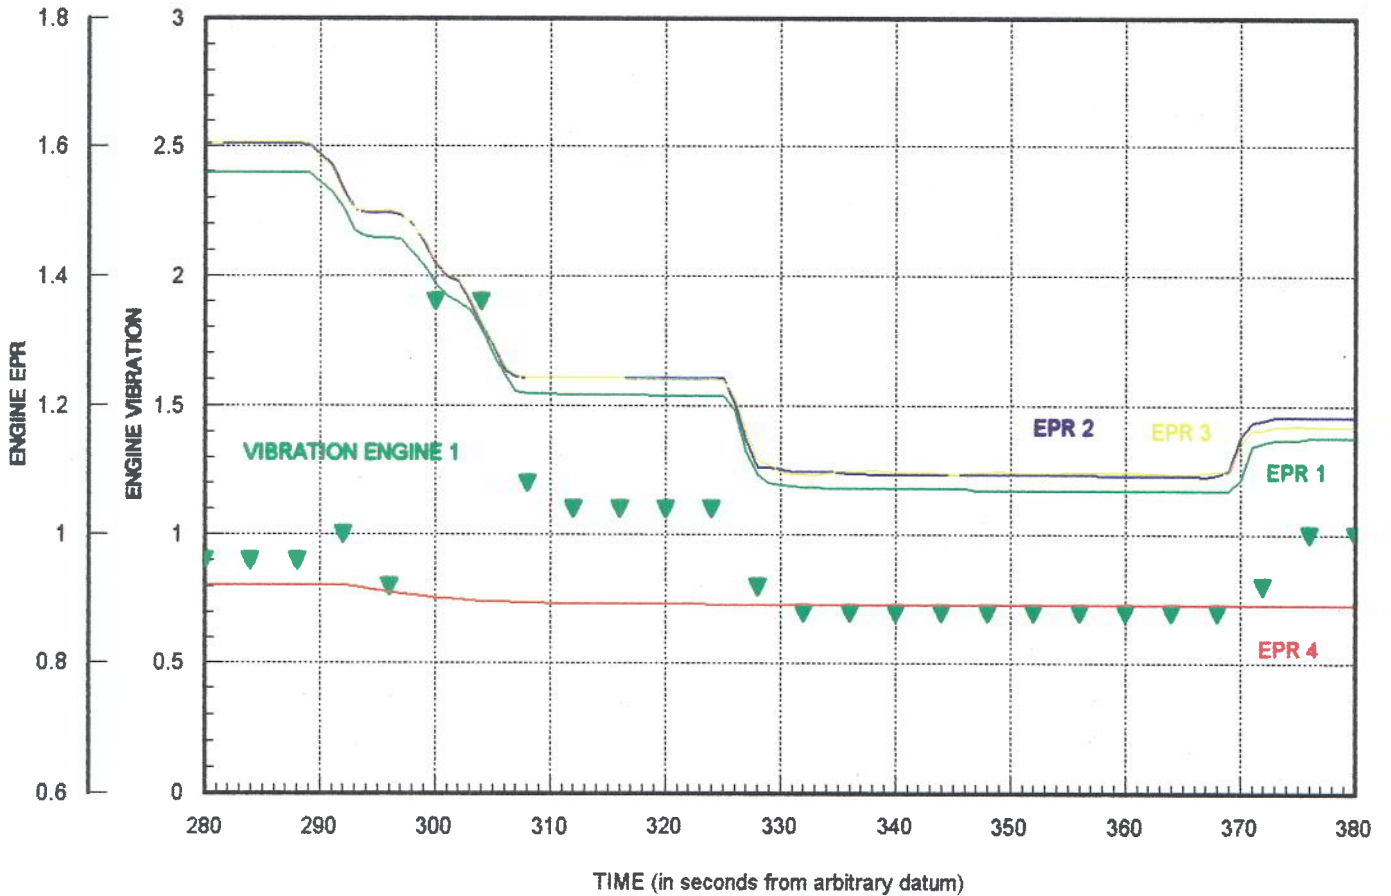
FIGURE 3

The EPR values on the remaining three engines were then increased to 1.6 to maintain altitude at 240 seconds, before decreasing as the aircraft was cleared to descend at 290 seconds. As the EPR on No 1 engine reduced, there was an increase in vibration for around 10 seconds to a maximum value of 1.9 units, before the vibration reduced to 1.1, and then again to 0.7, with the reducing EPR. During the descent, the vibrations on Nos 2 and 3 engines reduced from 0.5 to between 0.2 and 0.3 units. Figure 3 shows a more detailed plot of the engine parameters during the descent.

G-BDXG NO 1 ENGINE VIBRATION INCREASE DURING DESCENT
