ACCIDENT

Aircraft Type and Registration:	Piper PA-32-301 Saratoga, G-BIWL	
No & Type of Engines:	1 Lycoming IO-540-K1G5 piston engine	
Year of Manufacture:	1981	
Date & Time (UTC):	24 March 2007 at 1158 hrs	
Location:	Scilly Isles (St Mary's) Airport	
Type of Flight:	Private	
Persons on Board:	Crew - 2	Passengers - 2
Injuries:	Crew - None	Passengers - 1 (Serious)
Nature of Damage:	Damaged beyond economic repair	
Commander's Licence:	Private Pilot's Licence	
Commander's Age:	64 years	
Commander's Flying Experience:	150 hours (of which 21 were on type) Last 90 days - 4 hours Last 28 days - 3 hours	
Information Source:	Aircraft Accident Report Form submitted by the pilot and further enquires by the AAIB

Synopsis

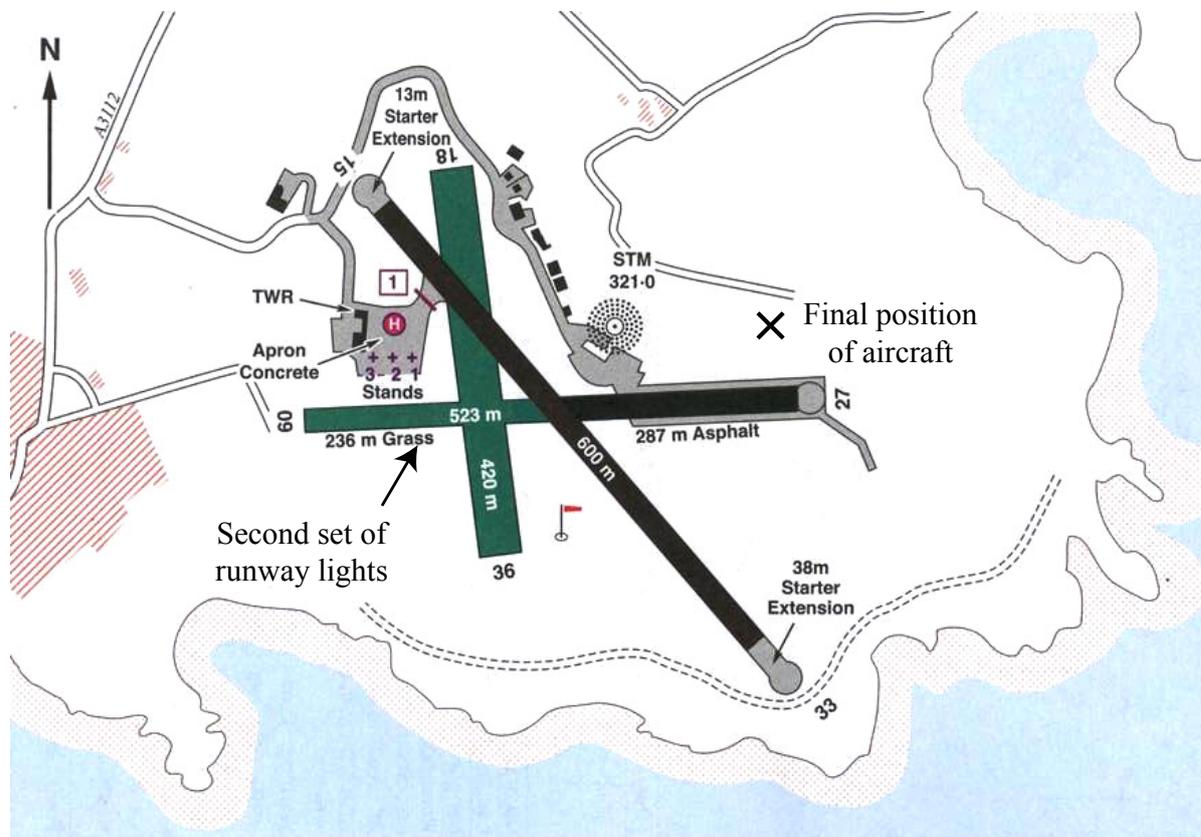
Figure 1
Scilly Isles Airport

Runway 09 at Scilly Isles Airport has a LDA of 523 m. The first 236 m is grass and the remaining 287 m is asphalt. The first 100 m of Runway 09 rises at a 1:20 gradient (5%) and the last 100 m descends at a 1:23 gradient (4.3%). There are no Precision Approach Path Indicators. There is a 100 feet high cliff approximately 400 m beyond the end of the runway, and four runway edge lights on the grass section. The second set of runway lights is half way along the grass which equates to 118 m from the threshold. Runway 15/33 (which the co-pilot had previously used) has a LDA of 600 m.
