ACCIDENT

Aircraft Type and Registration:	Piper PA-28-181, Cherokee Archer II, G-BXRG	
No & Type of Engines:	1 Lycoming O-360-A4M piston engine	
Year of Manufacture:	1978	
Date & Time (UTC):	12 November 2011 at about 1527 hrs	
Location:	27 nm west-north-west of Alderney	
Type of Flight:	Private	
Persons on Board:	Crew - 1	Passengers - 1
Injuries:	Crew - 1 (Fatal)	Passengers - 1 (Minor)
Nature of Damage:	Aircraft lost at sea	
Commander's Licence:	National Private Pilot's Licence	
Commander's Age:	79 years	
Commander's Flying Experience:	150 hours estimated (all were on type) Last 90 days - 3:30 hours Last 28 days - 1:20 hours	
Information Source:	AAIB Field Investigation

Synopsis

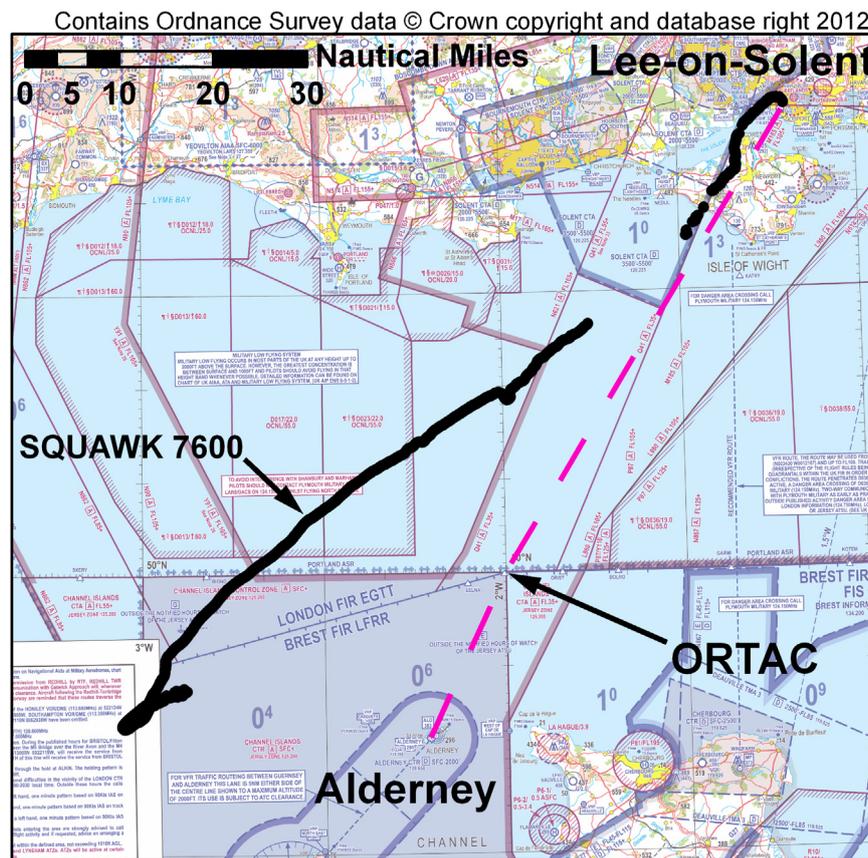
Figure 1

At about this time, an aircraft was observed on radar to the north of the zone, tracking approximately south-west. It was returning a transponder code of 7000 but with no altitude reporting. Although there was a suspicion that this aircraft was G-BXRG (based on timing), it was outside the zone and some considerable distance from

Radar derived plot of G-BXRG's track in black (accident flight, 12 November 2011), with expected routing via ORTAC in pink

The unknown track then displayed a 'radio fail' squawk (7600), indicating that the radio failure code had been selected on the aircraft's transponder. The aircraft, now believed to be G-BXRG (although still not confirmed) continued initially on a non-deviating track which was taking it some 25 nm to the north west of Guernsey and Alderney. Then the aircraft's track started to deviate left and right before, at about 32 nm west of Alderney, it flew a 180° turn to the right and flew back in the direction it had come from. During this manoeuvring, the aircraft's transponder returns ceased. The aircraft disappeared from ATC radar displays shortly afterwards.

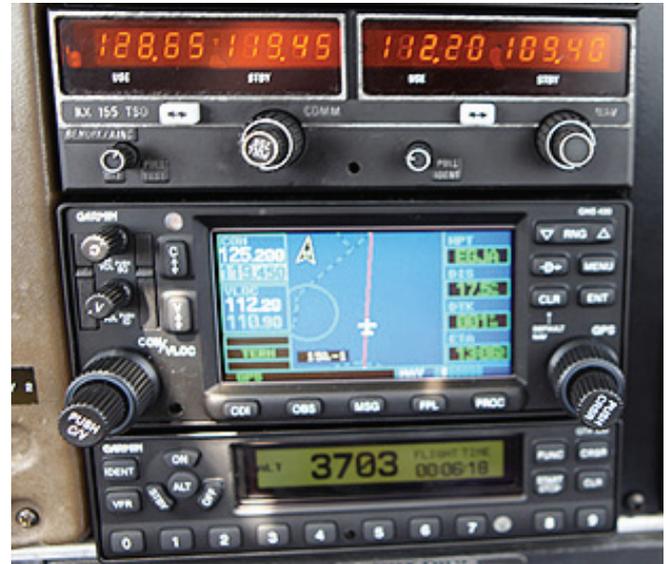
Figure 2

Detail of G-BXRG's instrument panel, showing a typical navigation display (with white aircraft symbol and the pink track line). Communications/navigation control panels radios are above and transponder panel below

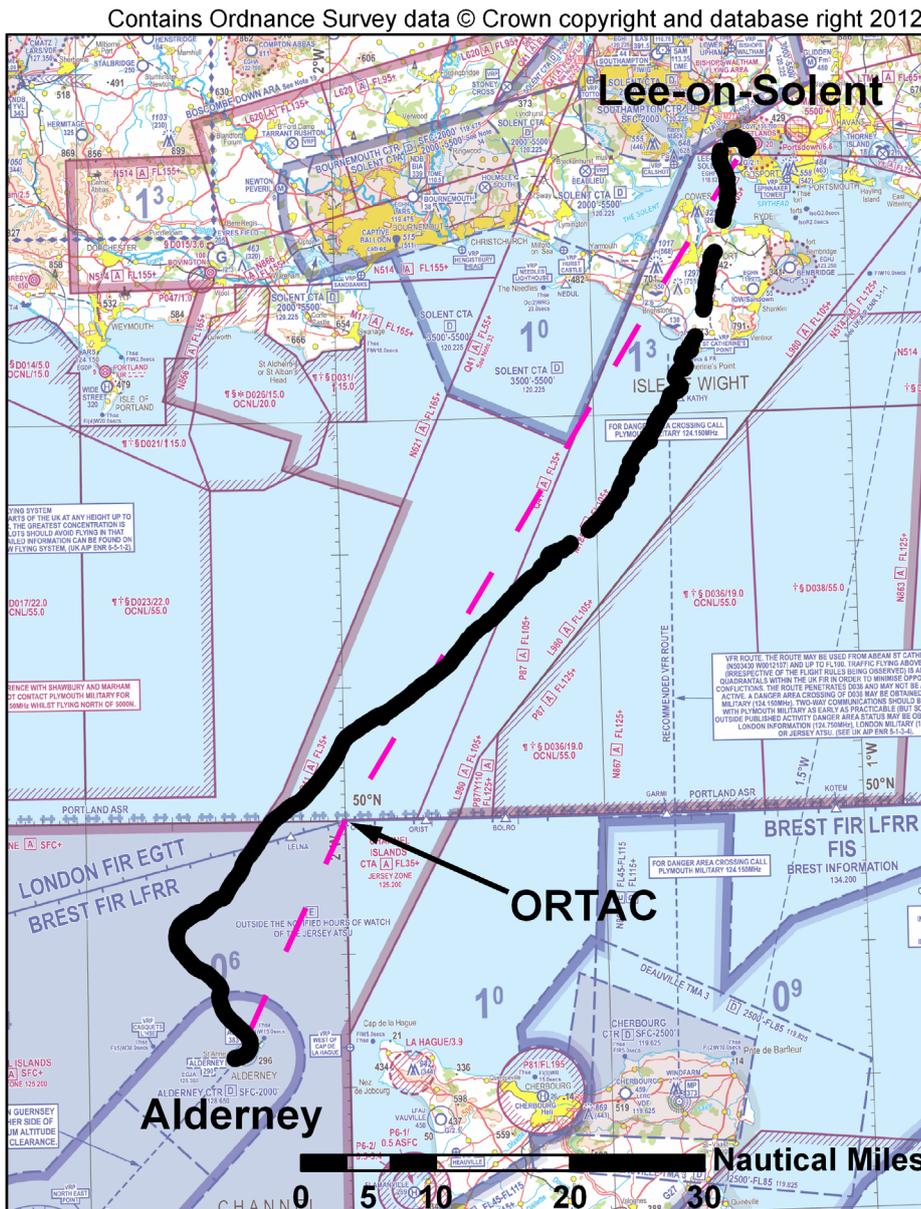
Figure 7

The outbound track (9 November) contained two anomalies (Figure 7). The first occurred immediately after departure from Alderney with the aircraft not tracking towards ORTAC as planned, and this was resolved through discussion between ATC and the pilot. The second concerned the en-route phase in which the aircraft did not follow the standard route to ORTAC and subsequently tracked south of the direct track for Lee-on-Solent before turning for the airfield as the aircraft neared the Isle of Wight.

Radar derived track in black showing flight to Lee-on-Solent on 9 November 2011.
Flight plan route shown by broken pink line

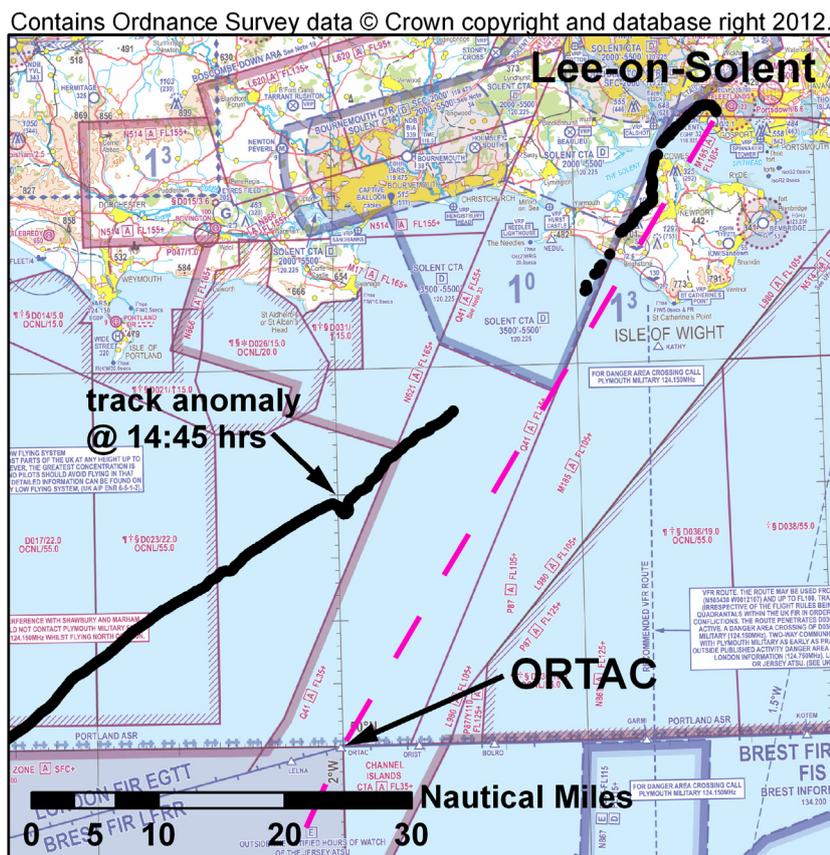
Figure 8

The initial portion of the accident flight is shown at Figure 8. The initial tracking out of Lee-on-Solent is as described by the pilot's wife, with a significant track adjustment occurring over the Isle of Wight. However, the aircraft then appeared to establish on a track which deviated to the right of the track for ORTAC. The track anomaly at 14:45 hrs occurred 20 nm north of ORTAC which, had the aircraft been tracking towards ORTAC, would have equated to the point where an initial call to Jersey ATC was required (ie 10 minutes from ORTAC). The pilot's wife thought that the anomaly was most probably due to inadvertent turning which occurred as the pilot was attempting to resolve his initial problem with the GPS display.

Initial portion of accident flight, showing departure from Lee-on-Solent and tracking anomaly. Flight plan course for ORTAC is highlighted in pink

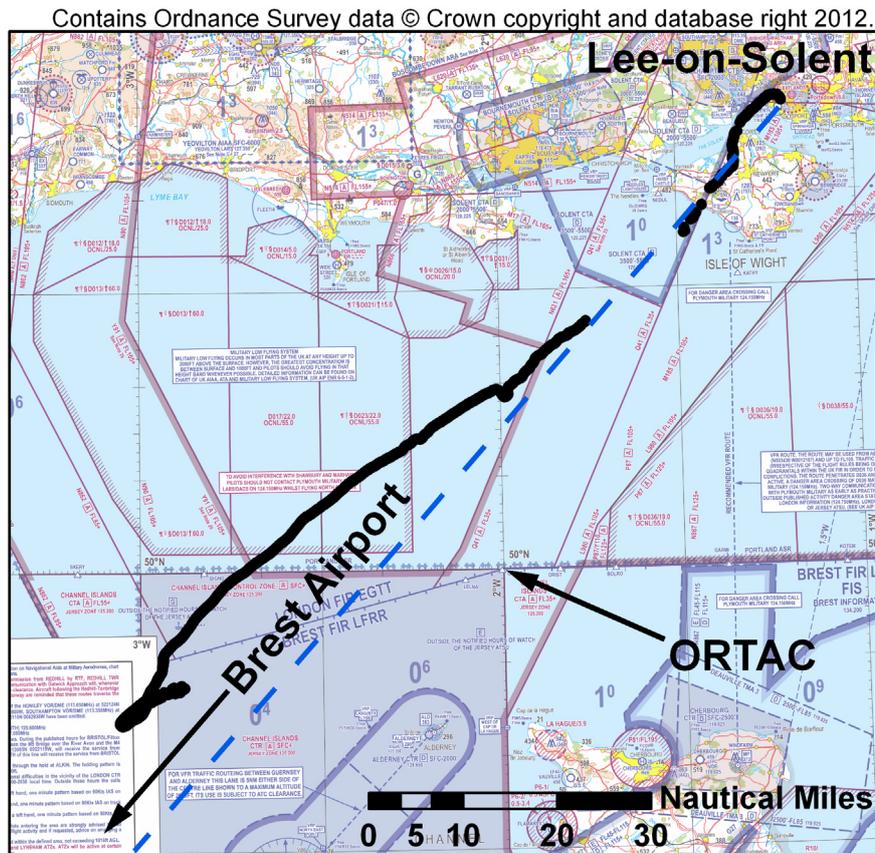
Figure 9
Accident flight with track for Brest Airport overlaid

The information available suggests that the pilot was using the GPS as his primary navigation aid, and that it was functioning satisfactorily in the early stages of the accident flight. His wife reported seeing the aircraft symbol on the GPS track line before drifting slightly right of it, which suggests that the GPS track guidance may have been based on an erroneous destination. One possibility examined was that the selected destination was Brest Airport. Figure 9 shows the aircraft’s track with a track for Brest Airport overlaid. There is no evidence that the pilot had inadvertently selected Brest as a

destination but such a scenario offers a good correlation with the pilot's wife's account of being on track initially before drifting slightly right of track shortly before the electrical problems occurred.

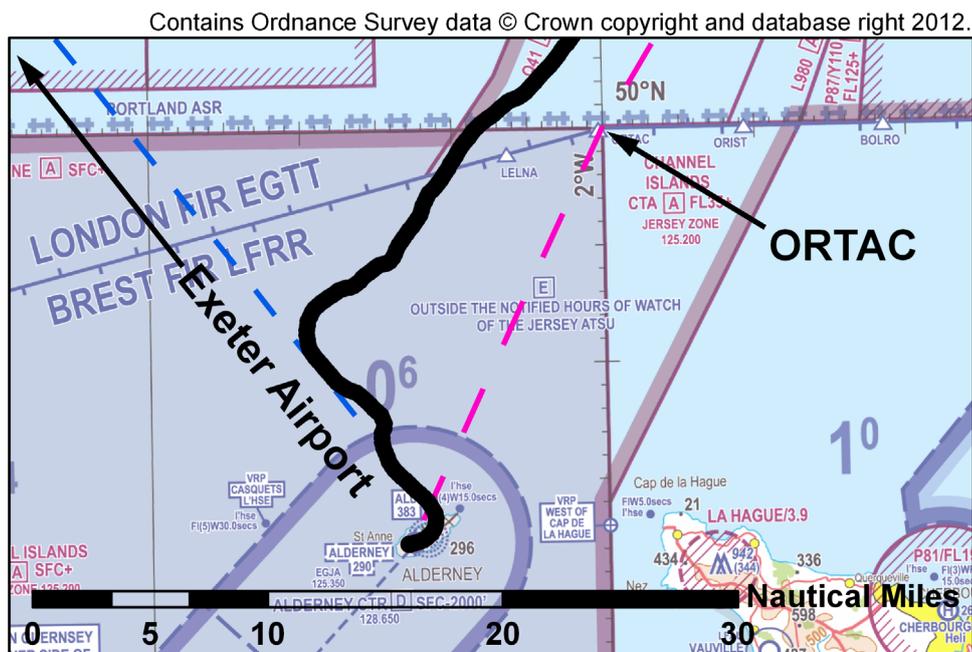
Figure 10

Navigation anomaly after takeoff from Alderney (9 November 2011), with direct track to Exeter overlaid
