ACCIDENT

| Aircraft Type and Registration: | Agusta A109A, G-DNHI | |

Synopsis

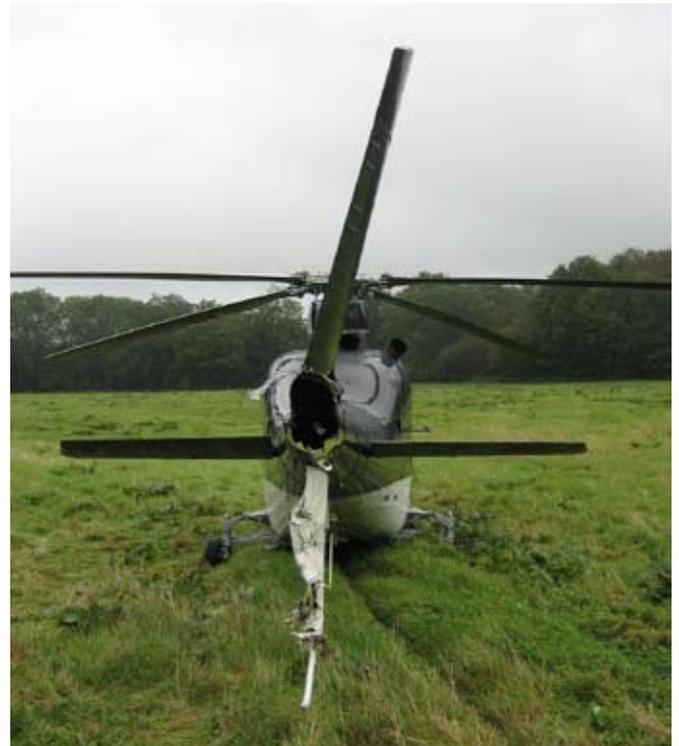
Figure 2

Initial examination of the helicopter revealed that the tail rotor assembly, including the gearbox, and left engine outboard exhaust duct were missing, Figure 2. One of the main rotor blades had a deep indentation on its under surface at, approximately, the half-span point. The upper vertical stabiliser was inclined about 25° to the right and its fixture to the tailboom was severely disrupted. The lower vertical stabiliser had suffered severe damage to its trailing edge consistent with being struck by the tail rotor blades.

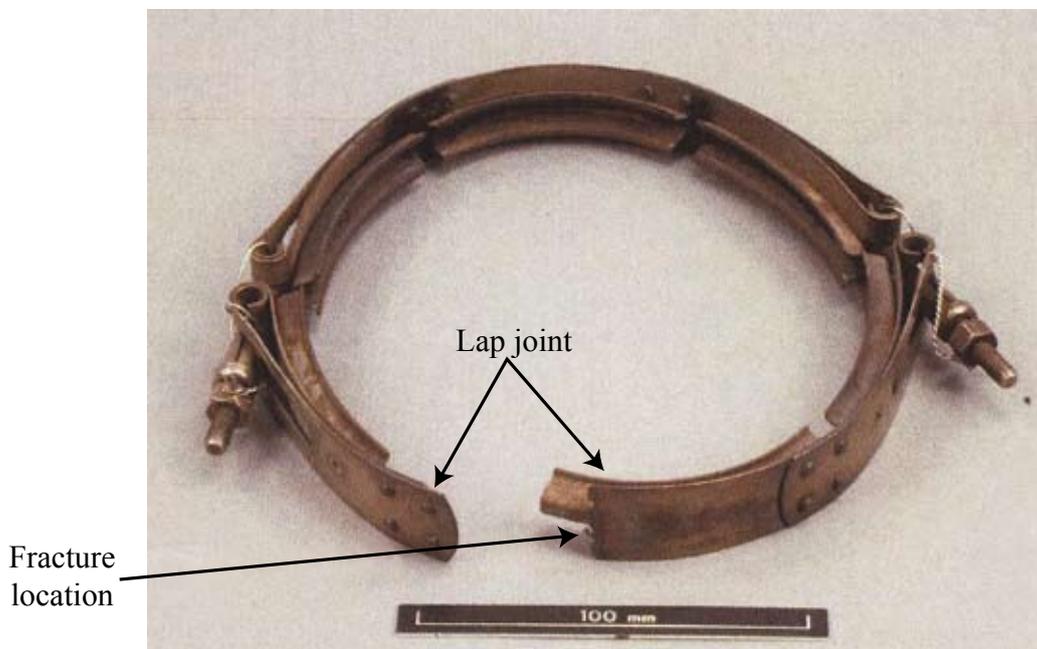
Figure 3

Mormon¹ clamp (part number 4606AC), that had been used to attach the outboard exhaust duct to the left engine, was found loose in the engine bay. This had failed at a position approximately one third of the way around the circumference of one of the two halves of the clamp, Figure 3.

Failed exhaust-duct-to-engine Mormon clamp

It was evident that a failure of the strap had occurred on one half of the subject clamp, beneath where it was overlapped by one of its folded back ends. Detailed examination revealed that a crack had formed and that this had initiated in the strap's central region. The crack had then propagated towards the strap's outer edges, running through two rivet holes, before the remaining material failed in overload, Figure 5. Metallurgical examination of the fracture faces indicated that the nature of the crack was consistent with chloride-driven stress corrosion cracking.

The location of the crack on the strap was effectively hidden by the overlap of its end section. This would not have allowed early detection by visual examination or non-destructive testing by, for example, fluorescent dye-penetrant, unless the clamp had been removed. Another area on the failed clamp associated with the strap overlap was found to have surface-breaking cracks which, on further examination, also exhibited characteristics of stress corrosion cracking.

It is recommended that the European Aviation Safety Agency require all helicopter manufacturers for whom they have airworthiness responsibility to institute similar Mormon clamp inspection regimes to those detailed in Agusta Service Bulletin Nos 109-123 and 206-242, where they are used to secure exhaust duct components to the turbine engines of helicopters.

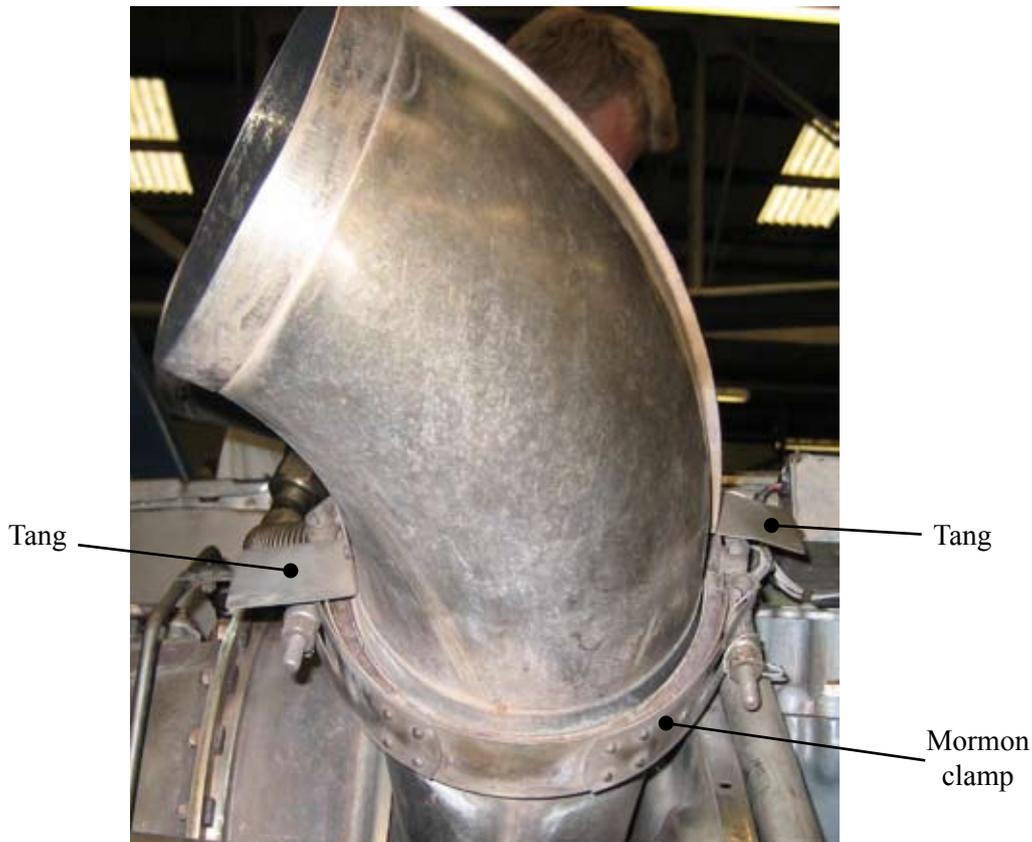
Figure 4
Exhaust Duct arrangement

The exhaust duct is a stainless steel ovalated tube curved through 45°, 26 cm in length, and with a lip formed at the engine casing interface end, Figure 4. This lip corresponds to a lip on the engine casing which facilitates the use of a Mormon clamp to join the two. A total of four clamps are used to attach two exhaust ducts to each of the engines.

duct from exiting through the aperture in the engine cowl in the event of a clamp failure, Figure 4. This modification has been applied to all production models of the Agusta 109 helicopter.

It is recommended that the European Aviation Safety Agency require all helicopter manufacturers for whom they have airworthiness responsibility, to review the design of engine exhaust duct attachment and retention systems, to ensure that no part of the ducting will be released from the helicopter in the event of a failure of the attachment.

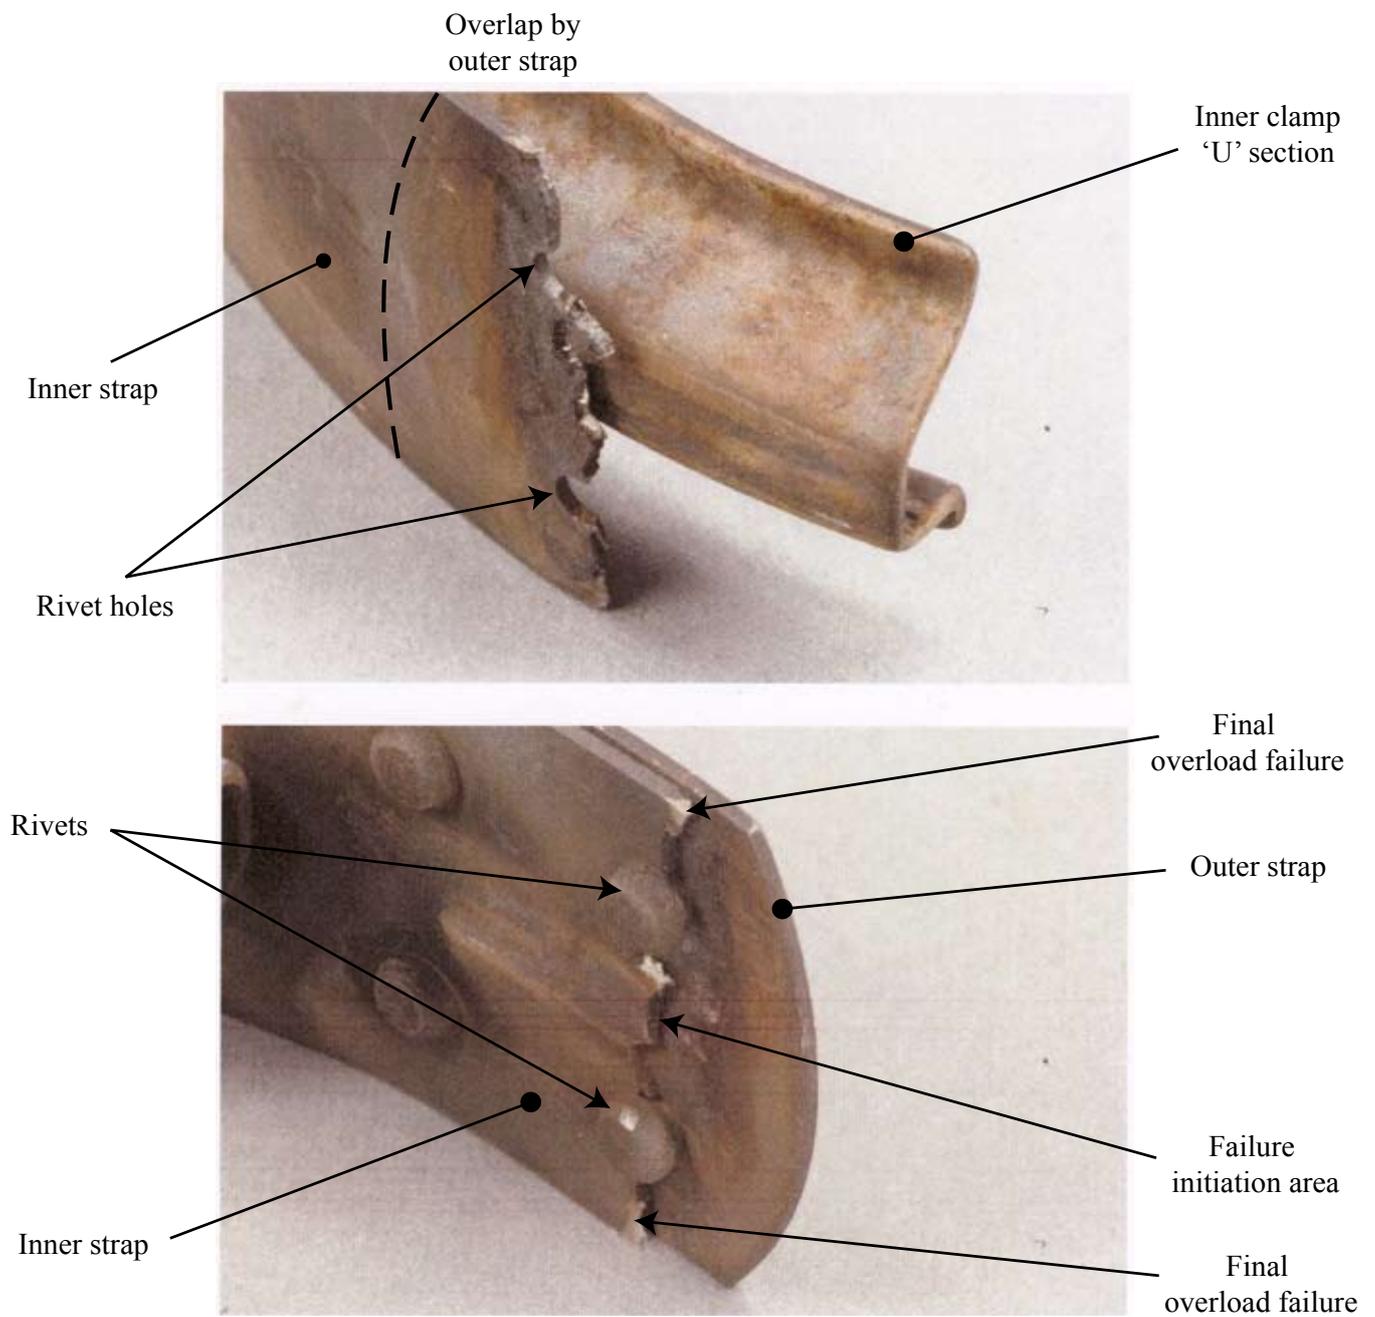
Figure 5
The two halves of the fracture of the failed clamp
