**INCIDENT**

<b>Aircraft Type and Registration:</b>	Piper PA-18-150, G-SUPA	
<b>No &amp; Type of Engines:</b>	1 Lycoming O-320-A2B piston engine	
<b>Year of Manufacture:</b>	1957	
<b>Date &amp; Time (UTC):</b>	23 June 2005 at 1500 hrs	
<b>Location:</b>	Headcorn, Kent	
<b>Type of Flight:</b>	Private	
<b>Persons on Board:</b>	Crew - 1	Passengers - 1
<b>Injuries:</b>	Crew - None	Passengers - None
<b>Nature of Damage:</b>	Main landing gear support frame failure	
<b>Commander's Licence:</b>	Private Pilot's Licence	
<b>Commander's Age:</b>	52 years	
<b>Commander's Flying Experience:</b>	1283 hours (of which 479 were on type) Last 90 days - 11 hours Last 28 days - 6 hours	
<b>Information Source:</b>	Aircraft Accident Report Form submitted by the pilot

**Synopsis**

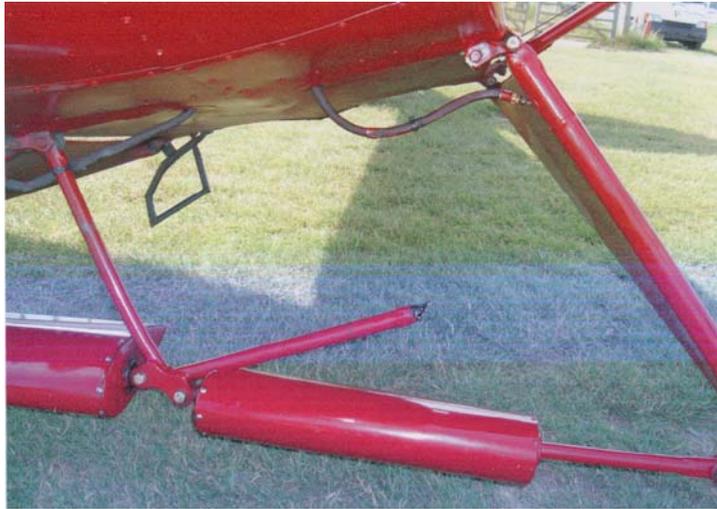
As a result of a missing bush from the left side of the main landing gear V section support frame, the end of the frame failed at its attachment to the airframe, which resulted in the wing dropping gently to the ground.

Whilst taxiing to the hanger, following an uneventful landing, the right wing slowly dropped until it rested on the ground. The engine was shut down and the propeller remained clear of the ground. An examination of the aircraft revealed that the left side of the V section support frame, which supports the main undercarriage suspension units, had failed across the hole where it is bolted to the airframe mounting lug, see Figure 1.

**Figure 1** Undercarriage V Section Frame Failure

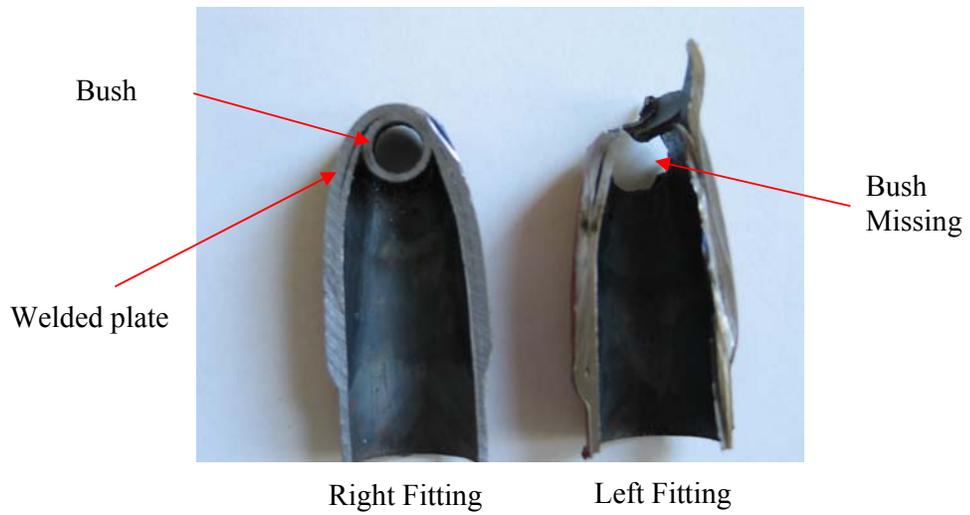
The landing gear support frame is manufactured from two steel tubes welded together to form a V section. The airframe attachment at the end of each tube consists of a bush mounted on the end of the tube, which is held in place by a shaped plate welded around the end of the tube. A comparison of the left and right attachment fittings, which were sectioned to facilitate inspection, revealed that the bush on the left fitting was missing, see Figure 2. The repair agency for the aircraft confirmed that the bush was not attached to the securing bolt that remained fitted to the aircraft. Witness marks inside the tube indicate that a bush had originally been fitted to the leg, which suggested that the bush might have come out when the frame had been removed from the aircraft. Reassembly of the V section frame without a bush installed would have left the securing bolt in contact with the welded plate, which then appears to have failed in overload during normal operations. The frame was last inspected during the annual maintenance undertaken six months and eight flying hours prior to the accident. Whilst there was no requirement during this inspection, to remove the fitting from the aircraft and inspect the bolt holes, the maintenance organisation have stated that the assembly felt secure with no sign of excess movement at that time.

**Figure 2** Sectioned V section frame end fittings
