ACCIDENT

Aircraft Type and Registration:	Jodel D18, G-BWV	
No & Type of Engines:	1 Volkswagen 1834 piston engine	
Year of Manufacture:	1997	
Date & Time (UTC):	26 June 2011 at 1534 hrs	
Location:	North Coates Airfield, Lincolnshire	
Type of Flight:	Private	
Persons on Board:	Crew - 1	Passengers - None
Injuries:	Crew - 1 (Serious)	Passengers - N/A
Nature of Damage:	Aircraft destroyed	
Commander's Licence:	National Private Pilot's Licence	
Commander's Age:	52 years	
Commander's Flying Experience:	385 hours (of which 4 were on type) Last 90 days - 9 hours Last 28 days - 4 hours	
Information Source:	AAIB Field Investigation

Synopsis

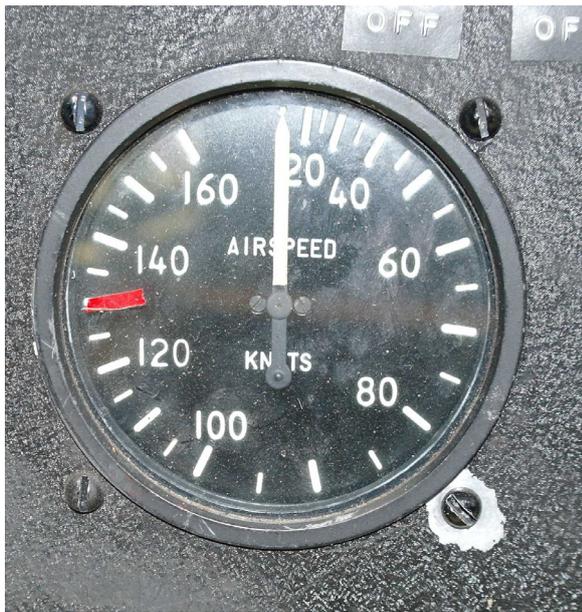
Figure 2

The airspeed indicator had a V_{NE} marked at 132 kt as required by the LAA Type Acceptance Data Sheet. No other speeds were marked nor required to be marked on the instrument (shown in Figure 2). The aircraft was not equipped with a stall warning system. The pilot did not have any formal handbook for the aircraft but he had some handwritten notes regarding approach speeds and other data which he carried with him in flight. These notes cited a stall speed of 46 kt, a best angle glide speed of 60 kt and a final approach speed of 65 kt.

Airspeed indicator

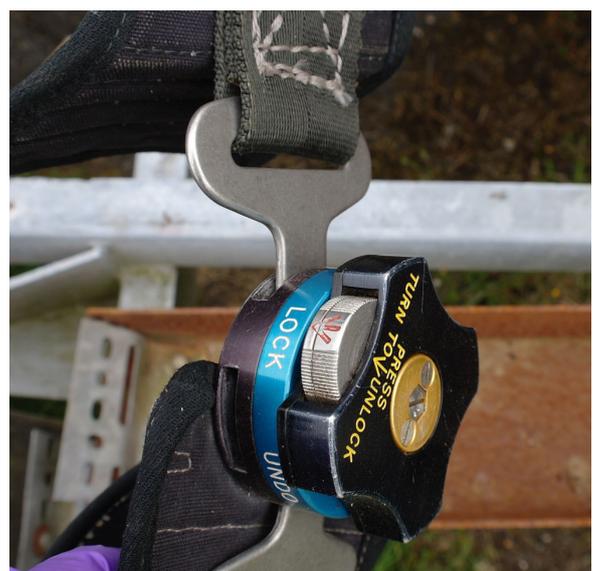
Figure 3

The lap straps of the pilot's harness had pulled away from their mounts and both sides of the lap strap were attached to the buckle. The removable part of the lap strap was attached to one of the buckle slots meant for the shoulder harness, see Figure 3. The pilot's shoulder straps and their mounting point were undamaged and were found separate from the lap strap and buckle.

Close up of pilot's harness lap strap and buckle

The pilot reported that, with the shoulder straps fastened, he was unable to reach all the controls properly and as a result he flew with just the lap strap fastened. During the impact his shoulders were not restrained and he was therefore thrown forward through the top of the canopy, striking his head on the ground. He was very fortunate not to suffer more serious injuries from either the ground impact or as he recoiled back through the shattered canopy. The lap strap attachment fittings broke away from the structure during the break-up sequence.

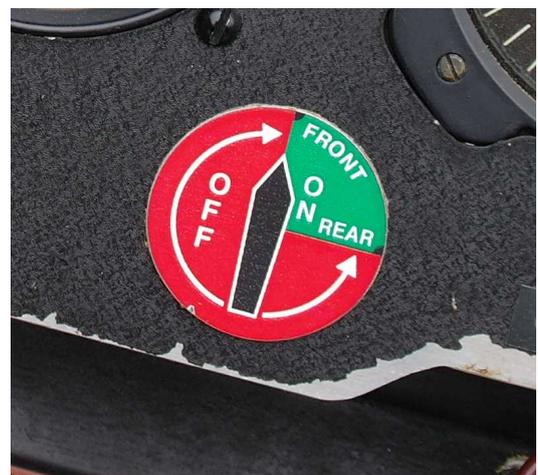
Figure 6
Fuel selector placard

The fuel selector and its placard made it difficult to confirm which tank had actually been selected and the pilot had discussed the fuel selector indication at length with another pilot prior to his departure. The placard is also misleading in that there is only one detented position for the front tank and one for the rear tank and not an arc of 90° as indicated.
