**ACCIDENT**

<b>Aircraft Type and Registration:</b>	Morane Saulnier MS.894A Rallye Minerva, G-HHAV	
<b>No &amp; Type of Engines:</b>	1 Franklin 6A-350-C1 piston engine	
<b>Year of Manufacture:</b>	1970	
<b>Date &amp; Time (UTC):</b>	18 June 2010 at 1000 hrs	
<b>Location:</b>	Perranporth Airfield, Cornwall	
<b>Type of Flight:</b>	Private	
<b>Persons on Board:</b>	Crew - 1	Passengers - None
<b>Injuries:</b>	Crew - None	Passengers - N/A
<b>Nature of Damage:</b>	Nose gear, engine mount, wings and propeller damaged	
<b>Commander's Licence:</b>	Private Pilot's Licence	
<b>Commander's Age:</b>	52 years	
<b>Commander's Flying Experience:</b>	4,430 hours (of which 200 were on type) Last 90 days - 1 hour Last 28 days - 1 hour	
<b>Information Source:</b>	Aircraft Accident Report Form submitted by the pilot and further enquiries by the AAIB

**Synopsis**

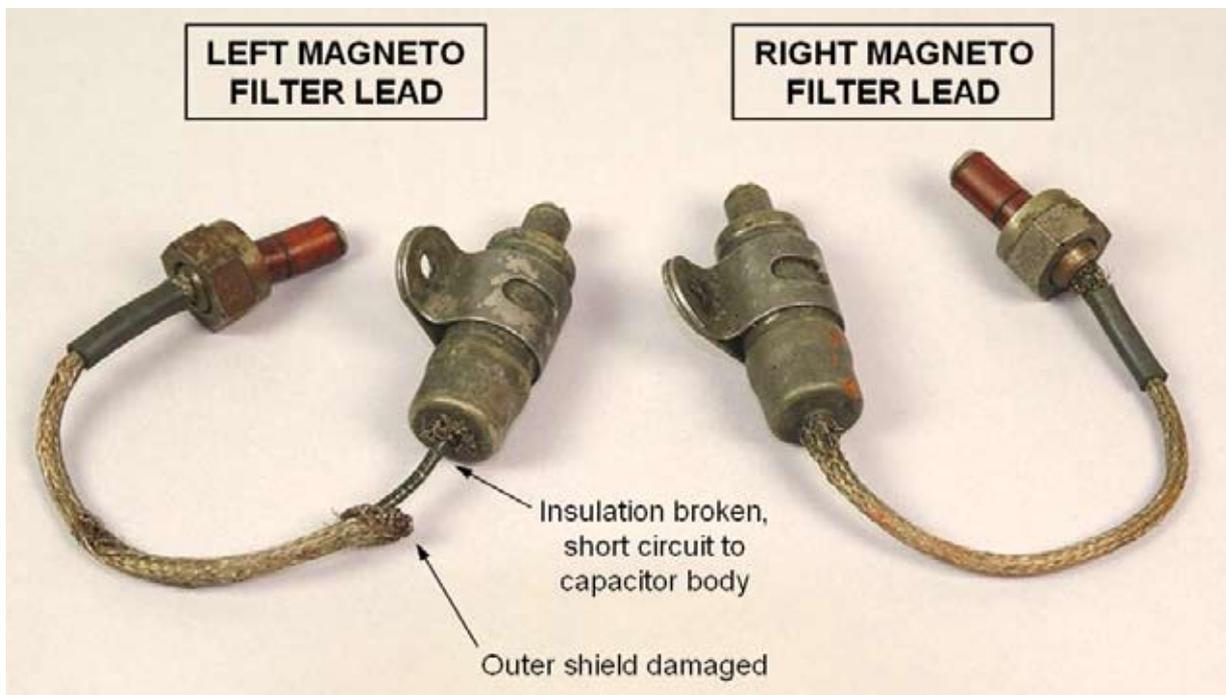
**Figure 1**

The left magneto filter lead (Figure 1) was in poor condition, exhibiting fraying of the outer shield material. The lead's insulation had failed at the exit of the filter capacitor body, and thus was electrically short-circuited to earth via the capacitor outer body.

Left and right magneto filter leads

Some of the shield material exhibited evidence of melting and fusing to the capacitor body consistent with high current flow.

The right magneto filter lead also exhibited damage to the shield material at the capacitor body exit but the insulation remained intact and no short circuit to airframe earth was detected.

As both left and right magnetos functioned correctly during the pre-takeoff checks, it is probable that the electrical short circuit between the left magneto filter lead and airframe ground occurred during the accident flight, caused by the poor condition of the lead. The electrical grounding of the left magneto filter lead inhibited the left magneto from functioning, leaving the aircraft with only the right magneto system to supply ignition to the engine. The right magneto was subsequently tested and shown to be serviceable.

Whilst the reason for the aircraft's engine failure was not be positively identified, a short circuit of the left magneto primary lead at the exit of the magneto filter lead capacitor body was discovered during engineering examination of the aircraft's ignition system. This fault was sufficient to prevent the left magneto from functioning. Attention is drawn to the ignition harness maintenance requirements contained in CAP 766 (*Light Aircraft Maintenance Programme*) which requires inspection of the magneto harness for unsatisfactory condition at either a 150 flying hour check, or annual check, whichever occurs first.
