SERIOUS INCIDENT

Aircraft Type and Registration:	Piper PA-34-200T Seneca II, G-BOCG	
No & Type of Engines:	2 Continental Motors Corp TSIO-360-EB piston engines	
Year of Manufacture:	1978	
Date & Time (UTC):	15 February 2012 at 1025 hrs	
Location:	Birmingham Airport	
Type of Flight:	Training	
Persons on Board:	Crew - 2	Passengers - 1
Injuries:	Crew - None	Passengers - None
Nature of Damage:	Electrical connector in cabin heater power supply overheated	
Commander's Licence:	Airline Transport Pilot's Licence	
Commander's Age:	44 years	
Commander's Flying Experience:	3,894 hours (of which 1,045 were on type) Last 90 days - 58 hours Last 28 days - 18 hours	
Information Source:	Aircraft Accident Report Form submitted by the pilot and AAIB enquiries

Synopsis

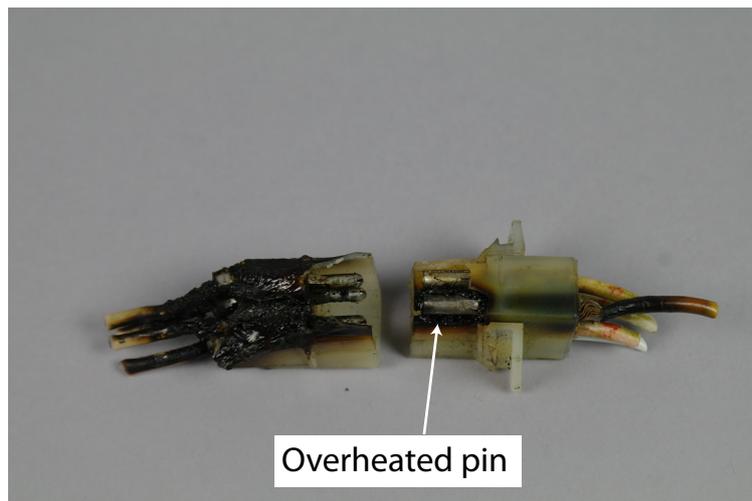
Figure 1
Electrical connector

The source of the fumes and flames was a partially melted plastic electrical connector, located in the centre console, through which the electrical power passes to the cabin heater. (See Figure 1) From an examination of the connector it was established that a pin in the connector, through which the electrical power from the CB to the heater selector switch is routed, had overheated.

Due to the extent of the damage it was not possible to identify why the pin had overheated. However, the organisation that maintained G-BOCG, and 12 other PA-34 aircraft, advised the investigation that the connector is frequently disconnected in order to inspect the flying control cables that run under the console. During this maintenance activity they have, on a number of occasions on different aircraft, found loose and corroded pins, and evidence of overheating. The affective parts were replaced on all these occasions.

Loose and corroded pins can result in an increase in electrical resistance, which might result in an increase in the voltage drop across the connector. This increase in voltage drop could cause the connector temperature to increase, which will further increase the electrical resistance and the temperature. This cycle of increased resistance and temperature increase is known as 'thermal runaway' and will continue until the power supply is disrupted.

The maintenance organisation had previously identified that the pins in the connector were susceptible to overheating as a result of corrosion or working loose. With the lack of any other obvious damage it is likely that these were the initiating factors which caused the thermal runaway that eventually resulted in the connector melting.
