AAIB Bulletin No: 11/93

Ref: EW/C93/6/5

Aircraft Type and Registration:	Thruster TST MK1, G-MTVU	
No & Type of Engines:	1 Rotax 503 piston engine	
Year of Manufacture:	1988	
Date & Time (UTC):	27 June 1993 at 1625 hrs	
Location:	Sandown Airport, Isle of Wight	
Type of Flight:	Private	
Persons on Board:	Crew - 1	Passengers - 1
Injuries:	Crew - Fatal	Passenger - Fatal
Nature of Damage:	Aircraft destroyed	
Commander's Licence:	Private Pilot's Licence (Aeroplanes) with Instructor's Rating	
Commander's Age:	42 years	
Commander's Flying Experience:	About 1,000 hours (of which some 200 were on type)	
Information Source:	AAIB Field Investigation

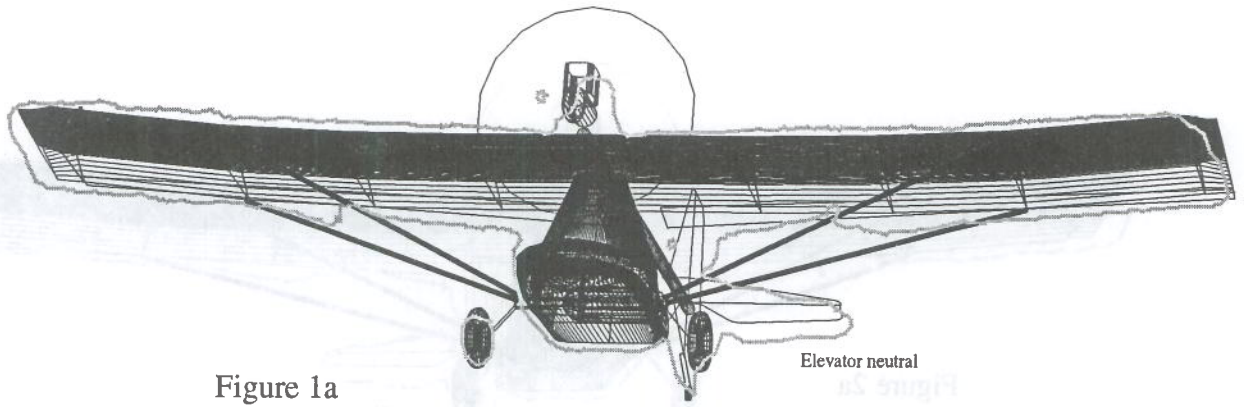
Figure 1a

It was not possible to perfectly match the perspectives of the two images, but within the limitations of the method a reasonable overall match could be obtained for the aircraft as a whole. Simulation of the bent rear fuselage tube resulted in minimal change in the overall image with the result that it was possible to obtain a reasonable match for both the *fuselage tube undamaged* and the *fuselage tube bent* conditions, as shown in figures 1 and 2, and therefore this analysis was unable directly to resolve the question of whether or not the rear fuselage tube was bent prior to impact. However, in both of these cases a down elevator deflection of between 15° and 30° most closely matched the video image, with neutral elevator in each case matching very poorly.

Elevator neutral

Figures 1
Condition: FUSELAGE TUBE STRAIGHT
Comparison between video image outline and 3-D CAD model of Thruster TST

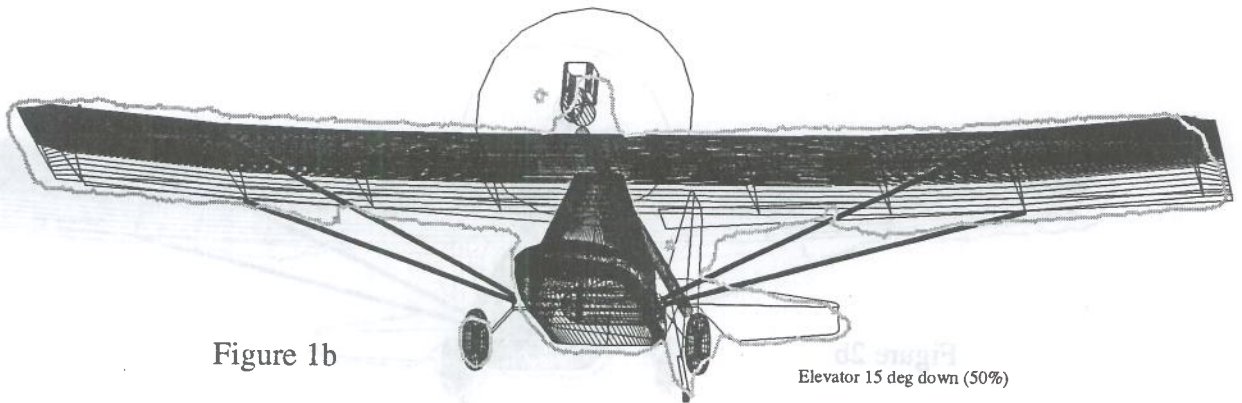
Figure 1b

Elevator 15 deg down (50%)

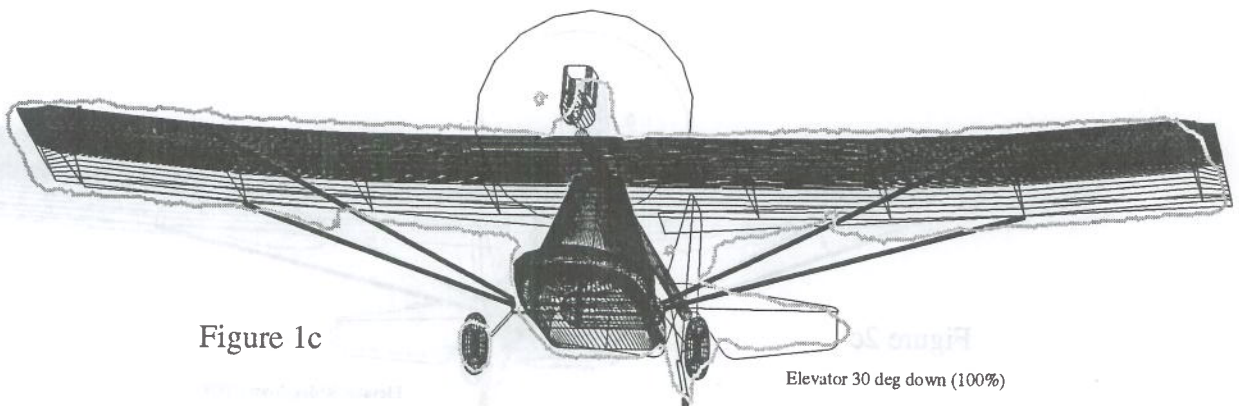
Figure 1c

Elevator 30 deg down (100%)

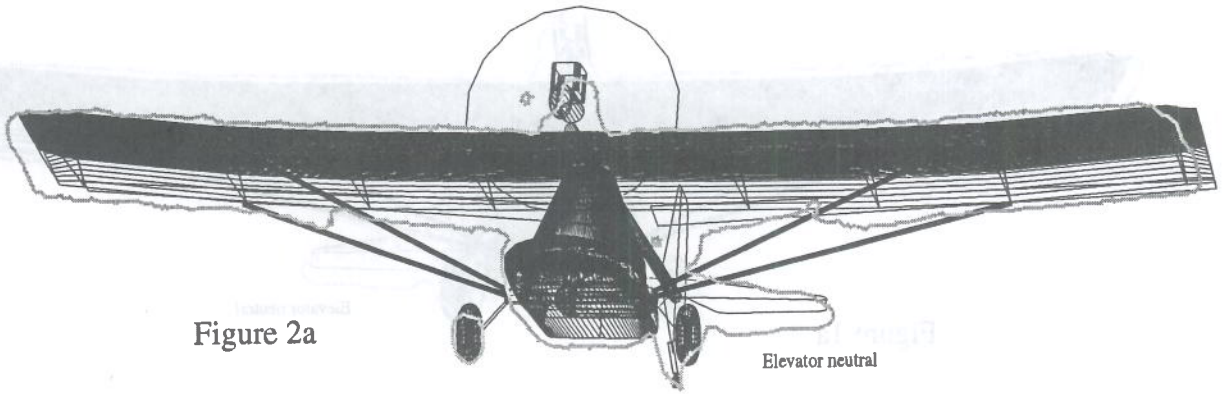
Figure 2a

Elevator neutral

Condition: FUSELAGE TUBE BENT "as found"

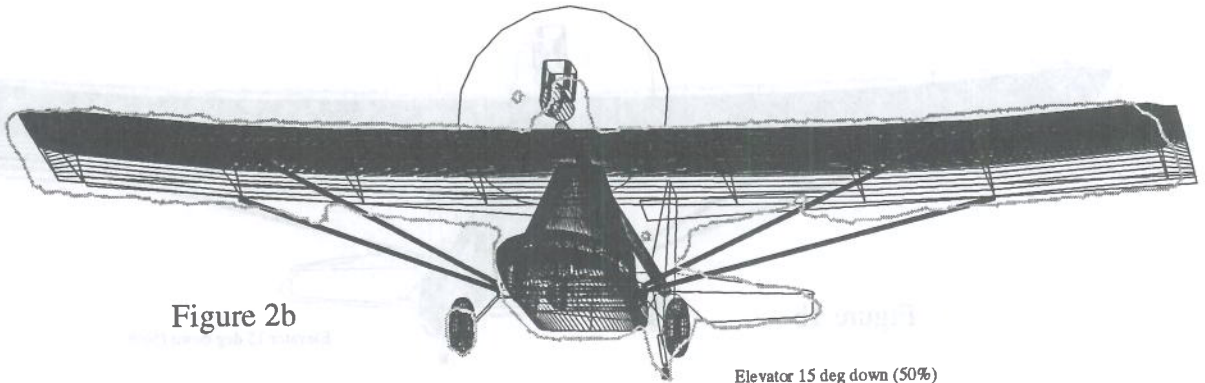
Figure 2b

Elevator 15 deg down (50%)

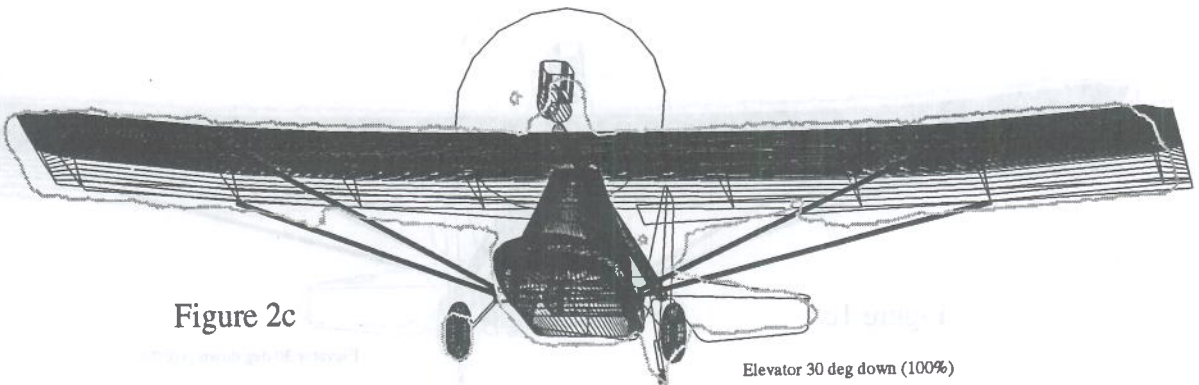
Figure 2c

Elevator 30 deg down (100%)

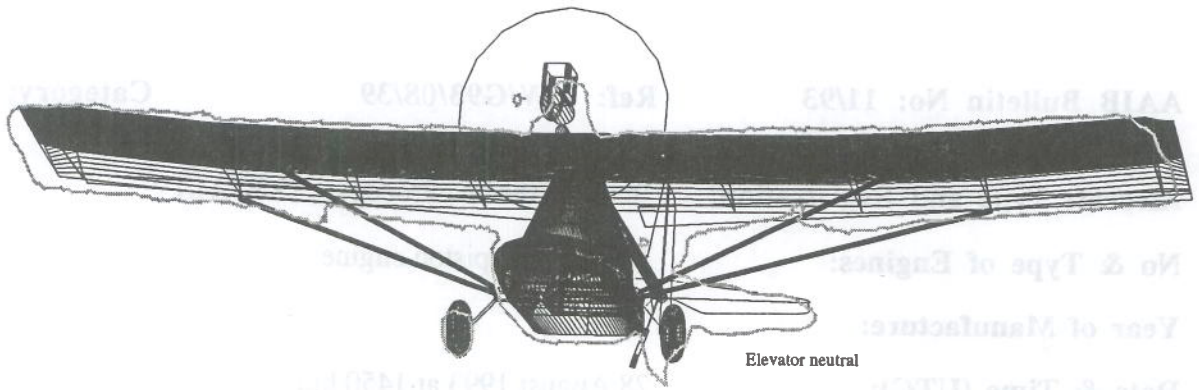
Figure 3 shows the image overlay with both the *fuselage tube and lower fin bent*. In this condition, it can be seen that the tailwheel and lower fin project outside the video image boundary sufficient to confirm that the lower fin damage was produced during the secondary ground impact.

Figure 3
Condition: FUSELAGE TUBE AND LOWER FIN BENT "as found"
Comparison between video image outline and 3-D CAD model of Thruster TST
