BV234 Main Drive System Component Layout

Page
1	Preliminary	
1.1	Accident	80
1.2	Investigation	80
1.3	Proceedings of Review Board	80
2	Facts	
2.1	Narrative	83
2.2	History of failed transmission, A7-1625	86
3	Decision of the Board	87

2.2 History of the Failed Transmission, A7-1625

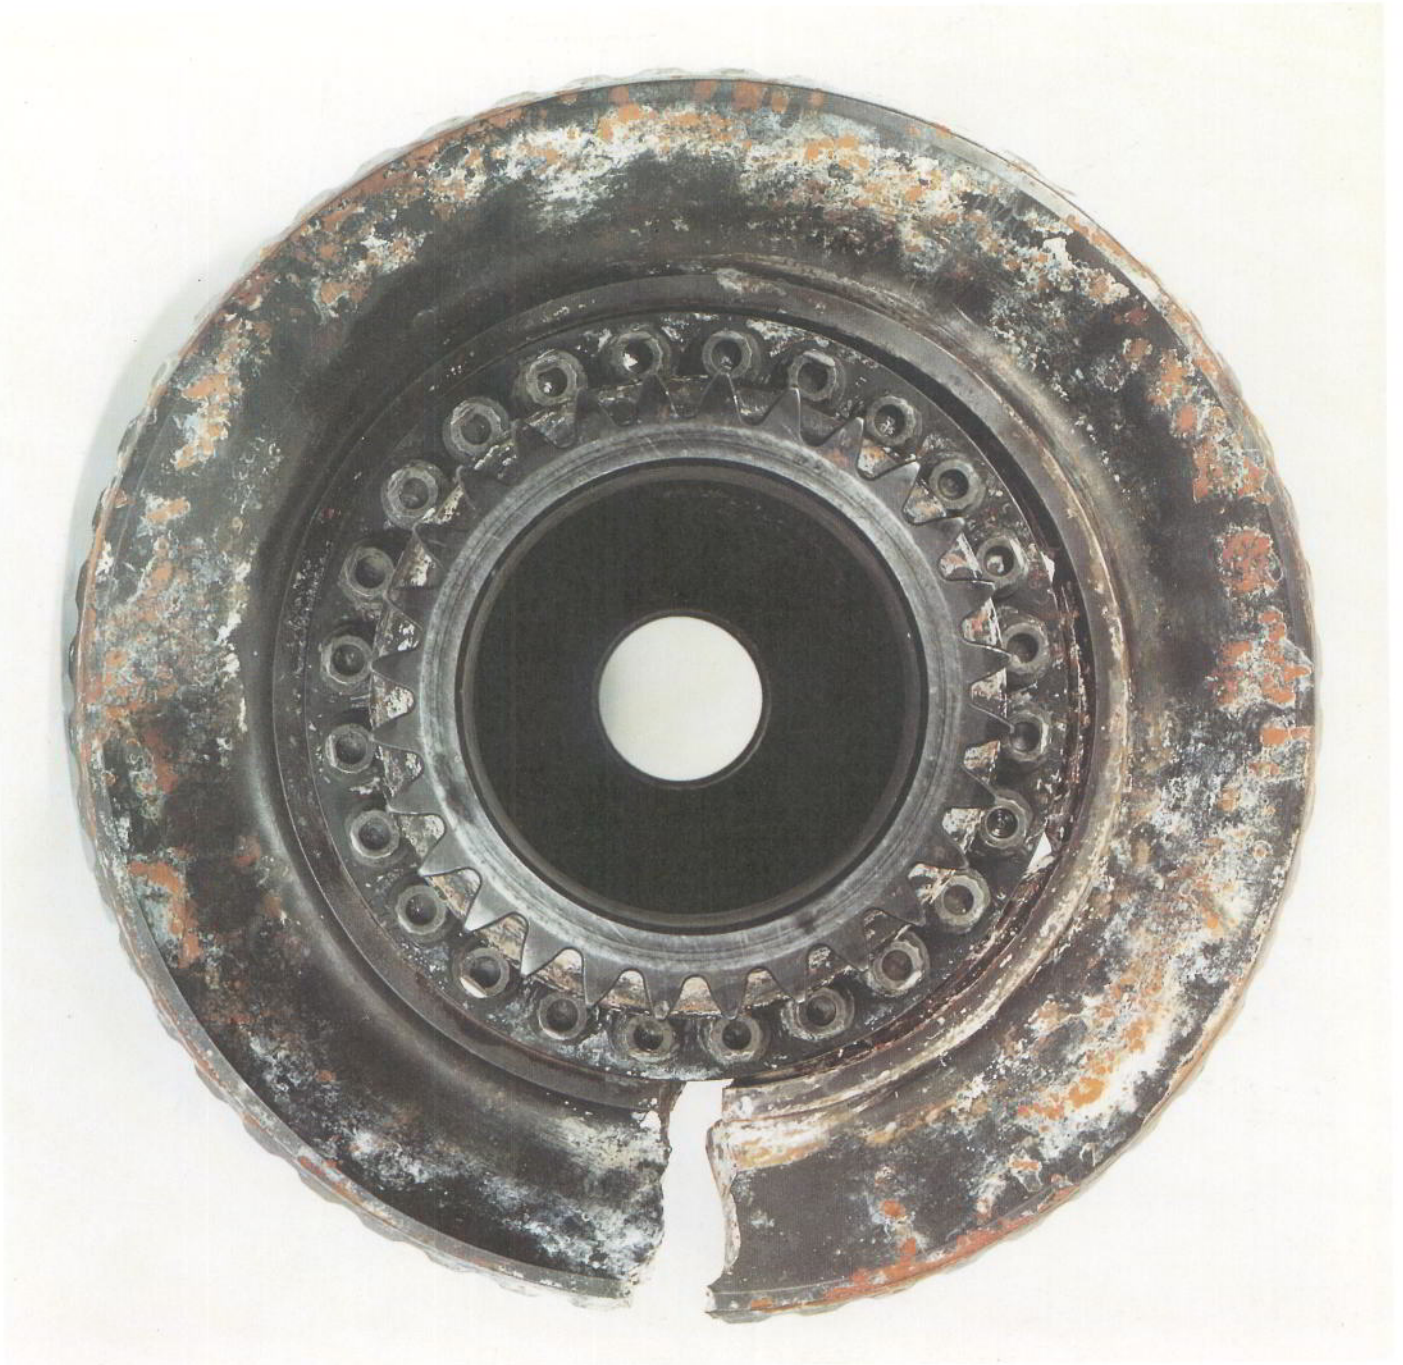
(Photograph taken after removal from transmission for clarity)

View of Spiral Ring Gear on Sun Gear Shaft as first seen

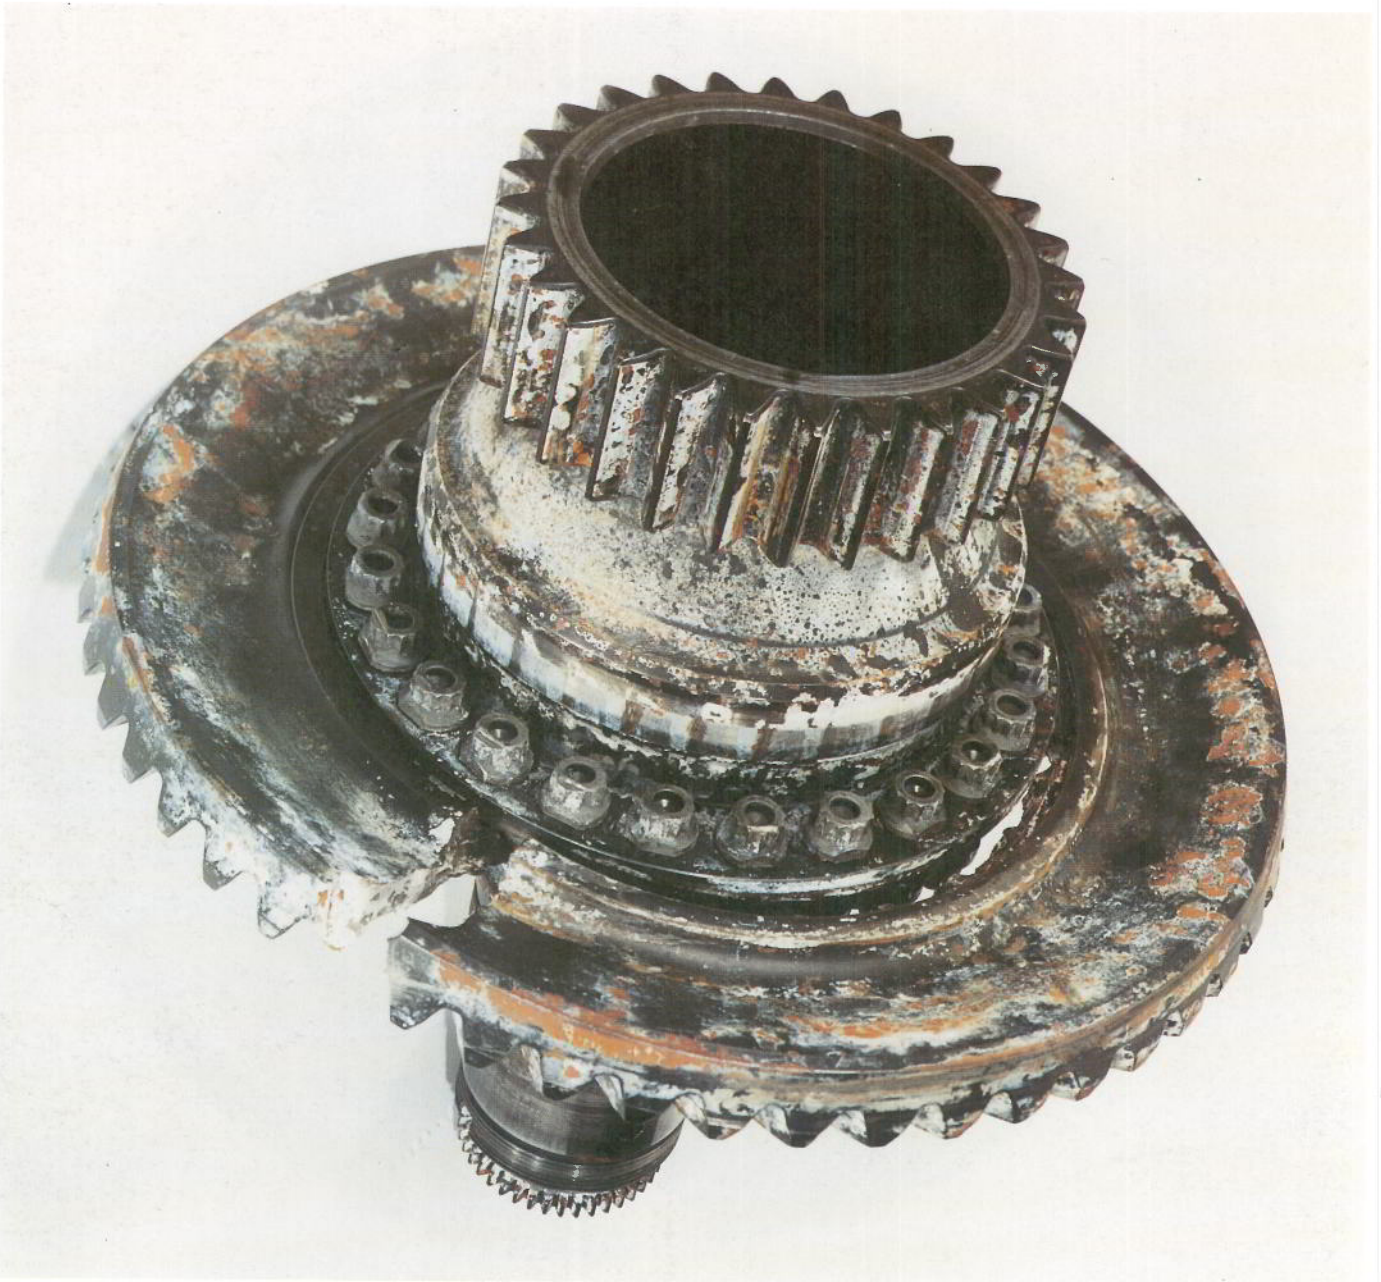
Spiral Bevel Ring Gear on Shaft before disassembly

Note:- a) Radial severance of gear rim at lower left.
b) Gap between rim and shaft flange at lower right.

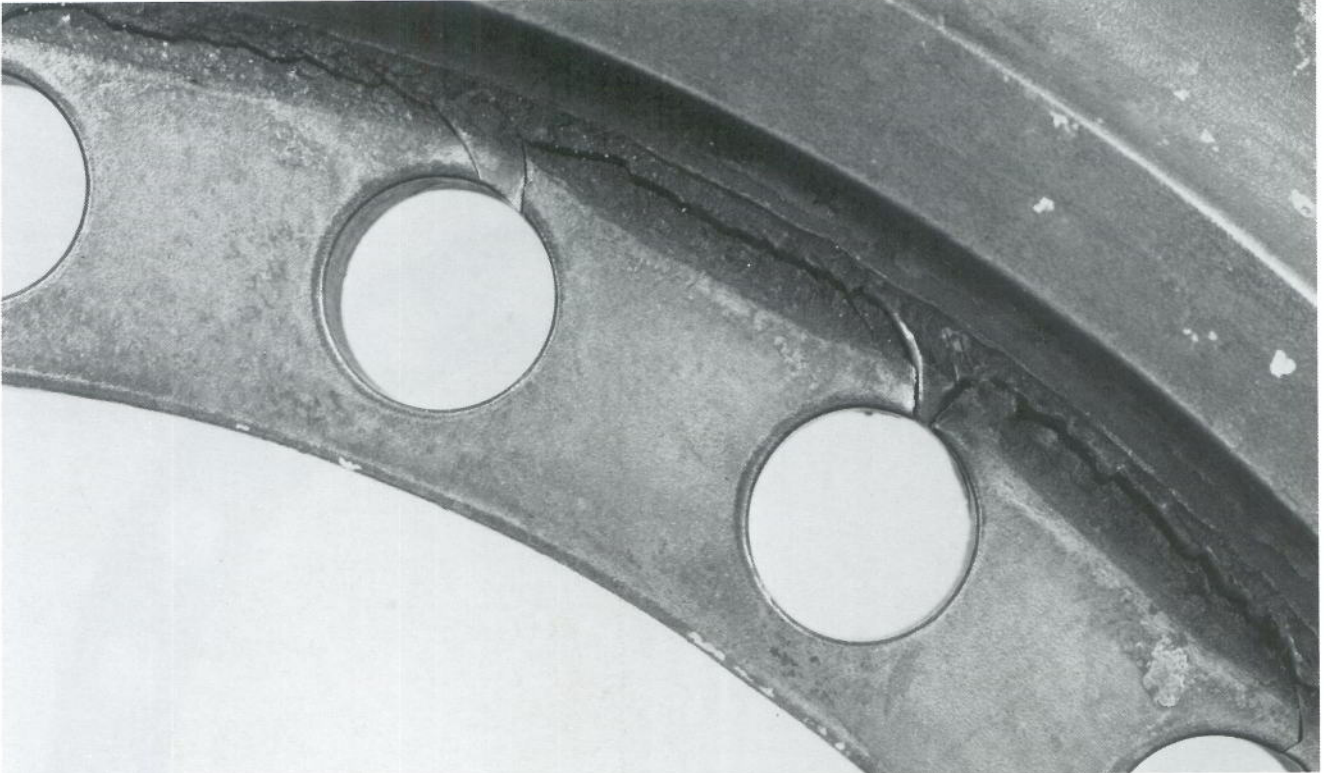
(1) Sector of the mating face of the attachment flange of the accident gear showing the groove in the flange face and the main circumferential crack.

Note cracklets crossing line of circumferential cracks

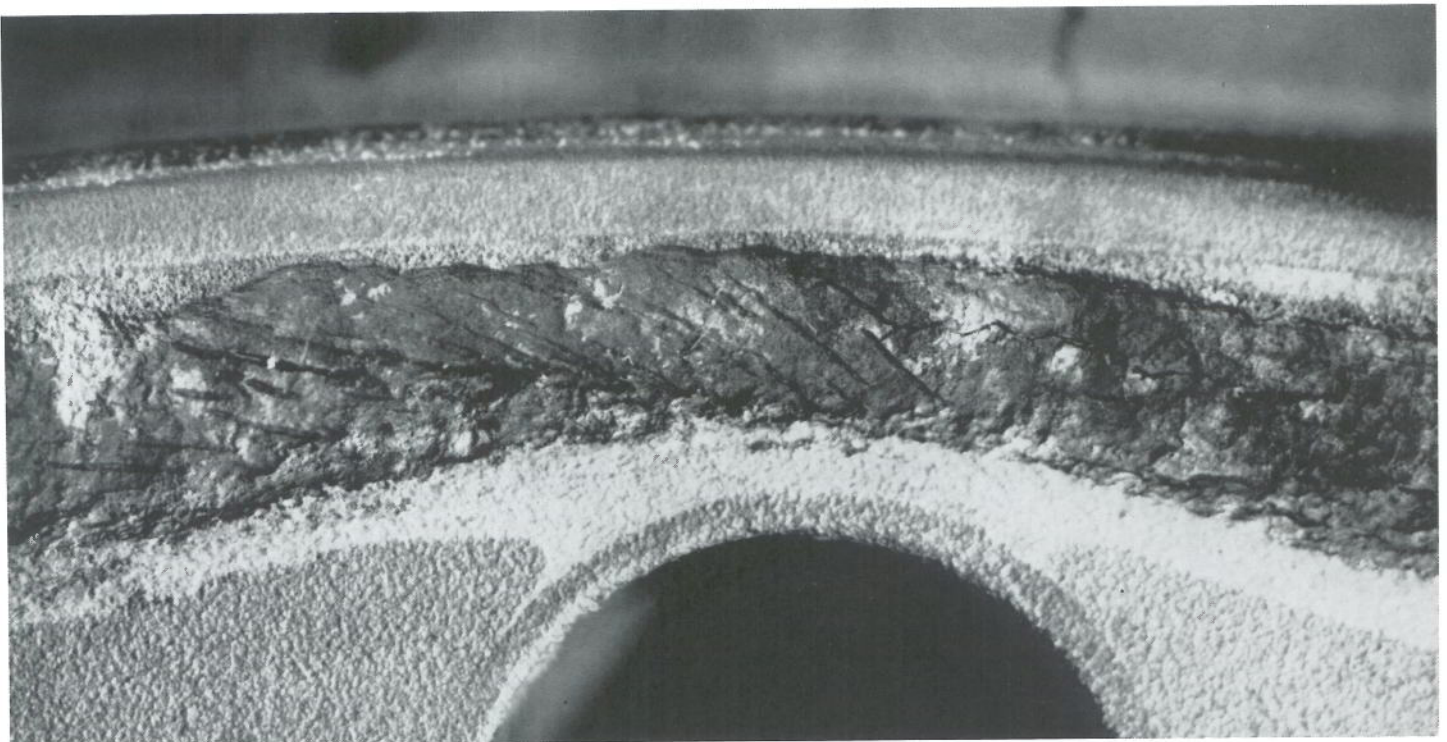
Crack Formation within Grooves on Gear Flange

(2) Sector of the mating face of the flange of another forward transmission ring gear, showing similar groove formation.

This figure shows more clearly the characteristic angular change in the orientation of the cracklets in the groove between and passing attachment bolt holes.

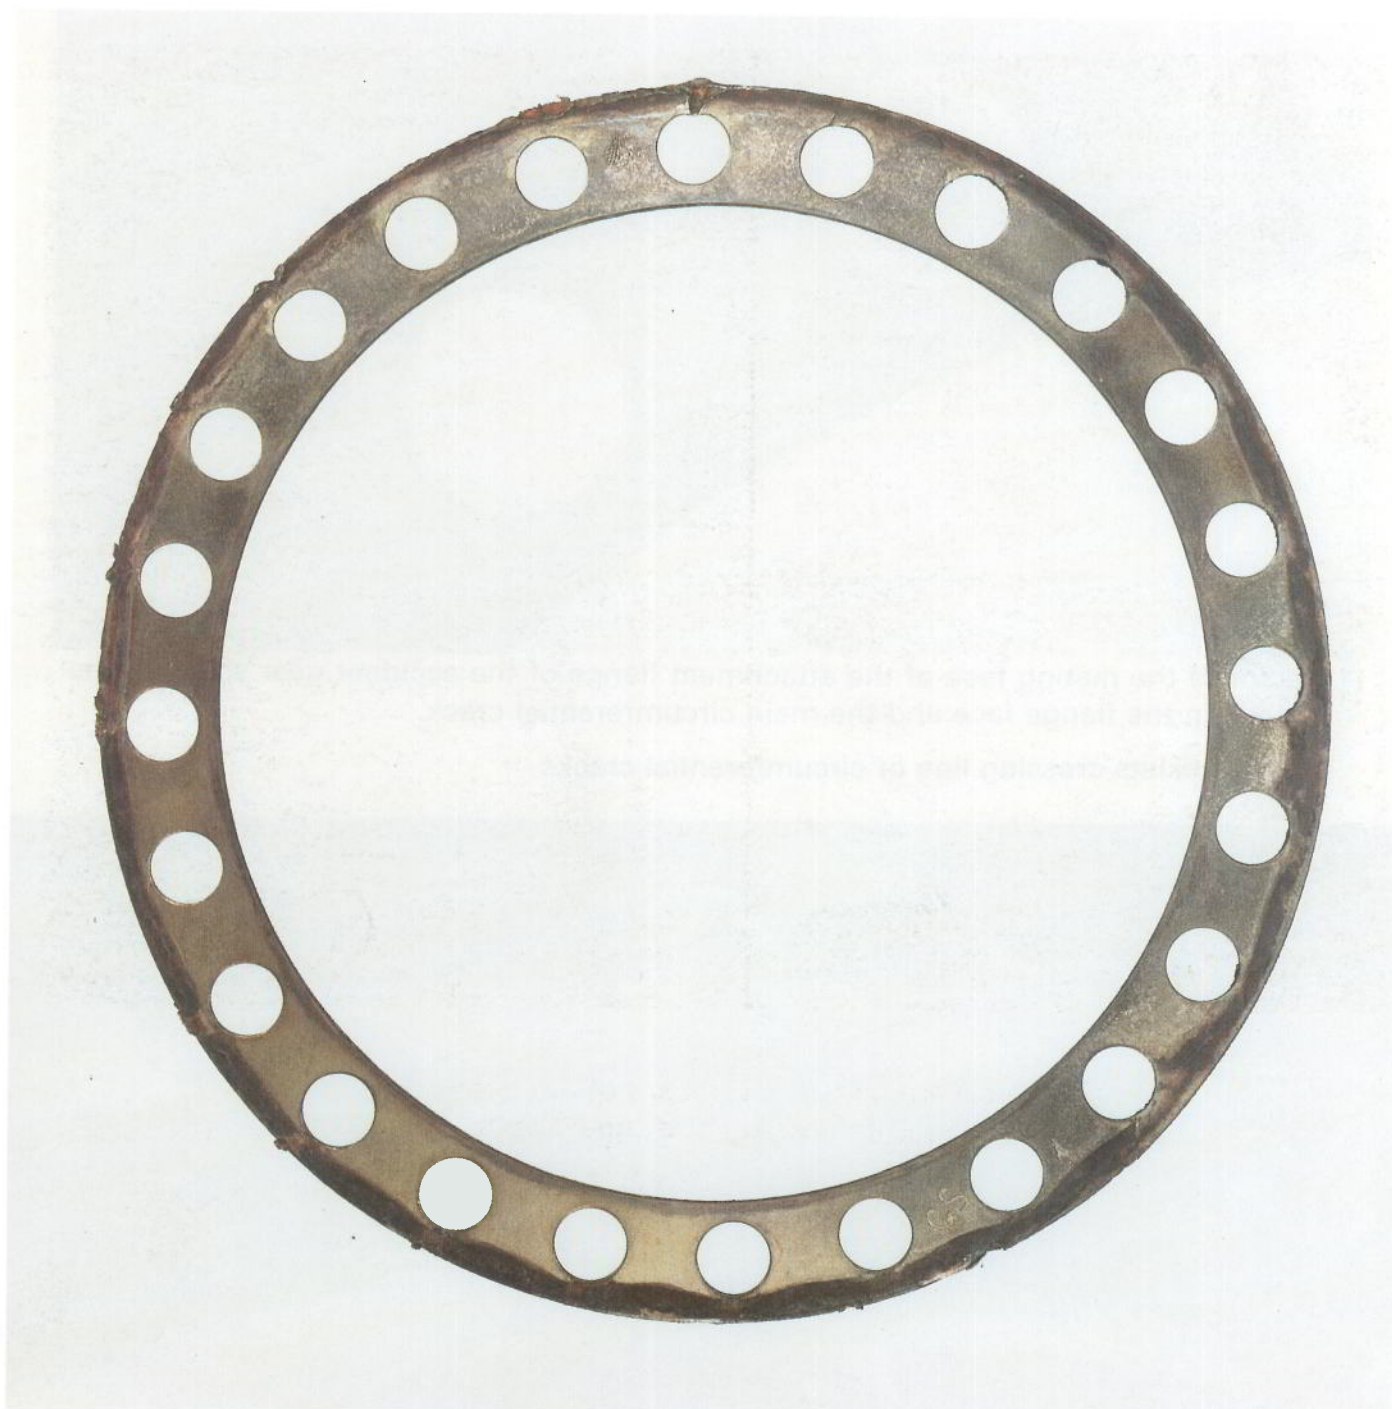
Shim

View of shim showing face which was in contact with the gear flange.
Dark anulus near outer rim shows area in which sticky deposit was formed

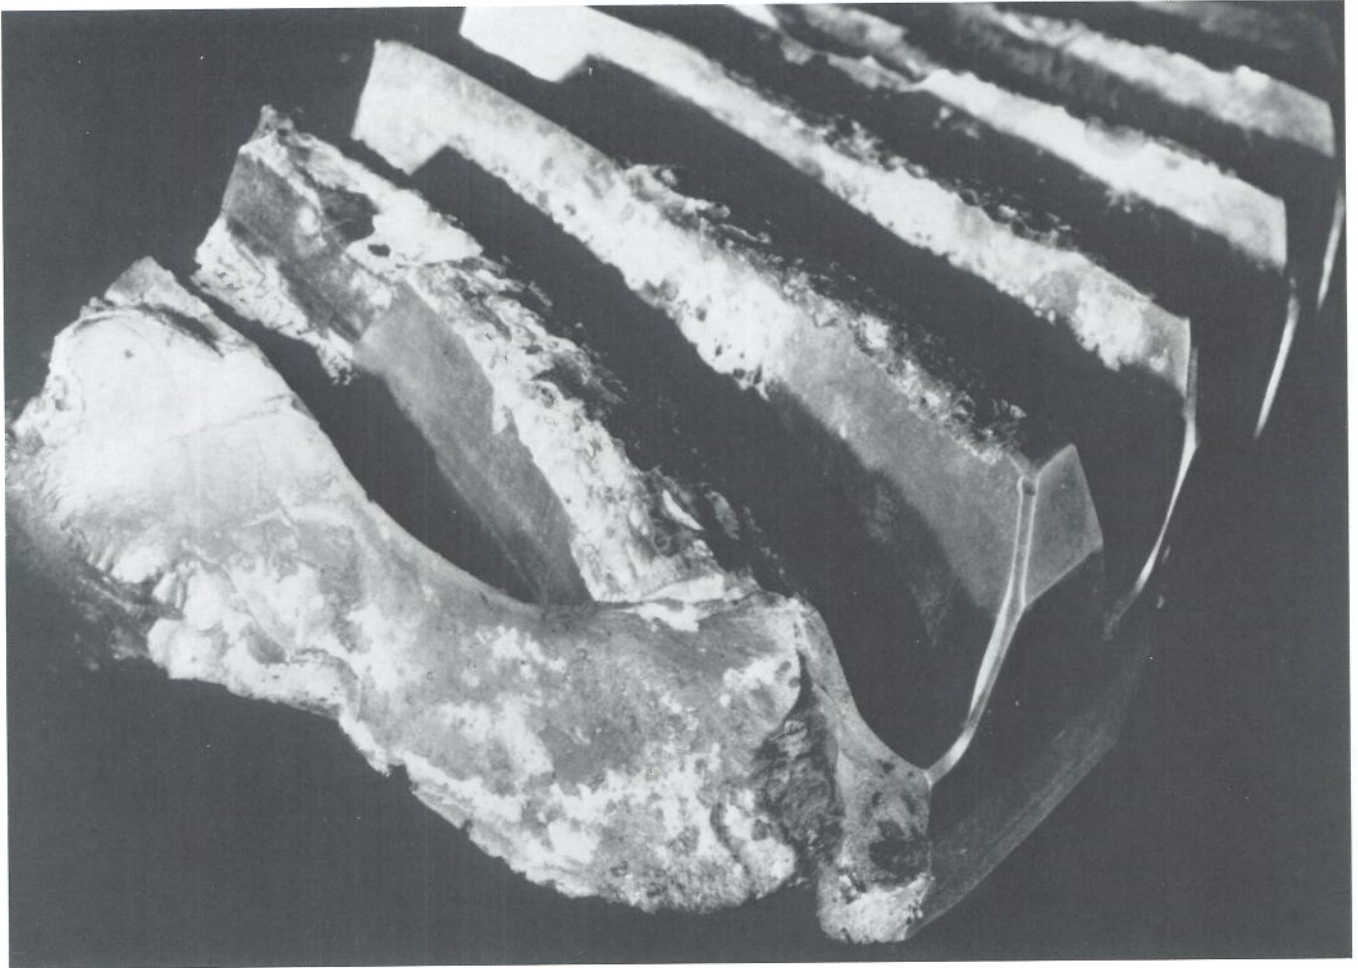
Radial Fracture of Gear Rim

Note more severe damage to crown of first gear tooth after fracture compared to that on subsequent teeth.

All fracture surfaces shown are stable fatigue crack growth except area's shaded:-

- Fast fracture during opening of cracks at RAE
- Fast tearing during final break-up of the transmission

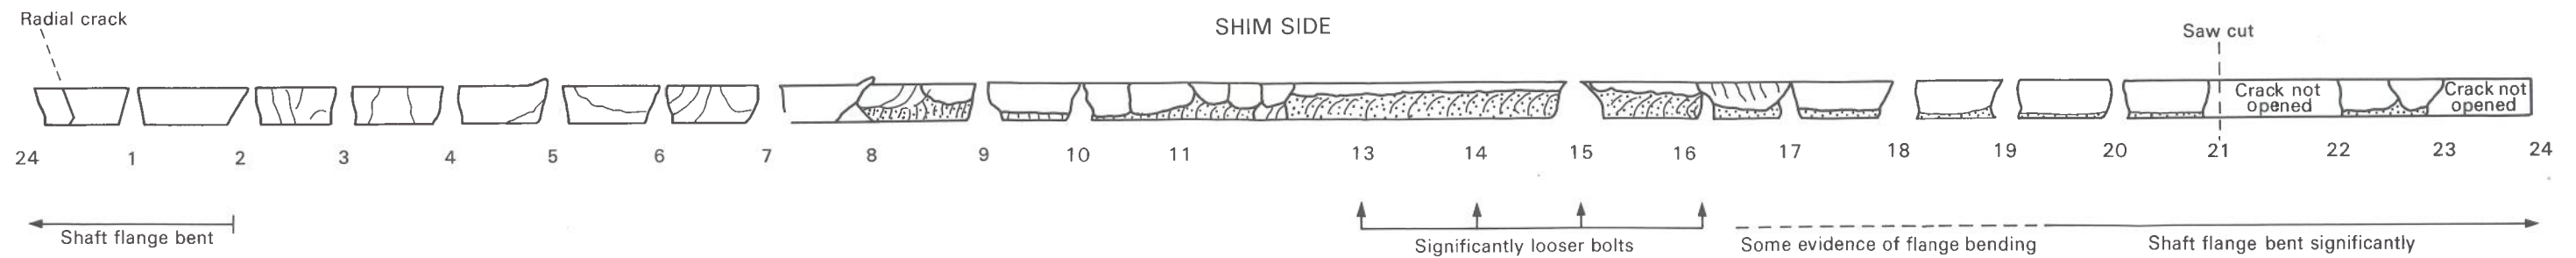
Peripheral View of the Crack Faces in the Flange looking inwards towards Shaft Centre

Features of circumferential crack

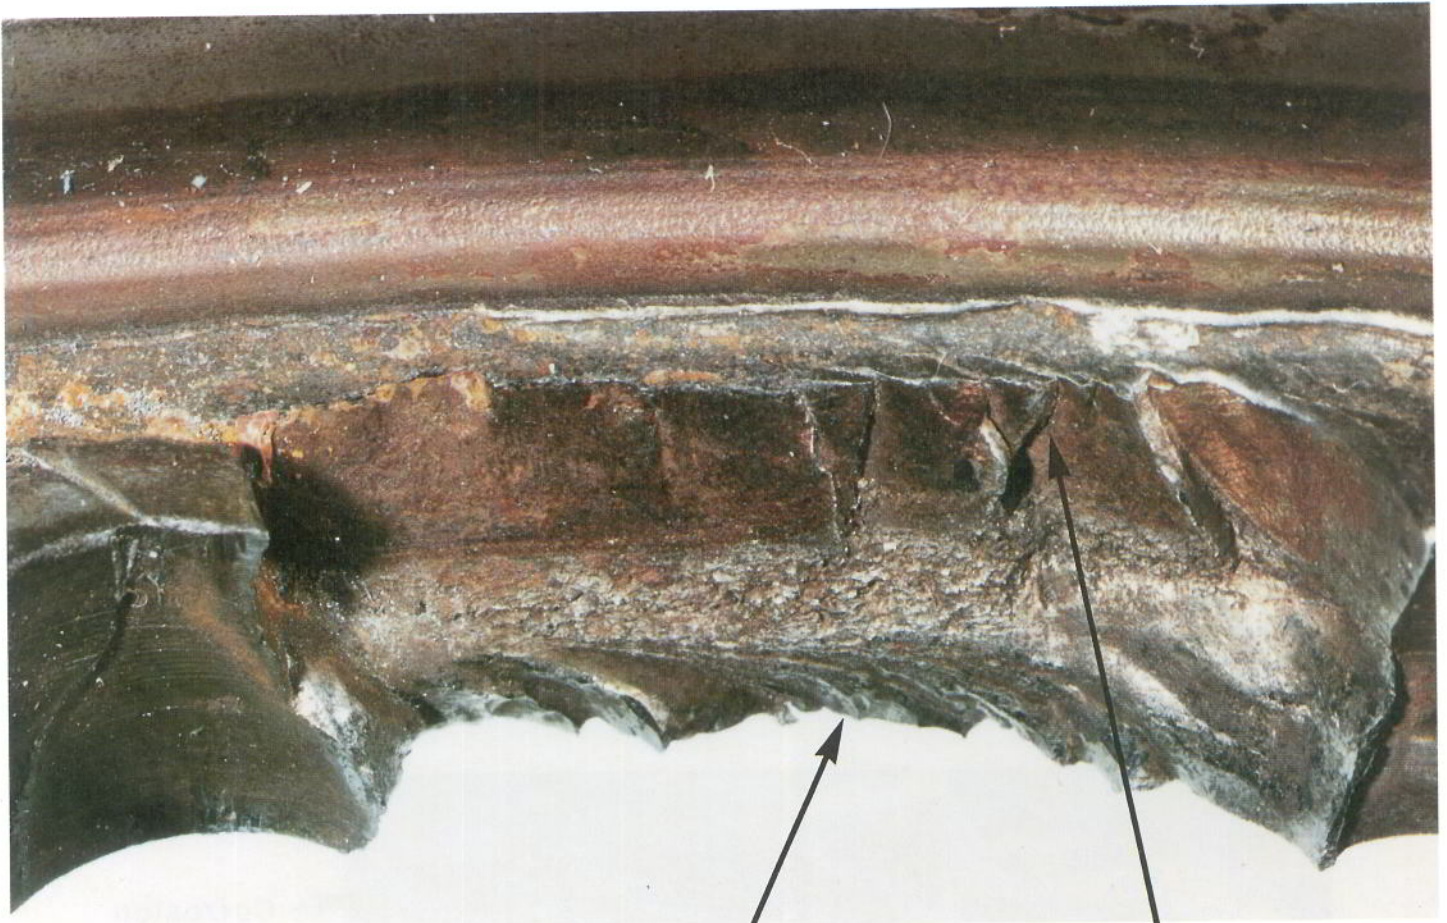
Portion of Circumferential Fracture Face between Holes 9 and 10

Area of fast cyclic tearing.

Area of fatigue with cracklets crossing main fracture.

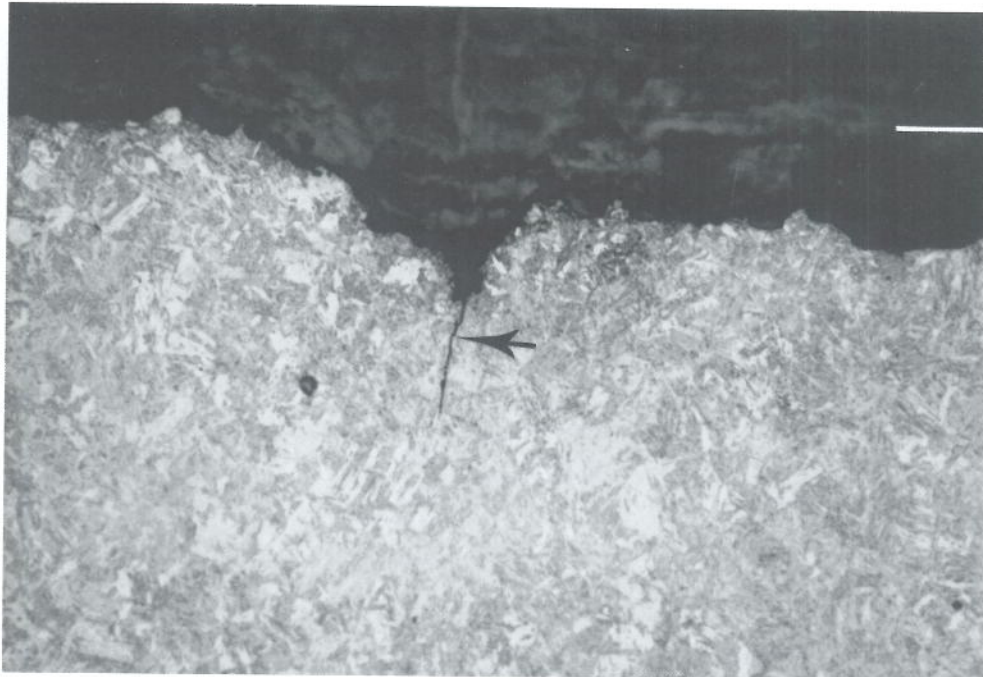
a

Corrosion product

Sections through gear flange showing growth of fatigue cracks from the bottom of 'V'-notches and 'ghost' cracks in the corrosion product in the base of the groove.

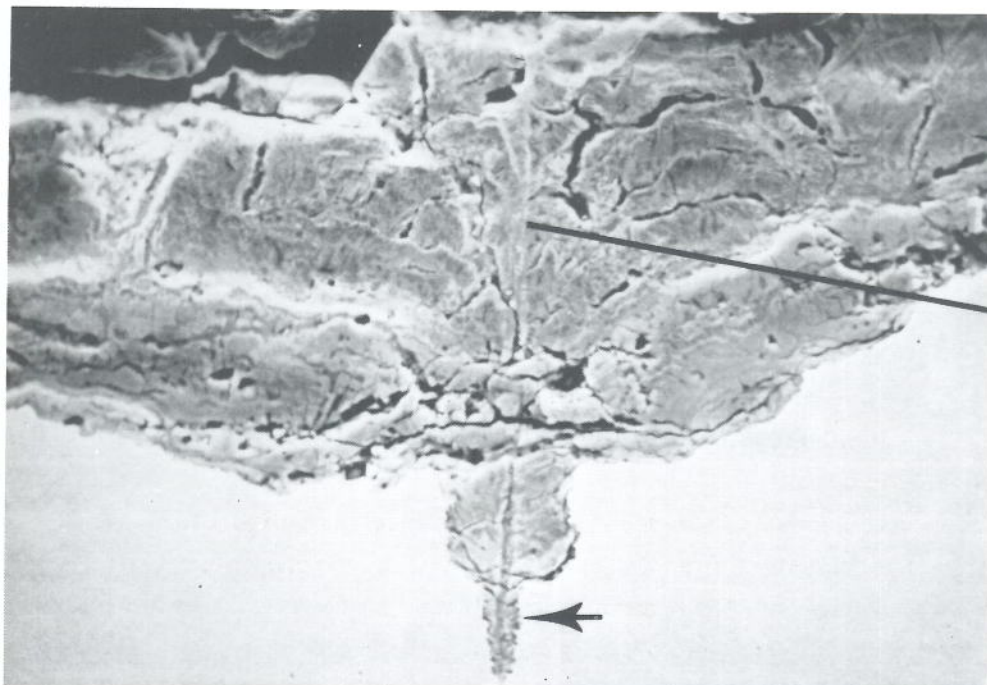
b

Corrosion product

Ghost mark

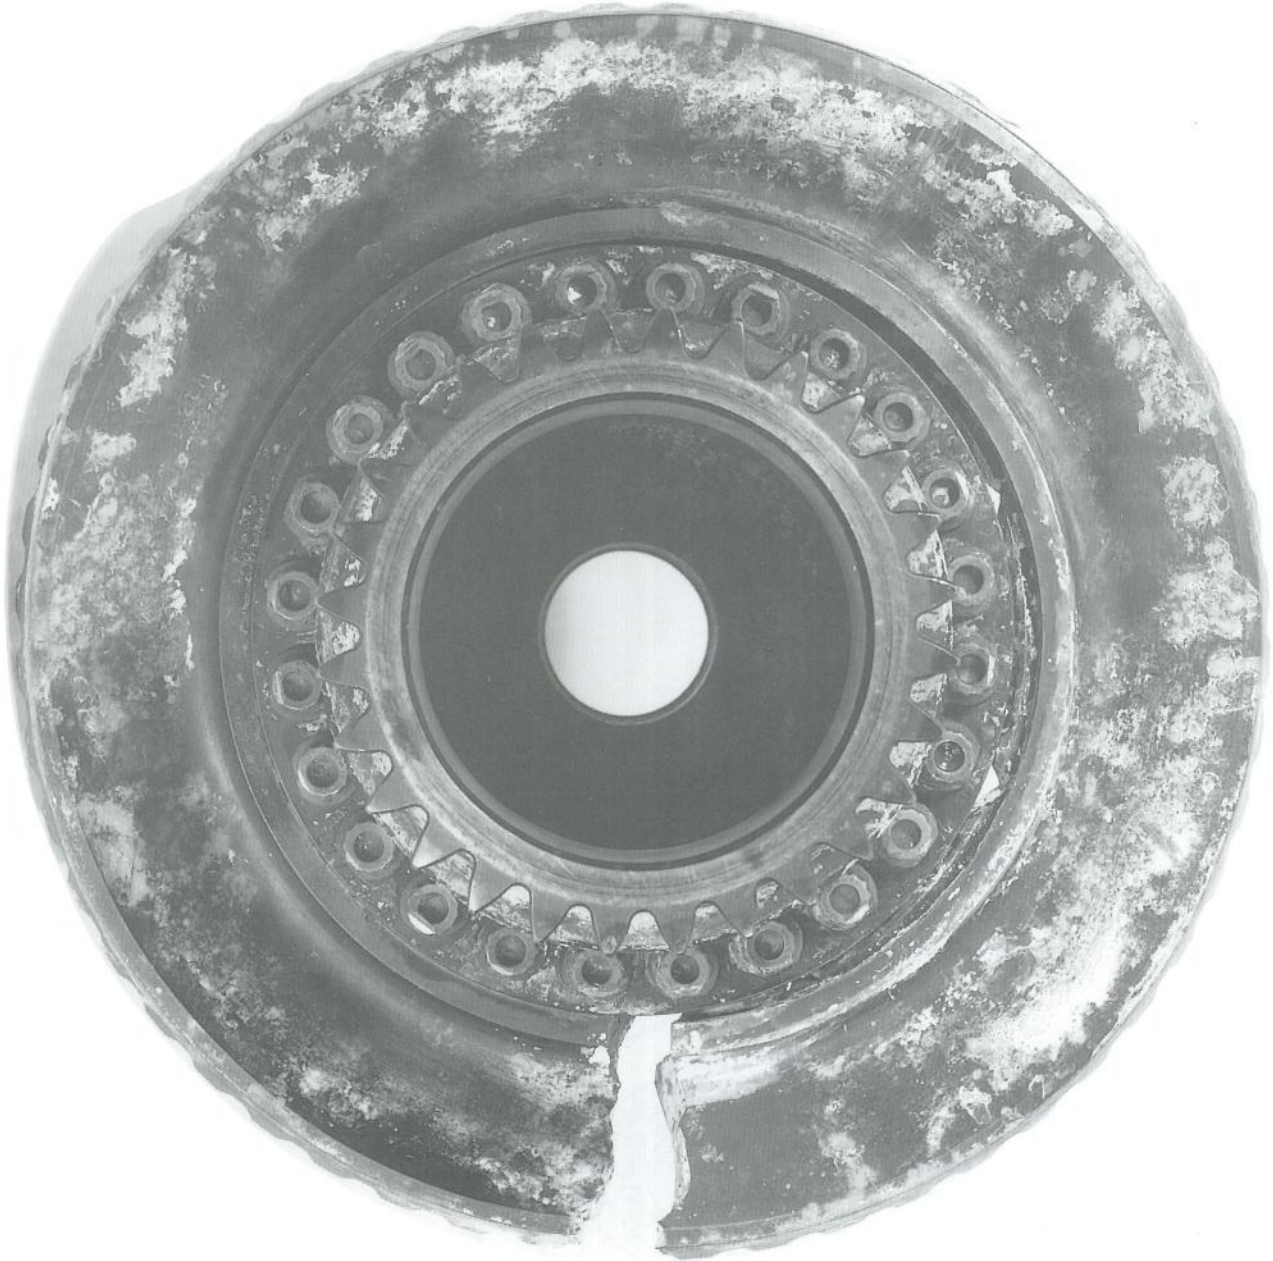
After its recovery from the sea, "the transmission casing was cut away to allow the first stage sun gear shaft and spiral bevel ring gear to be removed as an assembly. Besides the radial crack, the ring gear had a circumferential failure around the outer radius of its flange which appeared to exist round at least 60% of the circumference." Figure 4 shows the radial crack at the bottom of the picture and the 60% circumferential failure.

(Photograph taken after removal from transmission for clarity)

View of Spiral Ring Gear on Sun Gear Shaft as first seen
