**AAIB Bulletin No:** 9/94

**Ref:** EW/G94/07/20

**Aircraft Type and Registration:** Piper PA-18-180 Supercub, G-BEUA

**Nature of Damage:** Damage to left main gear

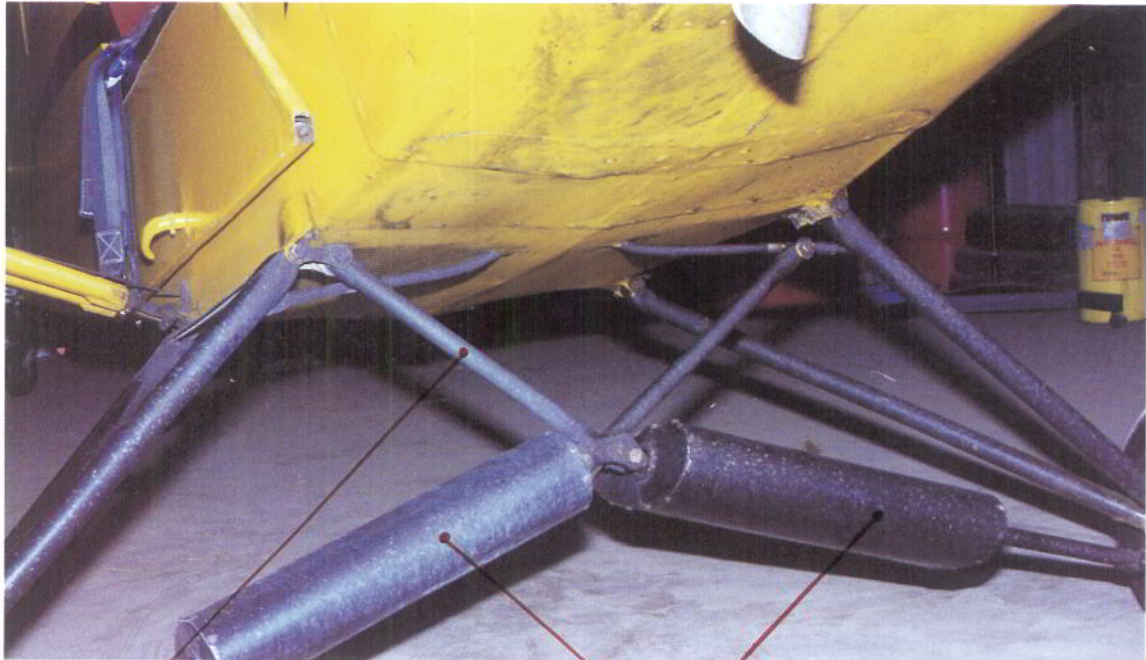
Figure 1

An initial examination of the aircraft revealed that a failure had occurred to a pair of lugs on the forward left main landing gear fitting, which is welded to the fuselage lower left longeron. These lugs provide one of two location points for an inverted A-frame, the apex of which provides an anchor point for the main gear bungee suspension units, as illustrated in Figures 1 and 2. The fuselage fitting, Piper Part No 21272-03, is fabricated from a weldable (nominal 30 ton) steel, each lug being locally thickened on

*Inverted A-Frame*

*Bungee Suspension Units*

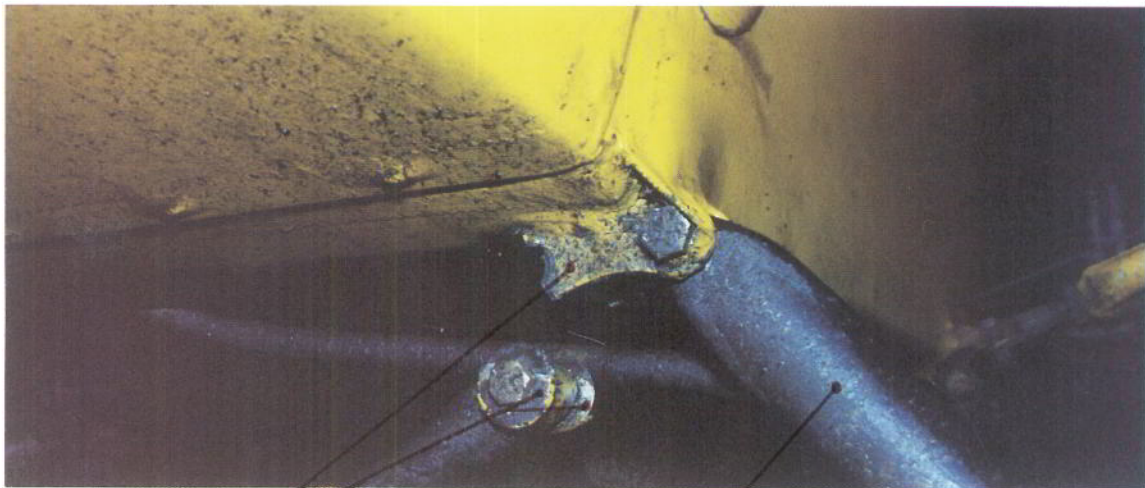
Figure 2

*Failed Lugs*

*MLG Forward Strut*

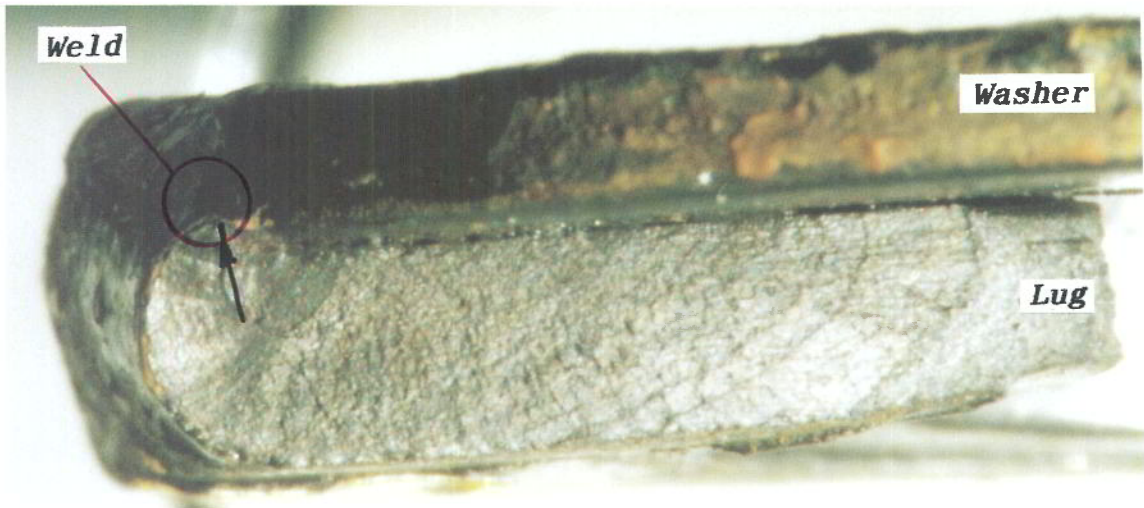
Figure 3

its inner face by the addition of a washer around the A-frame attachment bolt hole. These washers are attached by welding, but only around the outer  $\frac{2}{3}$  of their circumference. Metallurgical examination of the two fractures revealed that both had failed as a result of a fatigue mechanism, the aft lug exhibiting characteristics of long term crack growth over many hundreds of thousands of tension cycles, the forward lug exhibiting short term growth. It was also apparent that the aft lug had probably failed completely before fast fracture of the uncracked portion of the forward lug had occurred. The origin of both fatigue cracks was associated with the run-out of each weld, areas where significant stress concentrations might be expected to occur (see Figures 3 and 4). The quality of the weld and weld material was not in question. The landing gear fittings on the Piper Cub series of aircraft are located in an area which often becomes contaminated with oil/dust/dirt etc which, in addition to the compact nature of this particular joint, mitigates against the likelihood of a crack being readily detected during, for example, a daily inspection.

*Short term fatigue fracture face. Initiation region arrowed*

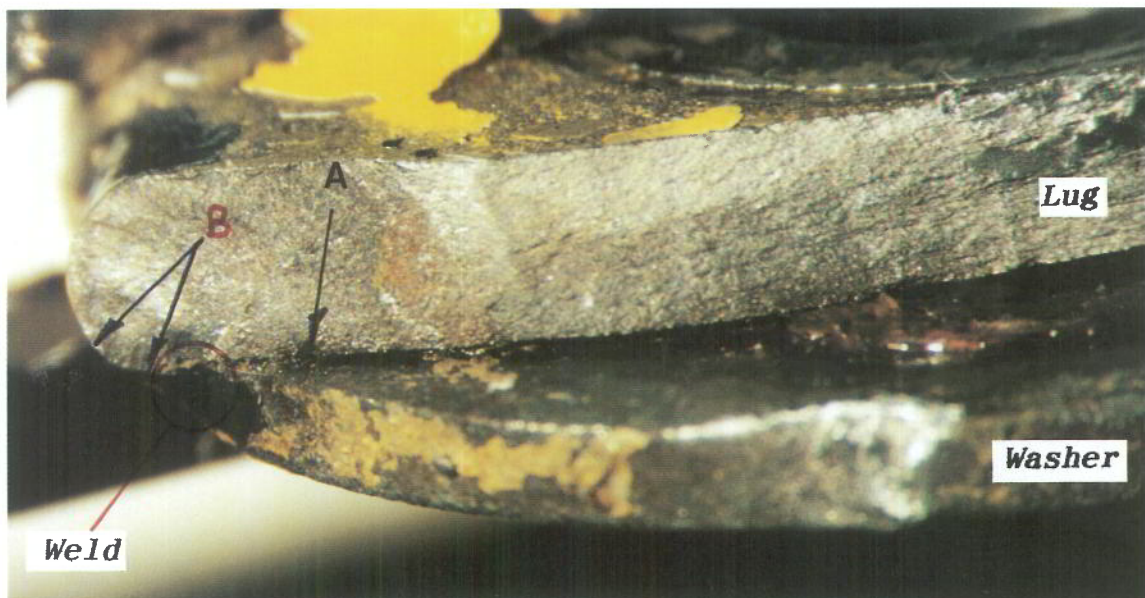
Figure 4

There was evidence on the aft lug fracture face, close to the origin of the fatigue crack, of black paint similar to that applied over the fuselage tubular steel structure, as arrowed in Figure 4. The aircraft had been completely refurbished in December 1992, some 430 flying hours prior to the failure, and had been operating from the airfield at Dunstable since 1979 when its total flight time was 2,856 hours. Its total time up to this failure was recorded as 8,970 hours, during which time it is estimated to have made 36,700 flights. The surface of the gently undulating field at Dunstable, whilst being acceptable for the gliding/winchng/aerotowing operation which has taken place there for some sixty years, is not generally considered to be as smooth as most airfields used by powered aircraft and, as such, the landing gear of aircraft regularly operating from this surface can be expected to sustain consistently high loads and load cycles. This is not an uncommon feature of aircraft operated from airfields used primarily by gliding clubs.

*Close up of long term Fracture face - initiation region arrowed B. Traces of black paint on fracture face along edge arrowed A*
