<b>Aircraft Type and Registration:</b>	McDonnell Douglas DC-8-63F, 9G-MKO	
<b>No &amp; Type of Engines:</b>	4 Pratt & Whitney JT3D-7 turbofan engines	
<b>Year of Manufacture:</b>	1971	
<b>Date &amp; Time (UTC):</b>	29 April 2003 at 1500 hrs	
<b>Location:</b>	RAF Lyneham, Wiltshire	
<b>Type of Flight:</b>	Public Transport (Cargo)	
<b>Persons on Board:</b>	Crew - 4	Passengers - None
<b>Injuries:</b>	Crew - None	Passengers - N/A
<b>Nature of Damage:</b>	Right main landing gear fractured	
<b>Commander's Licence:</b>	Airline Transport Pilot's Licence	
<b>Commander's Age:</b>	43 years	
<b>Commander's Flying Experience:</b>	10,200 hours (of which around 3,500 were on type) Last 90 days - 220 hours Last 28 days - 85 hours	
<b>Information Source:</b>	AAIB Field Investigation

### Synopsis

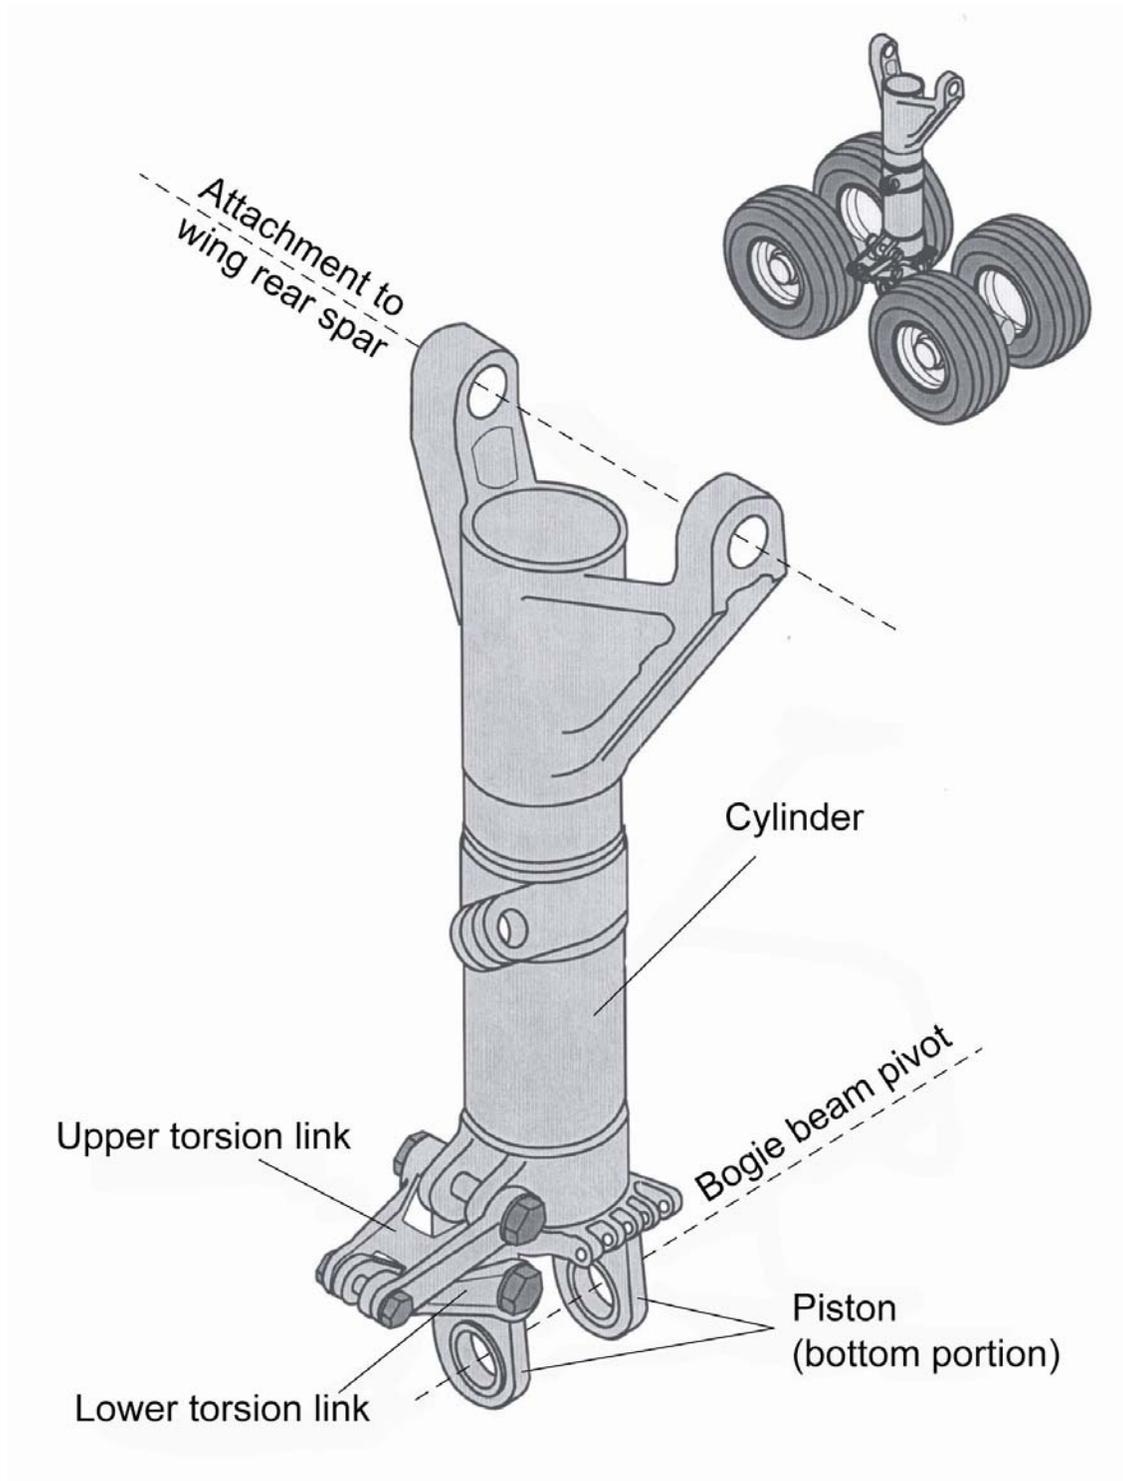
Main Landing Gear  
**Figure 1**

The MLG leg (Figure 1) consists of a cylinder/piston type oleo shock-strut. The shock-strut cylinder is attached to the wing structure and a four wheeled truck (bogie) is connected to the lower end of the piston by a pivot pin. The vertical load on the piston is supported by a pressurised nitrogen charge within the cylinder and shock absorption is provided by translation of the piston within the cylinder,

controlled by regulating the flow of oil between chambers within the oleo. Rotation of the piston relative to the cylinder is prevented by a scissor linkage, consisting of two torsion links, connected together by a horizontal apex pivot joint. The lower torsion link is attached to the piston via a horizontal pivot joint and the upper torsion link is similarly pivoted onto the cylinder.

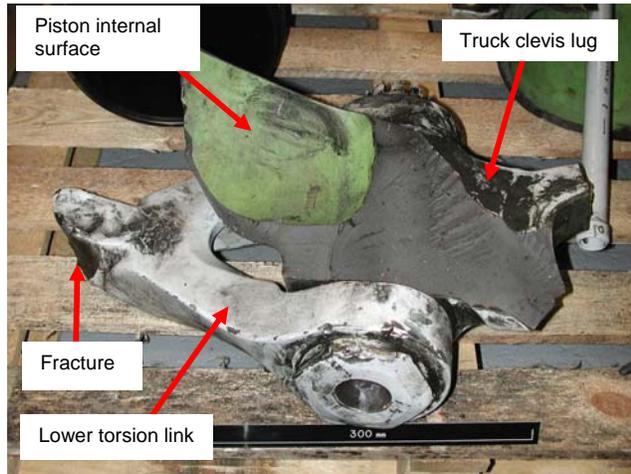
Part of piston and lower torsion link  
**Figure 2**

Initial examination revealed that the piston of the right MLG shock-strut had sustained extensive fracturing that had separated the piston into four main pieces and a number of fragments. A generally axial fracture passed through the base of the two lower torsion link clevis lugs and through the aft limb of the left (inboard) truck beam clevis lug (Figures 2 and 3). From this fracture, two fractures extended up the left side-wall of the piston. Around 9 inches from the base of the piston one of the fractures had become generally circumferential, separating the lower part of the piston into two pieces, detached from the remainder of the piston, with each piece including one of the truck beam clevis lugs.

The upper torsion link of the scissor linkage remained intact and connected to the cylinder. The lower torsion link had fractured at the apex pin connecting it with the upper torsion link. At its other end, the lower torsion link remained intact, but the unfractured forward limb of the left truck beam clevis lug had twisted around 40°. Deformation and markings indicated that both the torsion link fracture and the lug twisting had resulted from loads transmitted by the scissor linkage as the cylinder had rotated clockwise relative to the truck beam, as viewed from above.

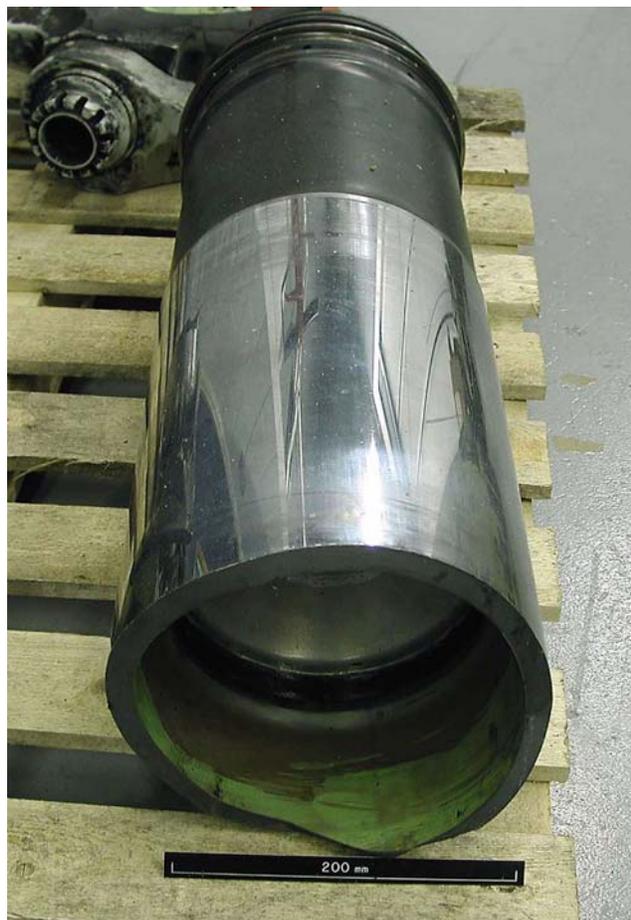
Piston upper part  
**Figure 4**

The right hand piston piece remained jammed into the cylinder and continued to support the aircraft weight. The smaller piston piece, on the left side, remained attached to the lower torsion link. Further fractures extended up the piston (Figures 4 and 5) beyond the circumferential fracture and separated an additional 6 inch length of the piston, which also remained in situ.
