**INCIDENT**

<b>Aircraft Type and Registration:</b>	Boeing 757-204, G-BYAT
<b>No &amp; Type of Engines:</b>	2 Rolls-Royce RB211-535E4-37 turbofan engines
<b>Year of Manufacture:</b>	1994
<b>Date &amp; Time (UTC):</b>	15 February 2010 at 1800 hrs
<b>Location:</b>	Stand 28, Glasgow International Airport
<b>Type of Flight:</b>	Commercial Air Transport (Passenger)
<b>Persons on Board:</b>	Crew - 8                      Passengers - 230
<b>Injuries:</b>	Crew - None                      Passengers - None
<b>Nature of Damage:</b>	Damaged recirculation fan
<b>Commander's Licence:</b>	Airline Transport Pilot's Licence
<b>Commander's Age:</b>	60 years
<b>Commander's Flying Experience:</b>	18,000 hours (of which 13,000 were on type) Last 90 days - 23 hours Last 28 days - 11 hours
<b>Information Source:</b>	Field Investigation

**Synopsis**

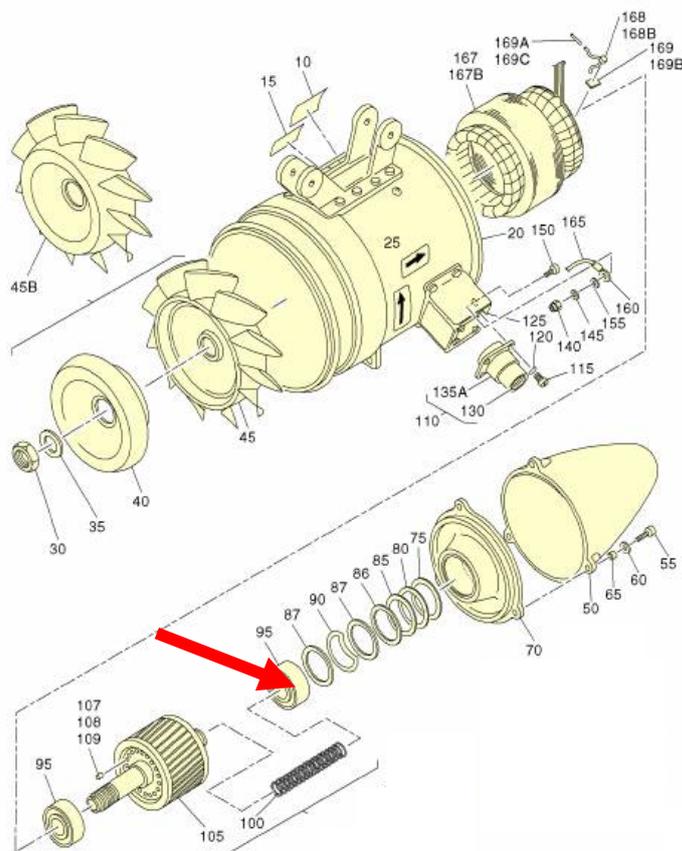
**Figure 1**

Conditioned air supply for the aircraft is provided by two air conditioning packs and is distributed to various zones via a ‘mix manifold’ where it is mixed with recirculated, filtered air, which is supplied by the left and right recirculation fans. The fans have different part numbers, with the right fan being designated as the ‘main’ unit. The slower-running left unit is operated as a back-up. The left and right recirculation fans are powered from the left and right Utility buses respectively, via a 20 amp circuit breaker. The right hand fan has a 3-phase motor, running at a nominal 11,400 rpm and drawing a maximum of 13 amps per phase. A diagram of the assembly is shown at Figure 1.

Exploded view of the recirculation fan; position of failed bearing indicated

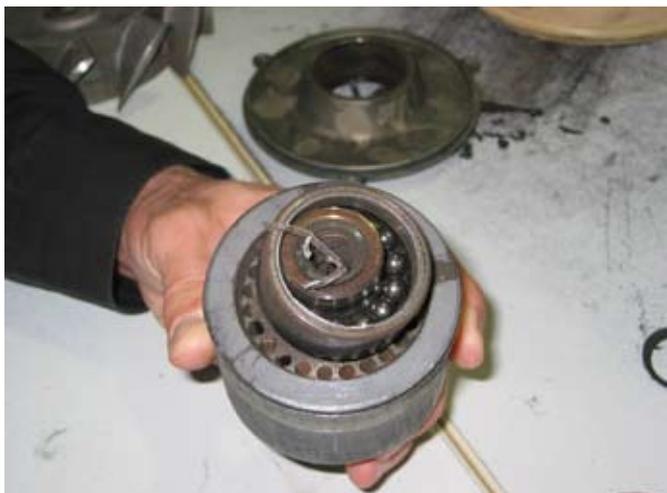
**Figure 2a**

Initially, the unit was placed on a test rig but the fan turned only briefly before the 68 amp rig circuit breaker tripped. The unit was disassembled and it was clear that the rear rotor bearing had failed (Figure 2). The radial play that had occurred at this end of the shaft had resulted in contact between the rotor and stator, which had resulted in smearing of the segments and the consequent generation of debris, mostly in the form of black dust.

Examination of the bearing components indicated that the fibre bearing cage had disintegrated and that there was no evidence of grease with which the bearing had been packed. Fragments from the bearing grease shield were found, which suggested that this may have come loose, leading to the escape of the grease and the subsequent bearing failure. Circumferential score marks on the external surface of the bearing outer race indicated that it had been spinning within its housing; this may have occurred as a result of friction generated within the bearing during the break-up process. It was also noted that grease had started to run out from the otherwise intact front bearing (ie fan end), indicating that the unit had been running in a hot condition.

View of rotor and failed bearing

The airline had experienced a number of similar failures with recirculation fans, which also equip their Boeing 767 fleet. The reasons for some of the failures were not always apparent from the available documentation, although it was clear that bearing failures had occurred in some cases. The fan manufacturer noted that the latest revision of the Component Maintenance Manual (CMM) now includes bearings from an alternative manufacturer as an option. This new bearing has a retaining pin with a larger diameter, which is considered to be potentially more robust than the old component. The operator intends to use the new bearing during overhauls, when they become available in 2011.

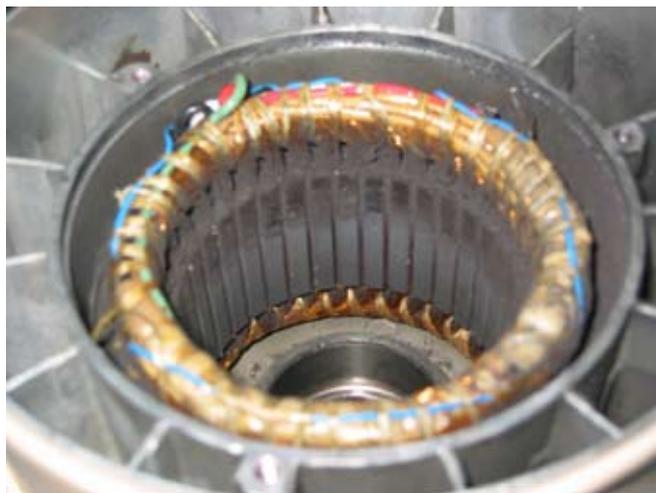
**Figure 2b**

View of contact damage from rotor
