ACCIDENT

| Aircraft Type and Registration: | Skystar Kitfox MK5, G-LESZ | |
| Location: | Swanborough Farm, East Sussex | |

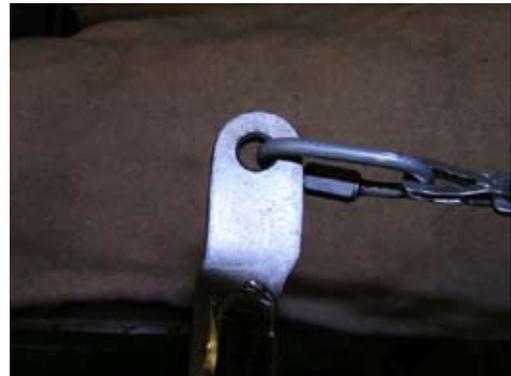
Figure 2

Subsequent discussion of the issue at his local LAA Strut meeting produced a consensus opinion that the tailwheel offset most probably had something to do with the springs in the tailwheel operating linkage. After some experimentation at home, the pilot found that it was possible for the disconnect links in the tailwheel operating horn to become displaced and shorten the effective length of the associated tailwheel control, producing an offset tailwheel with the rudder in the neutral position. Figures 2 and 3 respectively illustrate the implicated link in its normal and displaced positions.

Normal position

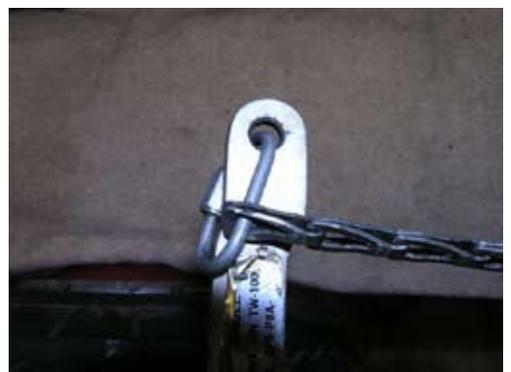
Figure 3

The pilot considered the tension induced in the affected spring to be insufficient alone to break the tailwheel out of its 'detented' straight-ahead position, and it was not possible to confirm that such a condition had

Displaced position

caused the accident. It is conceivable, however, that with the link displaced in this way, an operational side force on the wheel kicking it left as just as it lifted off, could potentially have broken it out of its detent, and maintained a left offset thereafter.

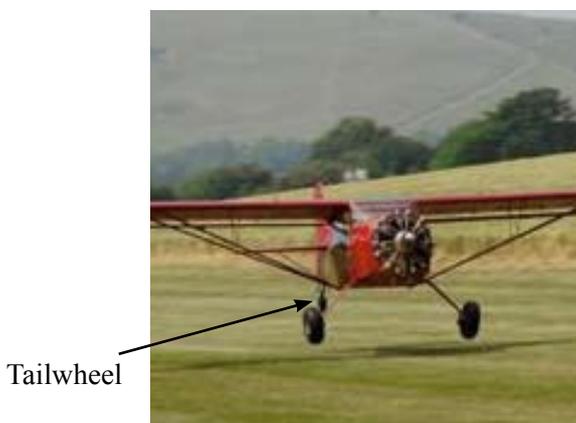
Figure 1

Photographs taken shortly after the accident with the aircraft in situ, showed the aircraft's wheel tracks diverging left towards the hedge. In photographs taken of the aircraft during its takeoff and subsequent approach to land, it was possible to discern that the tailwheel was offset to the left from the time it become airborne, Figure 1, but even after detailed inspection, the pilot was unable to offer any explanation for the offset.

G-LESZ on takeoff, with the tailwheel apparently displaced slightly to the left
