ACCIDENT

Aircraft Type and Registration:	Dassault-Breguet Mystère-Falcon 900B, G-HMEV	
No & Type of Engines:	3 Honeywell TFE731-5BR-1C Turbofan engines	
Year of Manufacture:	1986	
Date & Time (UTC):	20 January 2007 at 1651 hrs	
Location:	Approximately 7 nm south-west of Worthing, Sussex	
Type of Flight:	Commercial Air Transport	
Persons on Board:	Crew - 2	Passengers - None
Injuries:	Crew - None	Passengers – N/A
Nature of Damage:	Severe No 3 Engine damage, nacelle cowl holed, slight damage to the horizontal stabiliser	
Commander's Licence:	Airline Transport Pilot's Licence	
Commander's Age:	38 years	
Commander's Flying Experience:	6,515 hours (of which 3,002 hours were on type) Last 90 days - 139 hours Last 28 days - 45 hours	
Information Source:	AAIB Field Investigation

Synopsis

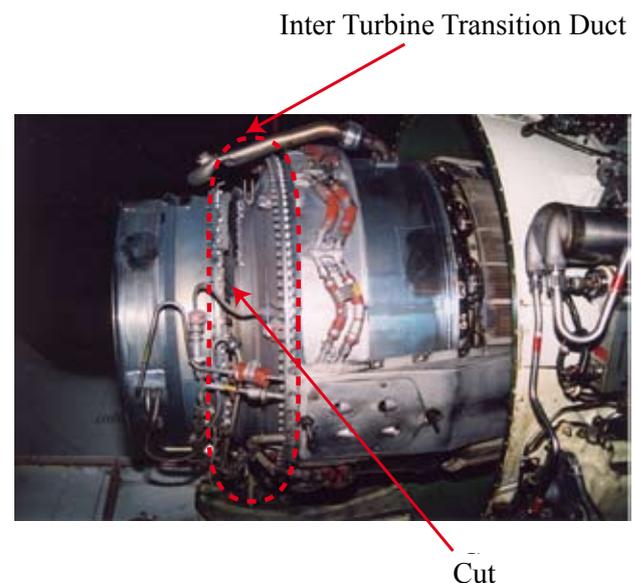
Figure 3

The rear part of the No 3 Engine ITTD had been cut through circumferentially just forward of its aft flange, round 310°. The edges of the cut had been bent outwards, producing a gap in the duct of up to 2 inches (Figure 3). An 8-inch length of the circumference on the left side remained intact. The panels covering the engine hot section had sustained multiple impact damage in a band centred on the cut in the ITTD, together with overheating

discoloration of the paint in this area. The damage included extensive holing of the panels; one area of holing coincided with the hole in the cowl.

No 3 Engine Turbine Assembly

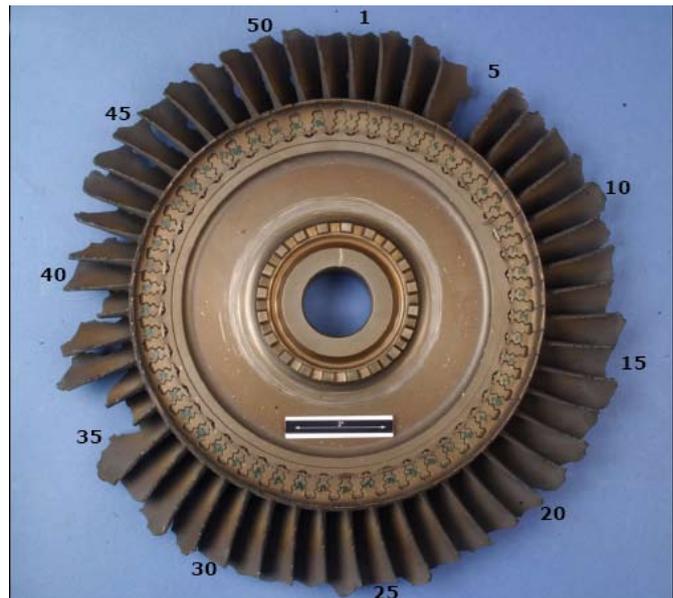
Figure 4

All of the LP turbine Stage 1 blades had suffered severe impact damage to their trailing edges and, for four blades, localised impact damage to the leading edge.

The outer portion of all Stage 2 blades had broken off, generally at around 1.5-2.0 inches from the root platform. However, three of the blades had fractured at around 0.5 inches from the root platform and one (No 5, numbered from a clocking index mark on the disk) had fractured at the platform (Figure 4). The outer portion of all Stage 3 blades had broken off, generally at around 70% span. Only a relatively small amount of the debris fractured from the turbine assembly remained with the powerplant, most of it having been ejected overboard. In particular, most parts of the Stage 2 and Stage 3 stators were absent.

Stage 2 LP Turbine

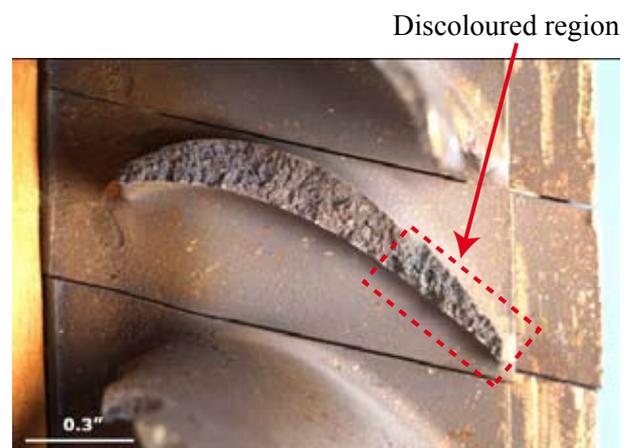
Figure 5

The fracture surface of the No 5 blade exhibited a discoloured region, extending over the rear one-third of the section, where the surface had a darker

appearance than for the remainder of the fracture (Figure 5). Detailed scanning electron microscope (SEM) examination of the discoloured region showed features of heavy oxidation and areas with a smooth appearance, lacking typical fracture features. The characteristics indicated that these areas had been unbonded, ie the material had been separated before the blade had failed. Features evident with the SEM on the

Stage 2 LP Turbine No 5 Blade

un-discoloured part of the fracture indicated that it had resulted from overload. The chordwise extent of the pre-existing crack was around 0.3 inches.

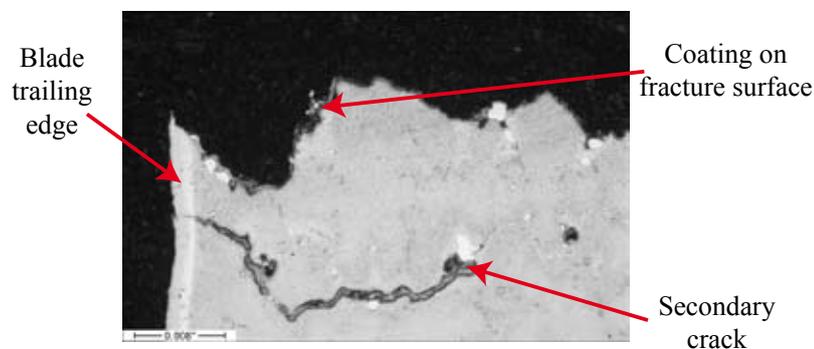
Figure 6

A section cut through the discoloured region revealed a relatively thick coating on the fracture surface, with the appearance of an oxidation product (Figure 6). The sectioning also revealed a secondary crack, beneath the separation fracture surface and generally parallel to it, also coated with the oxidation-type material. The secondary crack extended to the surface of the blade at the trailing edge but, on the plane of the section, was not open at the surface. Some alloy depletion was evident in the parent material beneath the coating layer on both the separation fracture and the secondary crack, also indicative of oxidation effects. Energy dispersive x-ray analysis of the coating layer material revealed the presence of the IN100 base metal elements and of oxygen, again indicative of an oxidation product. Aluminium was not present in a high concentration.

The presence of the secondary crack and the oxidisation both of its surface and of the discoloured region of the separation fracture were evidence of pre-existing cracks in this area that had been open at the blade surface while exposed to the hot oxidising environment. The features were indicative of a casting defect; the metallographic

Section through Discoloured Region of
Stage 2 LP Turbine No 5 Blade

appearance suggested that this had been a ‘hot tear’ (see below). The absence of appreciable aluminium in the oxidisation layers suggested that the cracks had not been open at the blade surface when the aluminide blade coating had been applied.
