AAIB Bulletin No: 2/97

Aircraft Type and Registration: DH82A Tiger Moth, G-ANPK

Date & Time (UTC): 18 August 1996 at 0830 hrs UTC

Location: Clacton Airfield

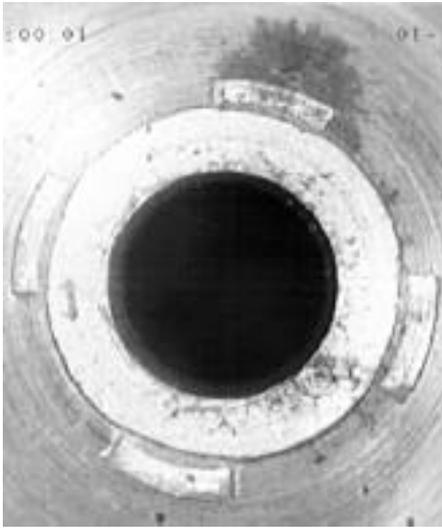
A flow test of the carburettor conducted with a fuel pressure of 4 psi showed that the float chamber needle valve was fully open; however, a subsequent strip examination did not determine whether this was due to the accident or to contamination of the needle valve seat. After the float valve had been reassembled it functioned correctly. Stains and deposits present on both the float needle valve seat and the float needle indicated that, *at some time*, contaminated water had been allowed to dry out in the float chamber.

Probable contamination from dried water deposits

Note: Different magnification used in both photographs

Similar contamination was not found on either the main or power jets, or in the fuel tank.

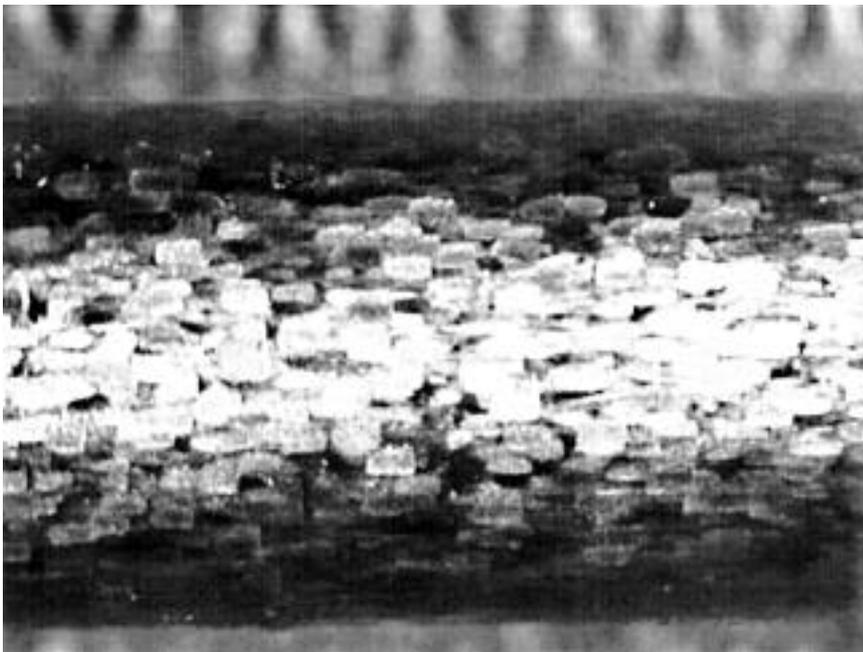
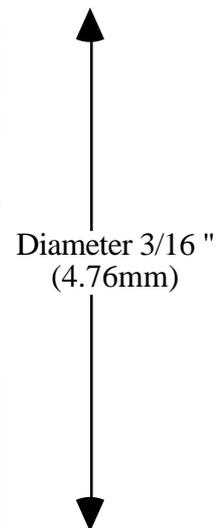
Various wear patterns on carburettor components indicated that the carburettor had flown for considerably more hours than the time recorded against the engine since overhaul; these components included: the float needle valve, and the float pivot pin and its housing in the float which showed extensive damage due to brinelling.

The Gypsy engine Technical News Sheet TNS G No 15, dated February 18, 1970 defines the overhaul period for the carburettor as the same as that for the engine to which it is fitted at the commencement of the overhaul life.
