No: 12/92

Ref: EW/C92/8/1

Aircraft Type and Registration: Boeing 767-200ER, N610UA

Nature of Damage: Damage to No. 1 engine, and fire damage to cowling

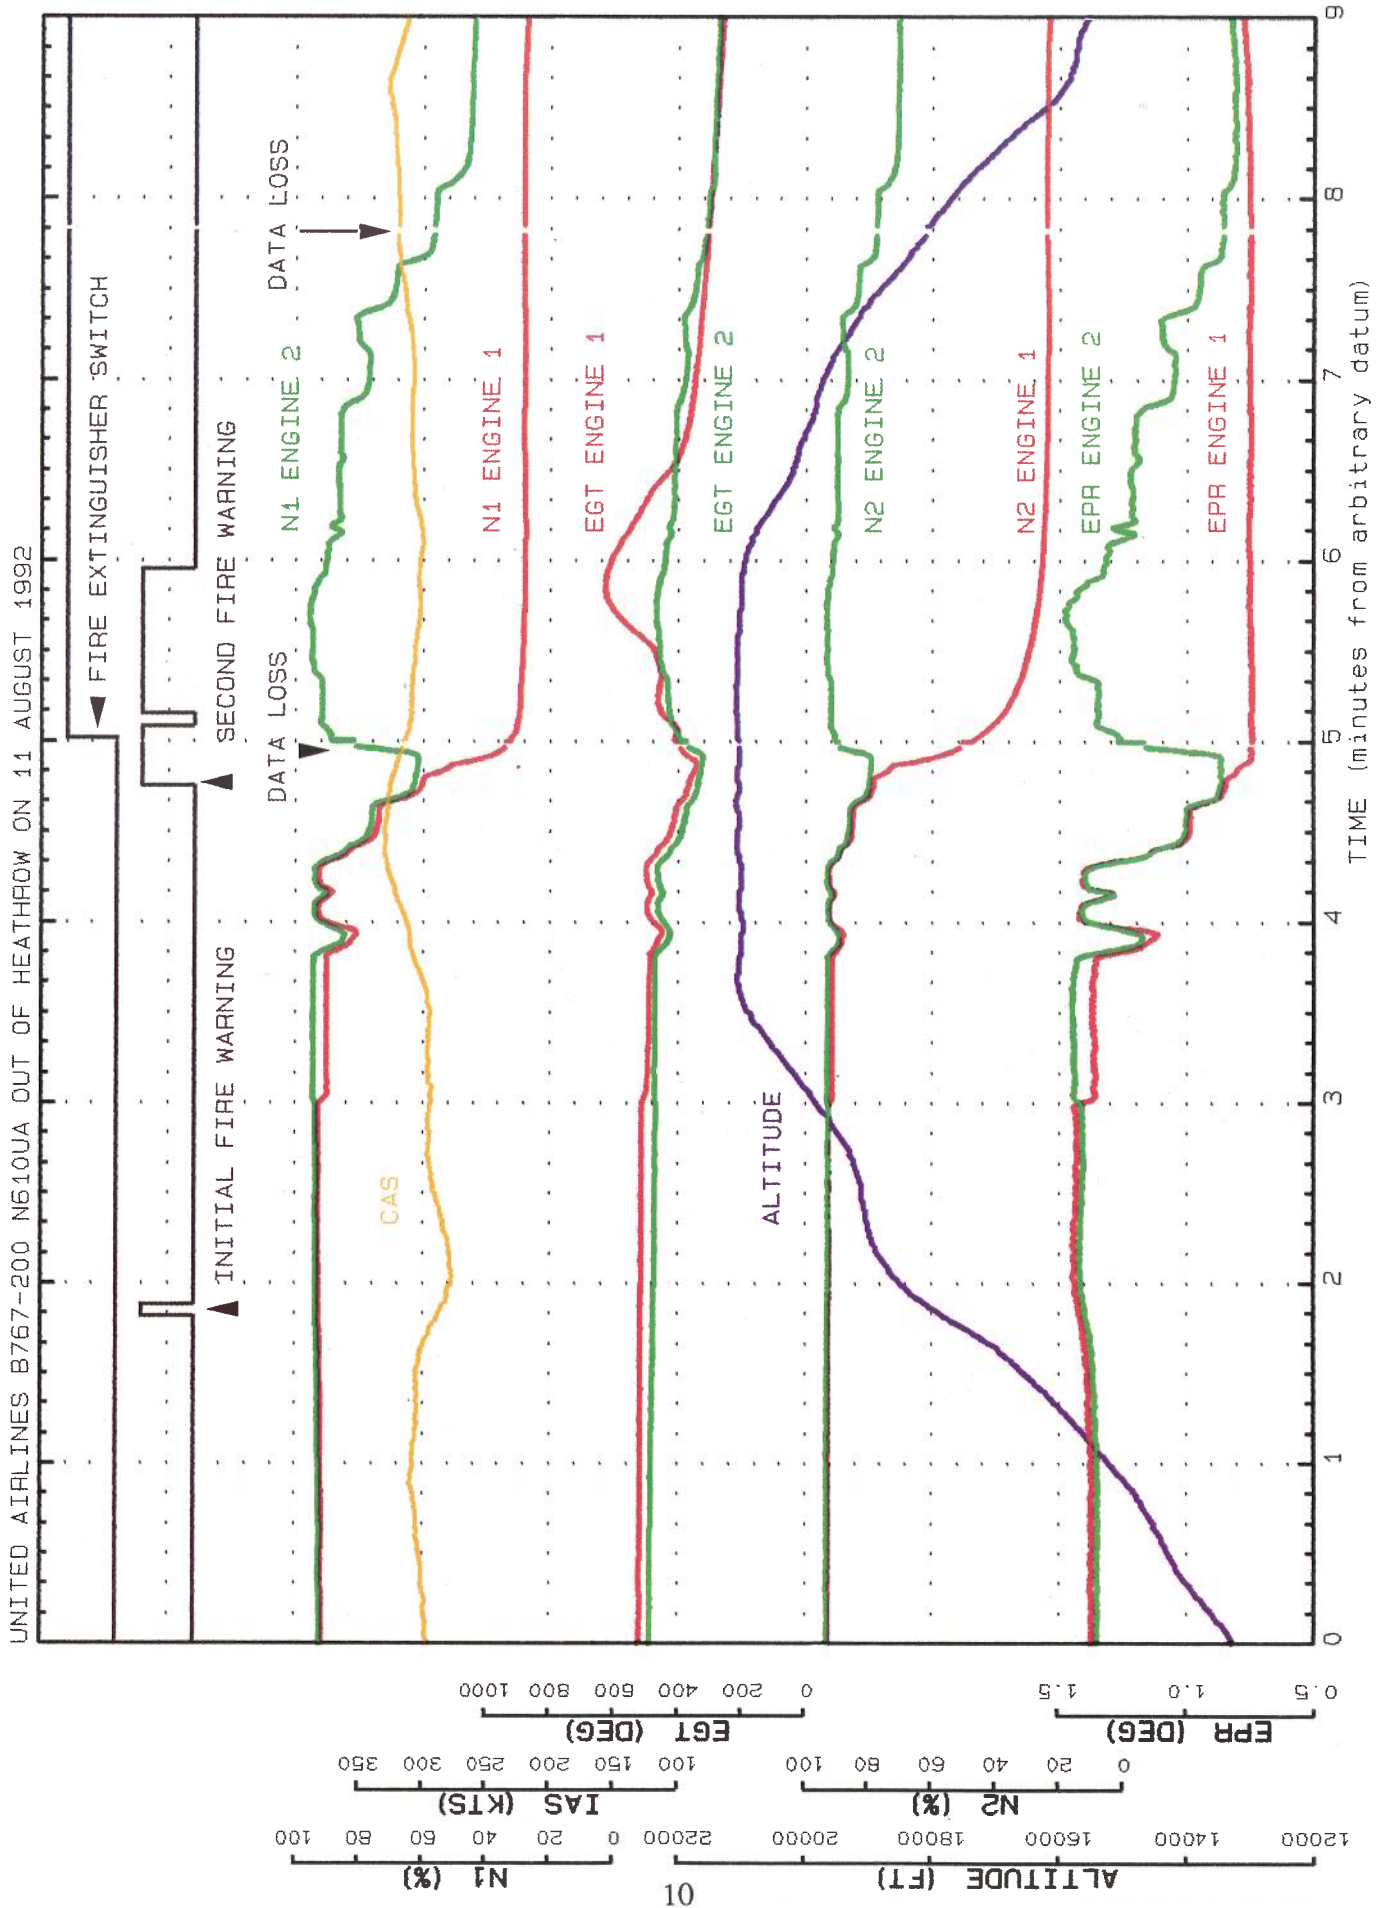
FIGURE 1

The aircraft was climbing through 17,800 feet at 288 kt CAS and 0.6 M when a fire warning occurred. Figure 1 covers the period of the engine fire warnings and engine shutdown. The initial warning lasted for less than four seconds, which is also the sampling period for the fire warning discrete, and returned 2 minutes 52 seconds later; the fire extinguisher switch operated up to 4 seconds later. The second fire warning lasted for 17 seconds. The No 1 Engine was throttled back and shutdown; there was a loss of 2 seconds of data following the engine shutdown, as shown in the Figure, due to the transfer of electrical bus connections. The EGT on No 1 Engine rose after shutdown to 629°C before decreasing.

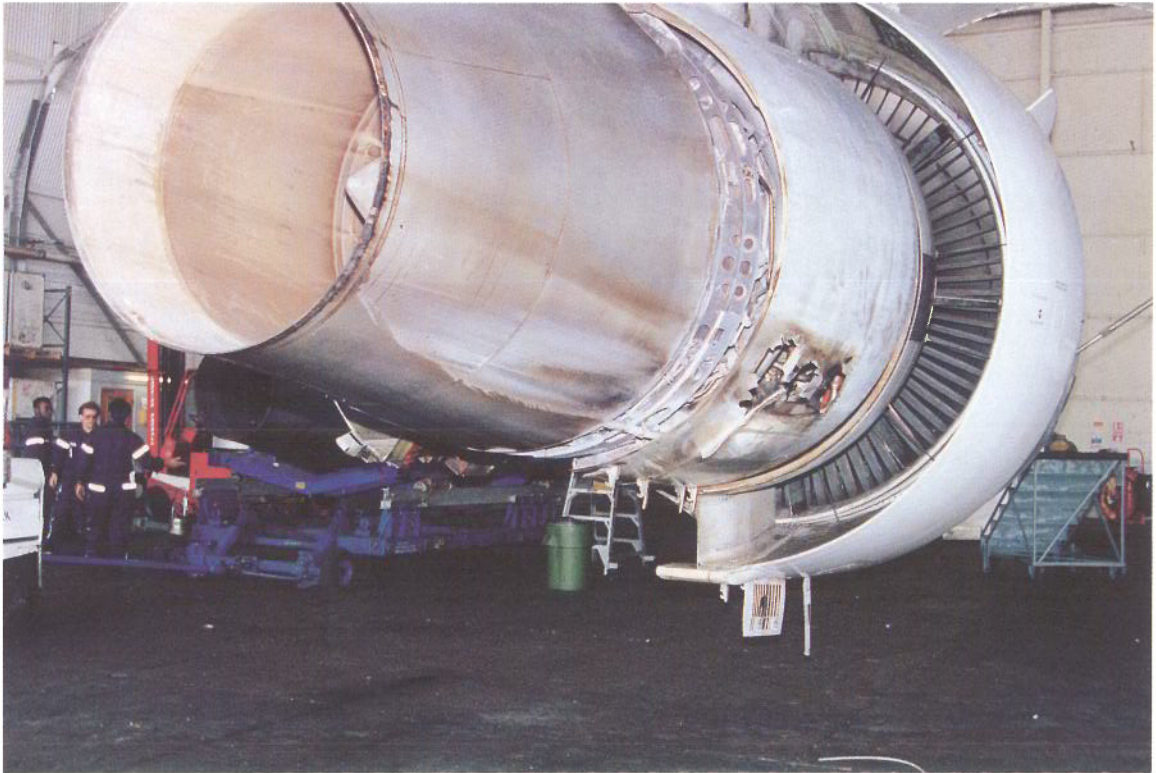
revealed a hole burned into the right hand side of the No.1 engine cowling (see Fig. 2), and some small fragments of metallic debris were recovered from the tail pipe.

Fig.2. External view of No. 1 engine showing fire damage

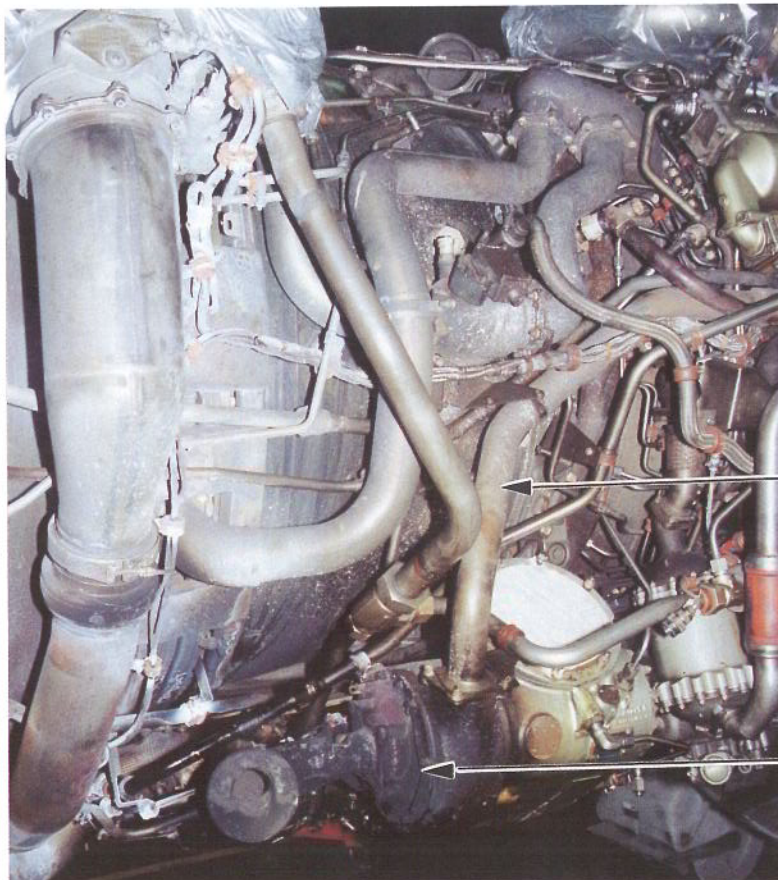
The initial examination was conducted with the engine mounted on a strip rail, and the only visible external damage was solidified molten alloy spatter on the right hand side of the engine casing. It was evident that this had been ejected from two holes that were burned into a short length of ducting between the deaerator (air-oil separator) and the exterior of the nacelle (see Fig. 3). The deaerator was mounted on the right hand side of the aft face of the accessory gearbox, and when the cover was removed, it was apparent that a severe fire had occurred inside, with the impeller (which performs the separating function on the air-oil mist drawn from the No. 3 bearing) having been completely destroyed. The impeller shaft could still be moved within the gear train backlash, suggesting that the impeller bearing was still intact. The breather ducting between the engine casing and the deaerator was intact.

Fig.3. Right hand side of engine showing fire-damaged deaerator

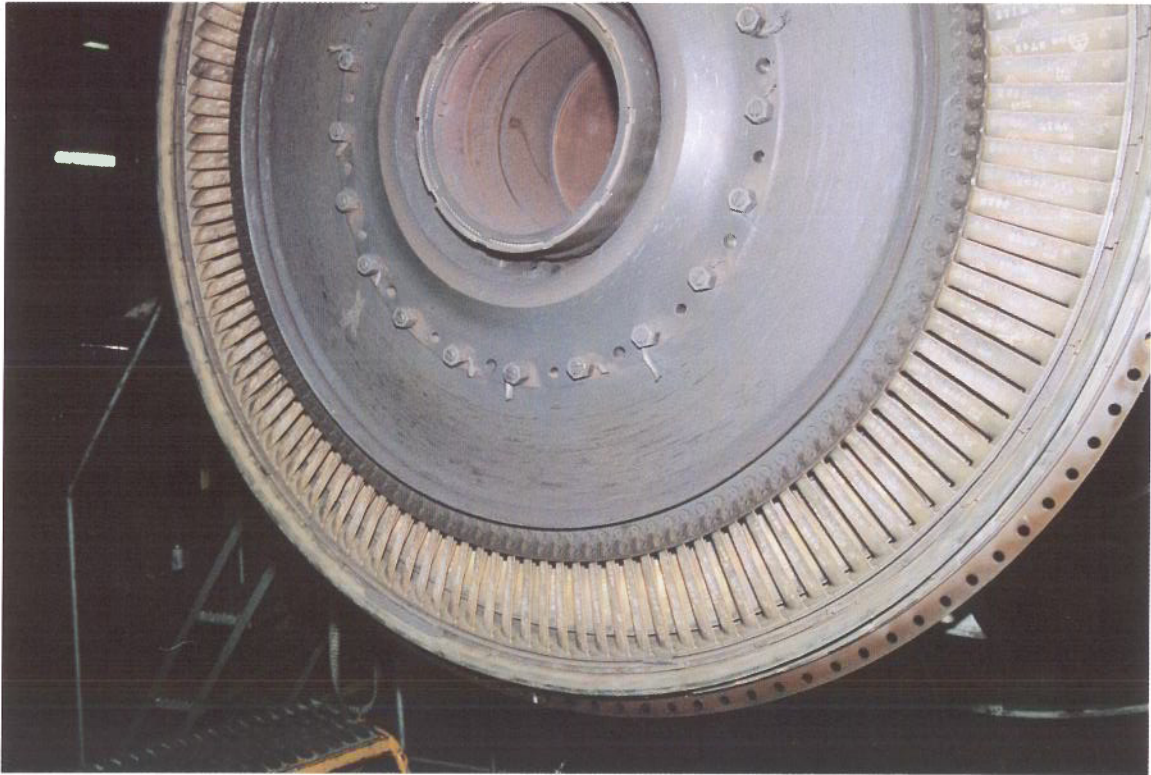
Having concluded from the boroscope examination that the compressor was undamaged, attention was concentrated on the removal of the hot section of the engine. No untoward features were observed on the LP turbine module; in particular, the No 4 bearing was in good condition. However, there were indications of intense heat between the second stage HP and the first stage LP turbines. Dumbell shaped locking tabs on the rear face of the second stage disc had been virtually melted by hot gases from adjacent holes (see Fig. 4). It was also apparent that the labyrinth-type rotating seal between this disc and the next stator stage had been completely destroyed by a combination of heat erosion and machining, resulting in the debris found in the rear of the engine (see Fig. 5). The stator stage was close to coming adrift as a result of this damage. Other heat damage included a scalloping effect on the HP shaft retaining nut; this appeared to have been caused by hot gases emanating from a ring of cooling holes near the centre of the disc. The nut can just be seen in Fig. 4.

Fig.4. Rear face of second stage turbine disc. Note melted locking tabs. Scalloping on HP shaft retaining nut (close to inner ring of cooling holes) can just be seen

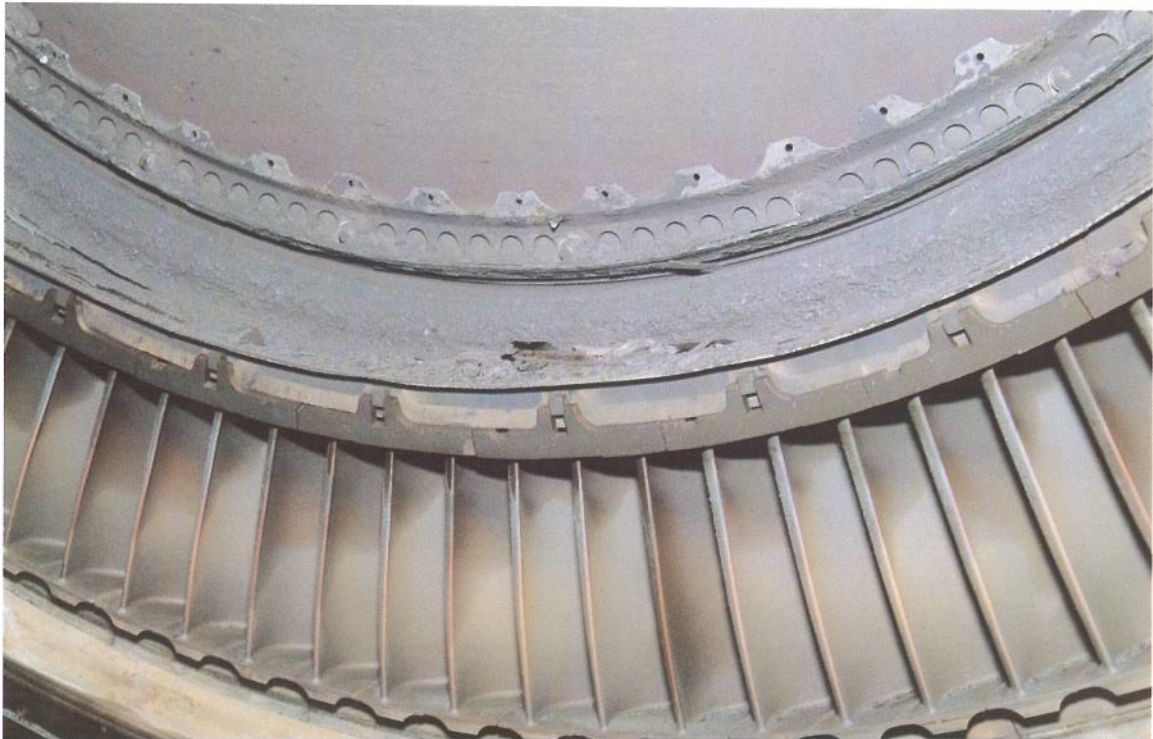
The engine was subjected to a boroscope examination which revealed blade impact damage on the second stage HP turbine. It was also apparent that there had been contact on the shroud and platform areas. Solidified molten metal spatter was evident on the third stage nozzle guide vanes. It was noteworthy however that no blades, or parts of blades, were missing, leading to the conclusion that the debris in the tail pipe was other than blade material.

Fig.5. View looking aft onto damaged third stage NGV shroud

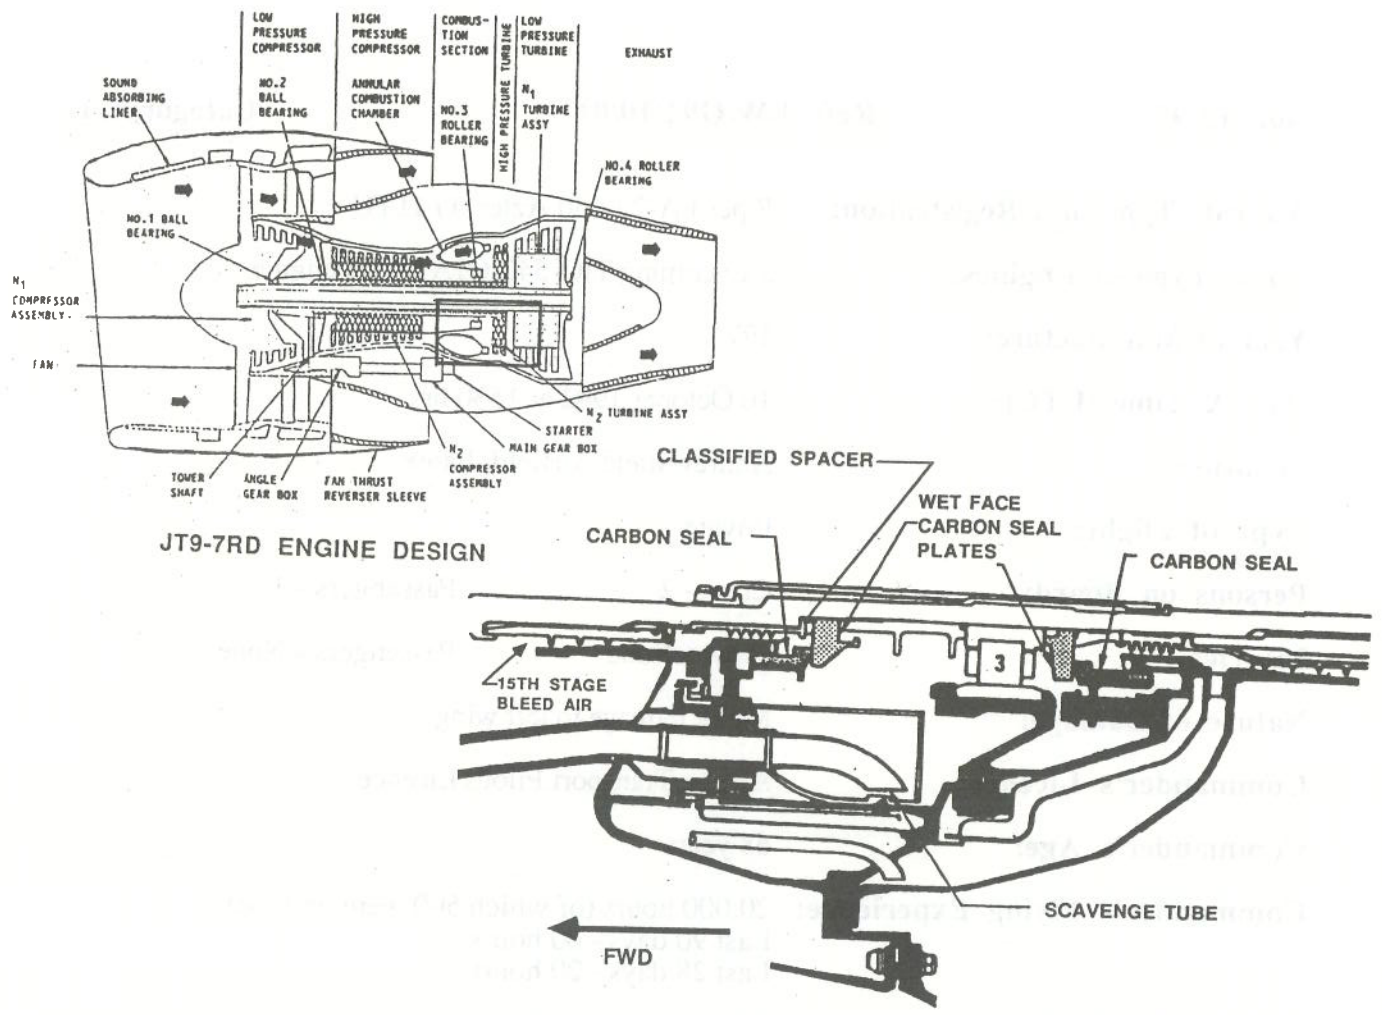
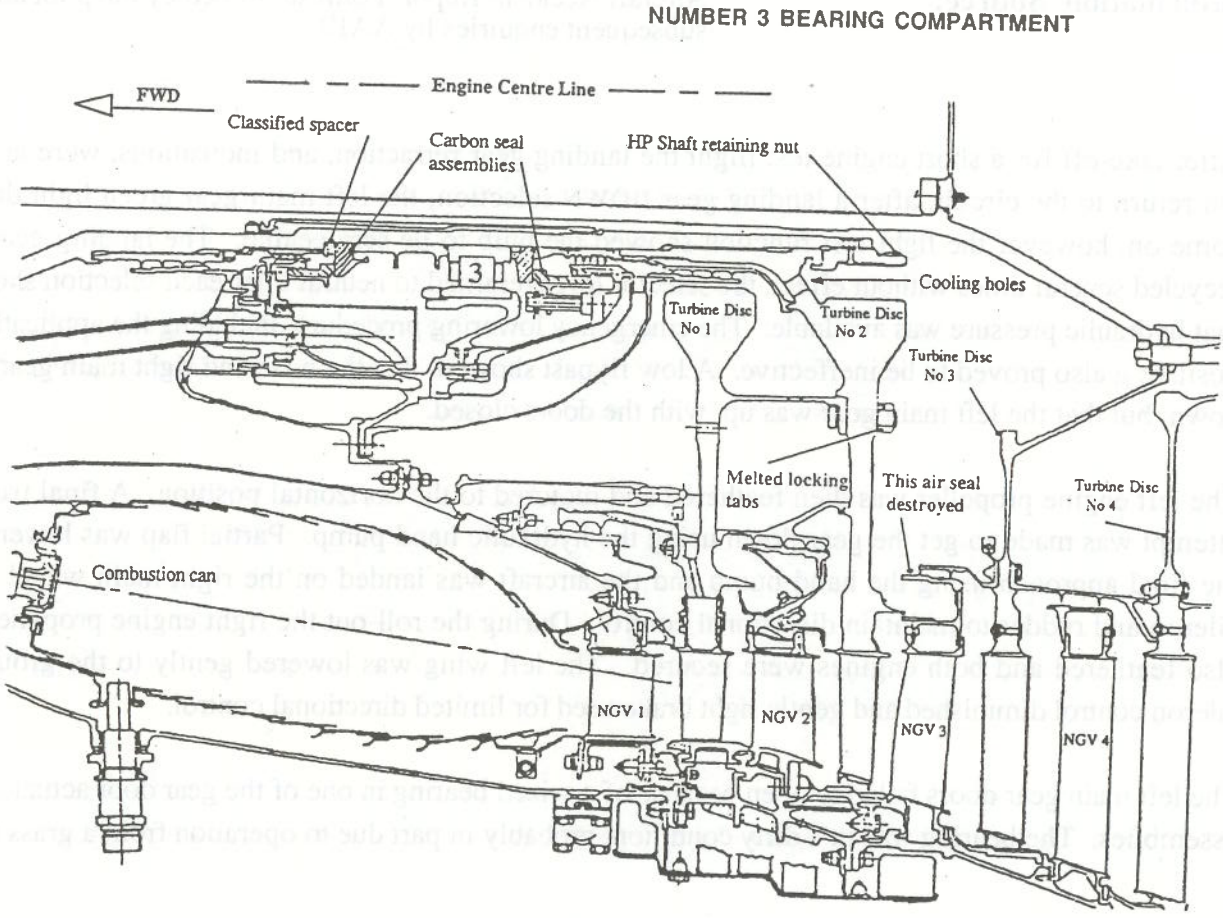
Fig. 6 Details of engine hot section and No. 3 bearing compartment

The HP shaft nut was retained by a locking ring. This was intact and had not been disturbed as a result of the engine problem. However the nut itself, which usually requires special tooling for removal due to high assembly torque, was found to be little more than "finger tight". Further disassembly revealed extensive heat damage to the No 3 bearing housing heat shield. Inside the housing, it was found that the front carbon seal assembly and the classified spacer located ahead of the front seal plate on the HP shaft, had broken up. The spacer was in 15 pieces, and its loss from the shaft accounted for the loss of assembly torque in the HP stack. The bearing itself, and the rear carbon seal, were in fair condition especially in view of the heat damage that had affected the area. The diagrams in Fig. 6 show the general layout of the relevant engine components.

The break-up of the forward seal would have allowed 15th stage compressor discharge air into the bearing housing, and the consequent ignition of the oil mist therein. It appears that the resulting fire was then drawn into the external deaerator via the breather ducting. Hot gases would also have been able to exit via the less damaged rear end of the compartment, and be drawn into the gas path via the damaged seals, thereby causing a rise in EGT.
