**ACCIDENT**

<b>Aircraft Type and Registration:</b>	Cessna R182 Skylane RG, G-BOWO	
<b>No &amp; type of Engines:</b>	1 Lycoming O-540-J3C5D piston engine	
<b>Year of Manufacture:</b>	1978	
<b>Date &amp; Time (UTC):</b>	6 October 2007 at 1600 hrs	
<b>Location:</b>	Wolverhampton (Halfpenny Green) Airfield, W Midlands	
<b>Type of Flight:</b>	Private	
<b>Persons on Board:</b>	Crew - 1	Passengers - 2
<b>Injuries:</b>	Crew - None	Passengers - None
<b>Nature of Damage:</b>	Damage to left main landing gear and tailplane	
<b>Commander's Licence:</b>	Commercial Pilot's Licence	
<b>Commander's Age:</b>	45 years	
<b>Commander's Flying Experience:</b>	2,463 hours (of which 25 were on type) Last 90 days - 46 hours Last 28 days - 15 hours	
<b>Information Source:</b>	Aircraft Accident Report Form submitted by the pilot and metallurgical examination of components

**Synopsis**

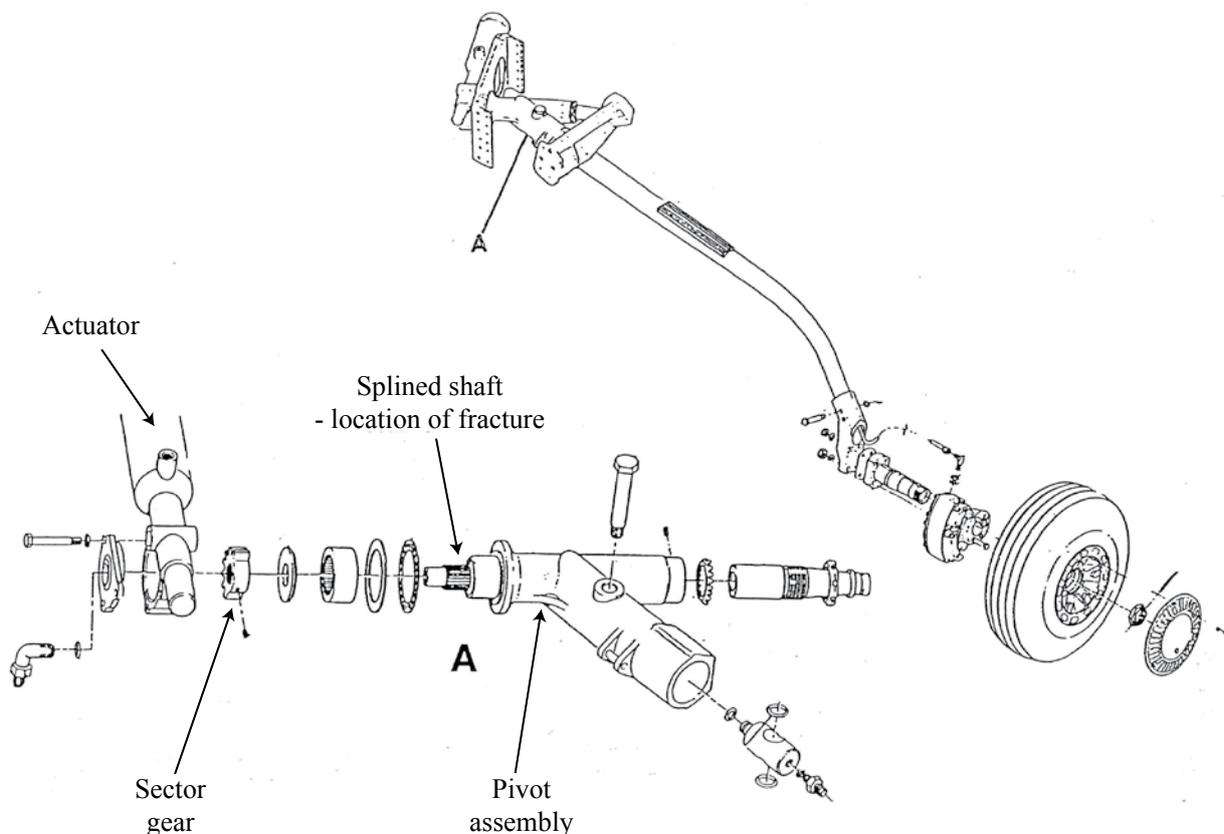
**Figure 1**

R182 Main landing gear pivot assembly

The detached pivot assembly was returned to AAIB for metallurgical examination. The pivot assembly had separated in the area of the splined shaft. The fracture surface had been partially damaged by smearing during rotational movement, most likely caused during the repeated attempts to operate the gear prior to the landing. A number of fatigue fracture initiation sites were found at the edge of the fracture face, adjacent to a lubricating hole (see Figure 2). The examination concluded that the separation of the pivot assembly had resulted from a cyclic fatigue mechanism during normal functioning of the landing gear in service.
