**ACCIDENT**

<b>Aircraft Type and Registration:</b>	Lancair 320, G-CBAF	
<b>No &amp; Type of Engines:</b>	1 Lycoming IO-320-B1A piston engine	
<b>Category:</b>	1.3	
<b>Year of Manufacture:</b>	2002	
<b>Date &amp; Time (UTC):</b>	11 June 2005 at 1652 hrs	
<b>Location:</b>	Lydd Airport, Kent	
<b>Type of Flight:</b>	Private	
<b>Persons on Board:</b>	Crew - 1	Passengers - None
<b>Injuries:</b>	Crew - None	Passengers - N/A
<b>Nature of Damage:</b>	Failed nose wheel attachment, damaged lower end of nose landing gear strut, shattered propeller and engine shock loaded	
<b>Commander's Licence:</b>	Private Pilot's Licence	
<b>Commander's Age:</b>	51 years	
<b>Commander's Flying Experience:</b>	298 hours (of which 16 were on type) Last 90 days - 18 hours Last 28 days - 9 hours	
<b>Information Source:</b>	Aircraft Accident Report Form submitted by the pilot and metallurgical examination

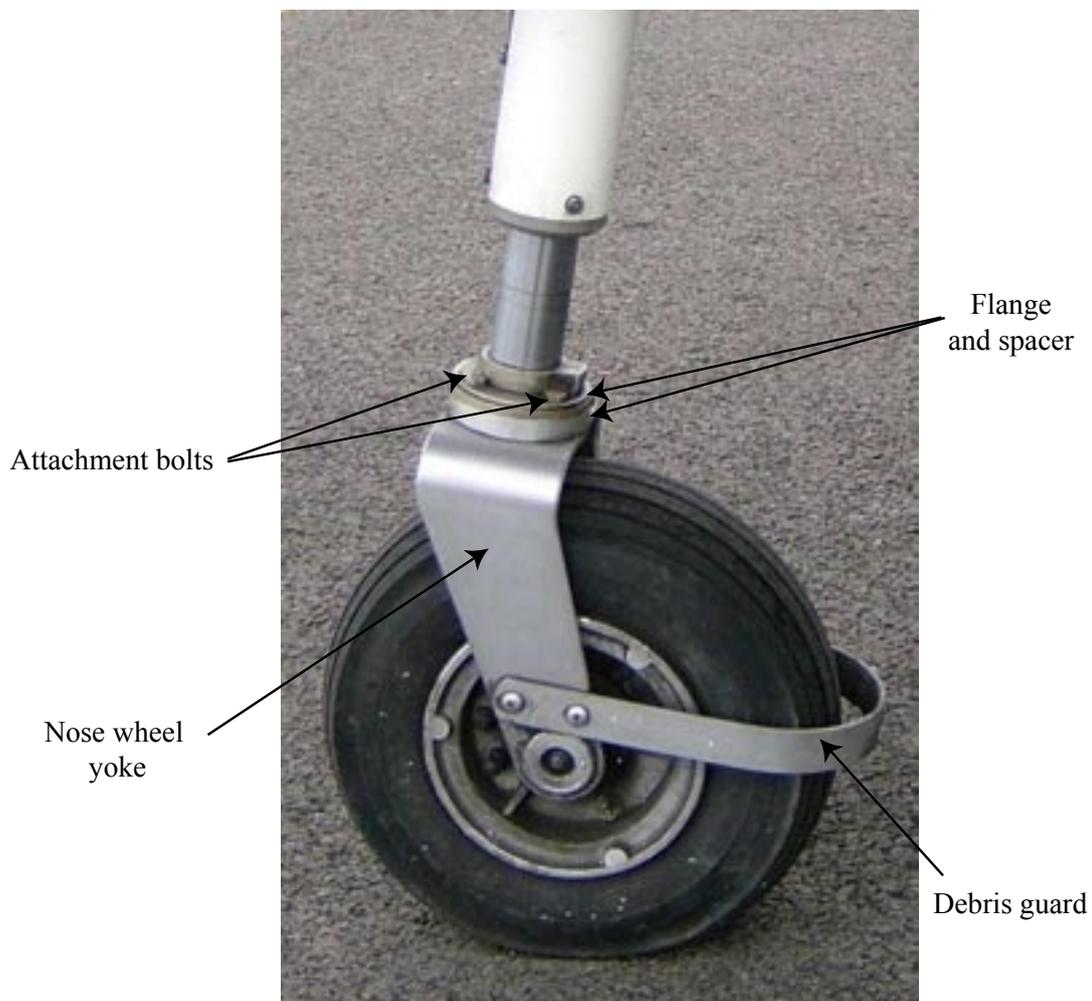
**Figure 1**

Examination of the aircraft showed that the nose wheel mounted in its attachment yoke had become detached from the nose leg (Figure 1). All four bolts that attached the yoke to the nose leg had remained located within the flange and spacer assembly that was fitted at the bottom of the nose leg. Three of the four stiff nuts from the attachment bolts were found scattered between the aircraft and the runway threshold.

All these items were taken to a metallurgical laboratory for examination. It was seen that the debris guard had been deformed to an extent that allowed it to come into contact with the tyre, stopping the wheel from rotating. The tyre was in a very good condition with no evidence of scuffing which would suggest that the wheel was free to rotate at touchdown and that the damage to the debris guard had occurred after the wheel had detached from the aircraft. Evidence of mechanical damage was seen at the forward edge of the nose wheel attachment yoke which is consistent with impact damage with the runway after the wheel had become detached.

Picture of the nose landing gear
