ACCIDENT

Aircraft Type and Registration:	Europa (Tri-gear variant), G-PUDS	
No & Type of Engines:	1 Rotax 914T turbocharged piston engine	
Category:	1.3	
Year of Manufacture:	1997	
Date & Time (UTC):	7 June 2005 at 1540 hrs	
Location:	Curry Rivel, Somerset	
Type of Flight:	Private	
Persons on Board:	Crew - 1	Passengers - None
Injuries:	Crew - None	Passengers - N/A
Nature of Damage:	Propeller, nose landing gear and fuselage underside	
Commander's Licence:	Private Pilot's Licence	
Commander's Age:	69 years	
Commander's Flying Experience:	13,700 hours (of which 2 were on type) Last 90 days - 5 hours Last 28 days - 5 hours	
Information Source:	Aircraft Accident Report Form submitted by the pilot and AAIB examination of the nose landing gear components

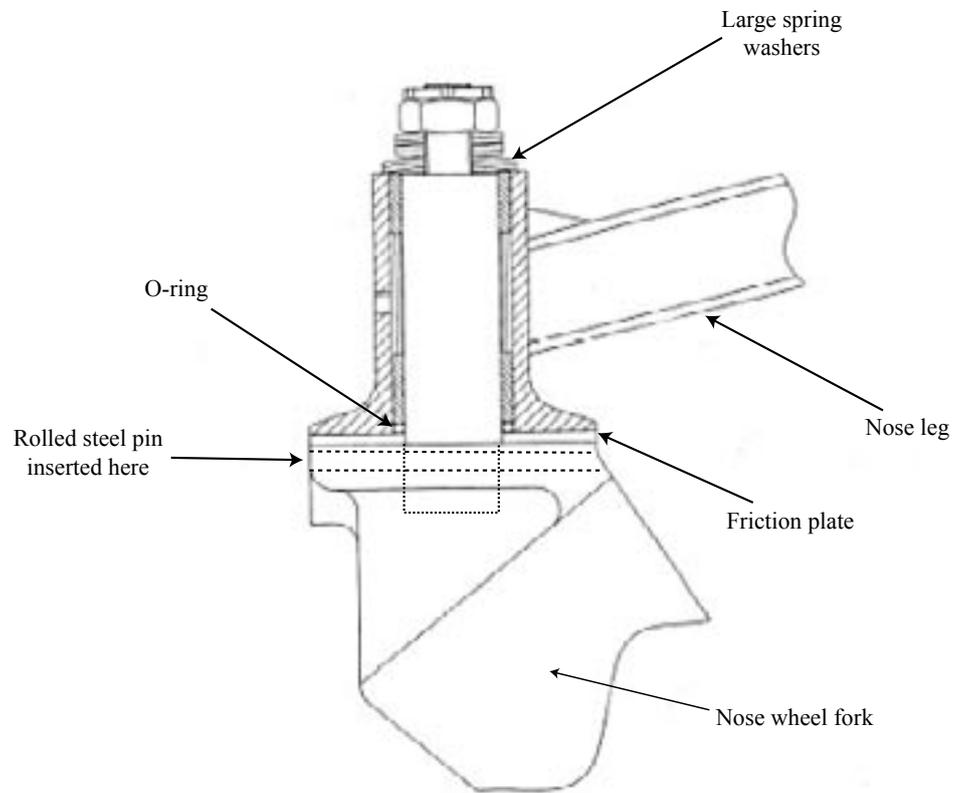
Figure 1

Details of attachment of nose wheel fork to leg

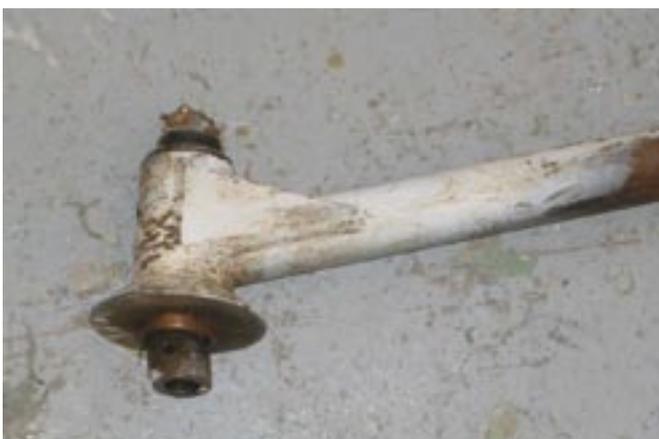
The loss of the nose wheel fork had left the stub of its associated shaft protruding from the bottom of the housing on the nose leg. This had clearly dug into the ground during the landing roll, causing the leg to be bent aft around its approximate mid point. Figure 2a shows the lower end of the leg, complete with the housing and nose wheel pivot shaft. It can be seen that the nut on top of the housing had been secured by a split pin and the lower end of the shaft had sustained considerable distortion in the accident, having been bent in an aft direction. It was also apparent that the lower of the two bronze bushes had partially migrated out of the housing during the failure process. The remains of the rolled steel pin had been retained within the bore of the shaft, both ends having suffered shear failures. Figure 2b shows a close-up view of the end of the shaft, where it can be seen that two holes have been drilled, in the same plane but at 90° to each other. Since the shaft had been supplied by the kit

View of nose leg, showing distortion of lower end of attachment shaft

The absence of the nose wheel assembly from the accident site suggests that the damage may have occurred at the Herefordshire strip, with some evidence pointing to the possibility of an earlier incident. However, whenever it occurred, the degree of distortion in the shaft to which the fork was attached ought to have made this damage clearly visible, although it seems probable that the nose wheel became detached during or perhaps shortly after the takeoff from Herefordshire.

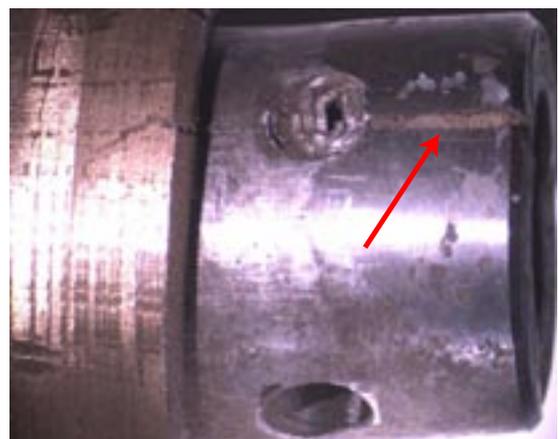
manufacturer in an un-drilled state, it was concluded that the two holes had been made during the construction of the aircraft, the first perhaps being slightly out of position, thus necessitating the drilling of the second hole. Also visible in Figure 2b is one of four cracks emanating from each of the holes and running longitudinally to the lower end of the shaft. It was considered that these occurred as a result of the rearwards distortion, with the sum total of all the damage being entirely consistent with a significant overload, such as could be caused by a hard landing or striking an obstruction.

Close-up view of shaft, showing additional drilling, remains of rolled steel pin and crack (arrowed)
