Boeing 737-204 Advanced, EI-CJH

AAIB Bulletin No: 5/2003	Ref: EW/C2001/8/3	Category: 1.1
Aircraft Type and Registration:	Boeing 737-204 Advanced, EI-CJH	
No & Type of Engines:	2 JT8D-15 Pratt & Whitney turbofan engines	
Year of Manufacture:	1980	
Date & Time (UTC):	15 August 2001 at 0620 hrs	
Location:	Manchester International Airport	
Type of Flight:	Public Transport	
Persons on Board:	Crew - 5	Passengers - 33
Injuries:	Crew - None	Passengers - None
Nature of Damage:	Both left main landing gear tyres burst	
Commander's Licence:	Airline Transport Pilot's Licence	
Commander's Age:	49 years	
Commander's Flying Experience:	9,800 hours (6,800 hours on type) Last 90 days - 190 hours Last 28 days - 50 hours	
Information Source:	AAIB Field Investigation

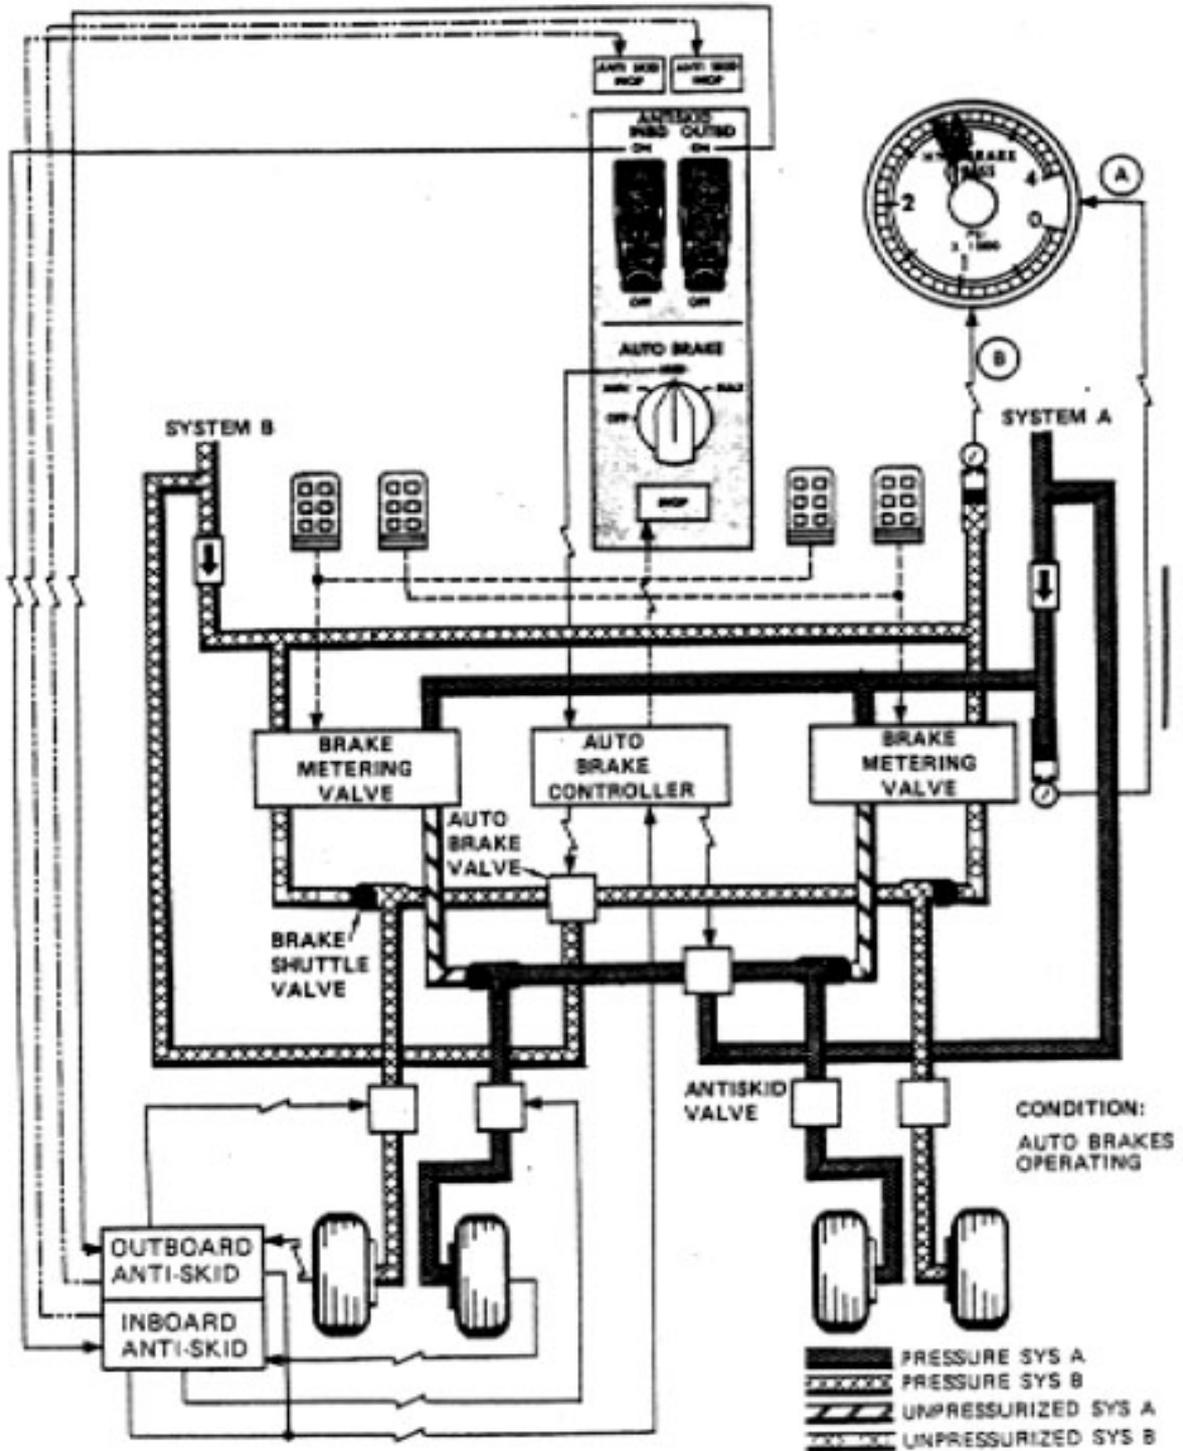
Figure 1

The anti-skid system in the Boeing 737-200 series, Figure 1, is controlled by two control switches located on the pilots' forward instrument panel. One switch controls anti-skid to both inboard mainwheels whilst the other controls anti-skid to both outboard mainwheels. The MEL permits despatch with the entire anti-skid system inoperative provided operations are conducted in compliance with the Aircraft Flight Manual (AFM).
