ACCIDENT

Aircraft Type and Registration:	1) Airbus A320-211, D-AIQA 2) Boeing 737-86N, EI-DKD
No & Type of Engines:	1) 2 CFM 56-5A1 turbofan engines 2) 2 CFM 56-7B26 turbofan engines
Year of Manufacture:	1) 1991 2) 2000
Date & Time (UTC):	5 August 2008 at 1223 hrs
Location:	Taxiway Juliet, Manchester Airport
Type of Flight:	1) Commercial Air Transport (Passenger) 2) Commercial Air Transport (Passenger)
Persons on Board:	1) Crew - 5 Passengers - 107 2) Crew - 6 Passengers - 180
Injuries:	1) Crew - None Passengers - None 2) Crew - None Passengers - None
Nature of Damage:	1) Right elevator and tail of the fuselage damaged 2) Right winglet damaged
Commander's Licence:	1) Airline Transport Pilot's Licence 2) Airline Transport Pilot's Licence
Commander's Age:	1) 42 years 2) 34 years
Commander's Flying Experience:	1) 10,820 hours (of which 7,912 were on type) Last 90 days - 128 hours Last 28 days - 54 hours 2) 4,652 hours (of which 3,483 were on type) Last 90 days - 257 hours Last 28 days - 82 hours

Information Source:	AAIB Field Investigation

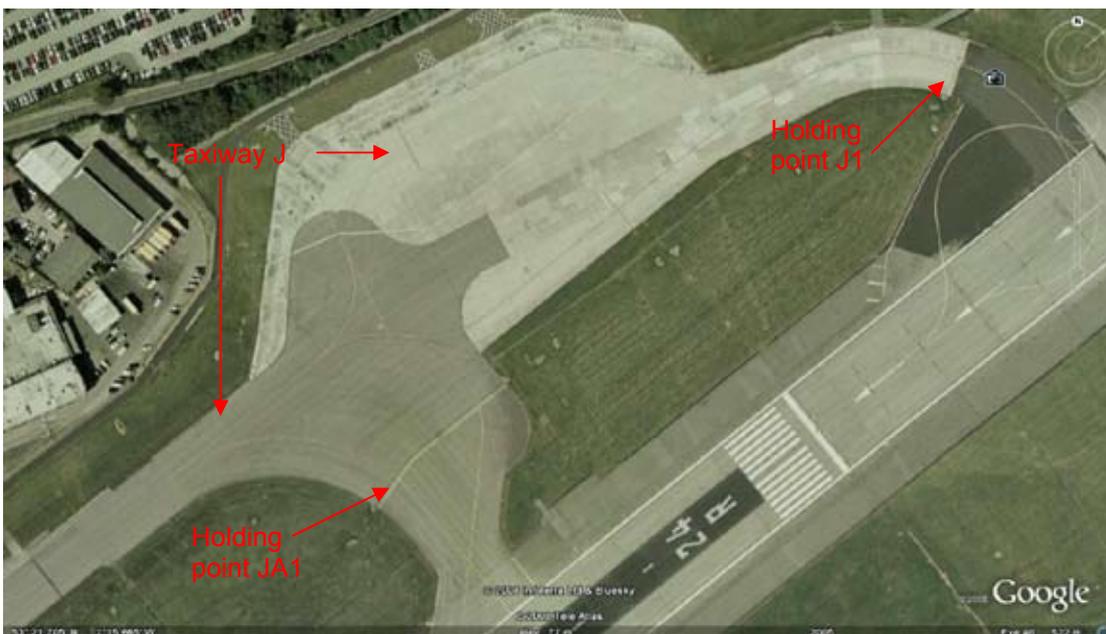
Figure 1

D-AIQA pushed back from its stand at 1211 hrs, for a flight from Manchester to Frankfurt, and taxied towards Runway 23R via Taxiway Juliet (J). The crew requested Holding Point J1 (see Figure 1), so that they could use the full length of the runway, but were told by the Aerodrome Controller (ADC) that it would lead to a delay in their departure as another aircraft was already holding at J1. Instead, the ADC cleared the aircraft to hold at Holding Point JA1, the last taxiway link to the runway before J1. The commander, who was the handling pilot (PF), stopped the aircraft at JA1 and applied the parking brake. The nosewheel was later measured to be 24.2 m short of the stop bar. He subsequently stated that he was able to see the left side of the stop bar but not the right. Although he could have moved forward “a little” if asked to by ATC, he assessed that he had stopped in a reasonable position relative to the holding point.

(since this photograph was taken, the runway has been redesignated as Runway 23R)
