AAIB Bulletin No: 10/95

Ref: EW/C95/3/1

INCIDENT

Aircraft Type and Registration: BAe ATP, G-MANP

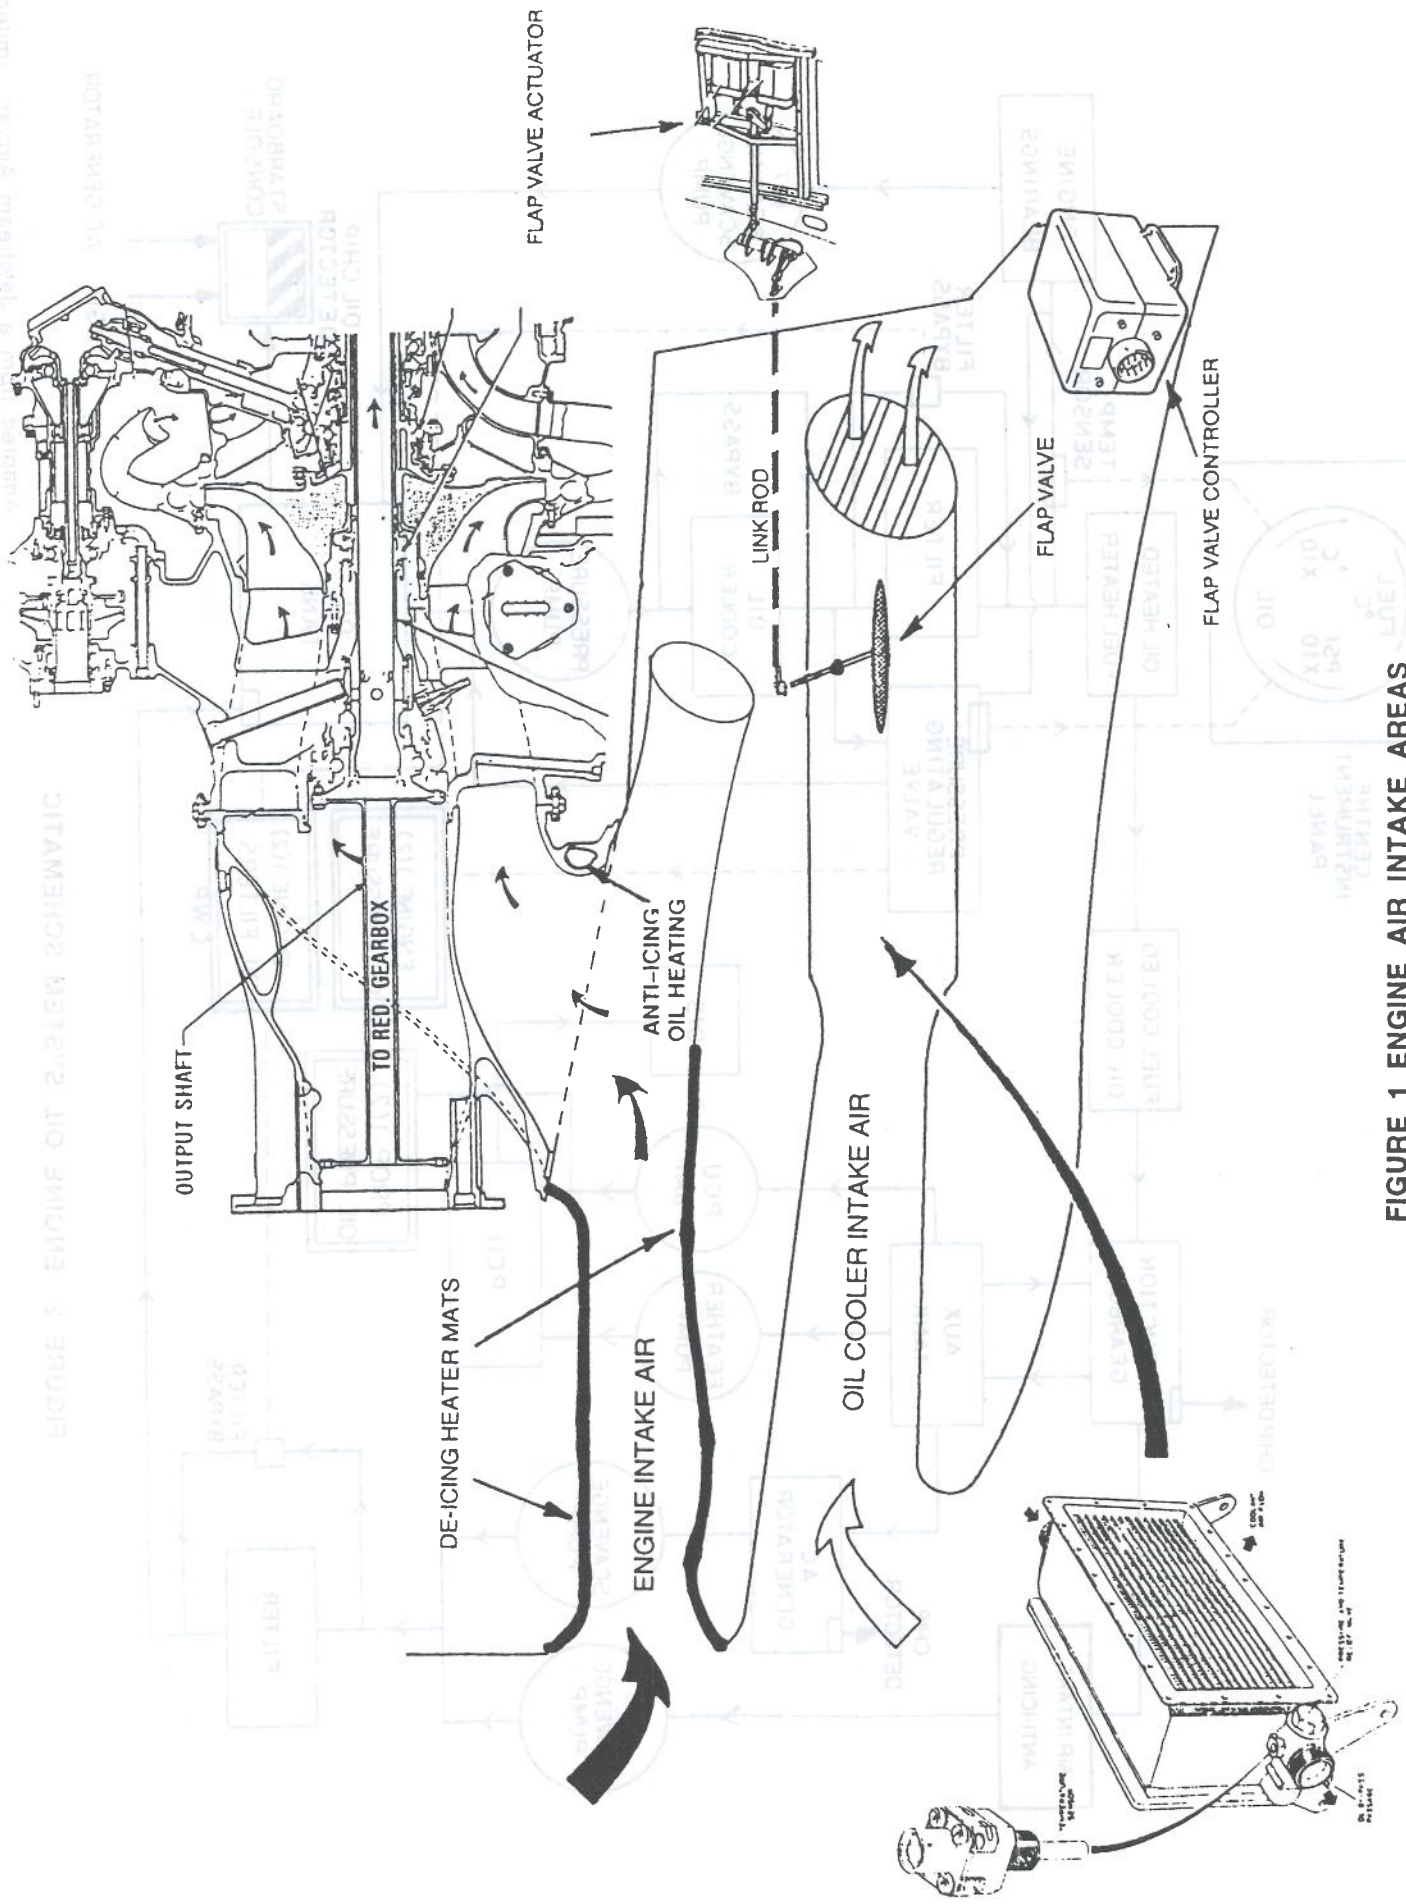
FIGURE 1 ENGINE AIR INTAKE AREAS

During the disassembly of the engine intake area it was found that the insulation on the two electrical cables that connected the engine oil cooler temperature sensor to the flap valve controller had been severely 'chafed' in the area where the cables were routed through a 'P' clip. This chafing had been sufficiently deep to expose the electrical conductors. It was noted that these two cables were not protected by 'spiral wrap', which was evident on other electrical cables within this zone. Tests carried out by the aircraft manufacturer showed that, under a particular condition, it was possible for a partial 'short' of these cables to cause the flap valve controller to fully open the flap valve, which would 'over-cool' the engine oil.

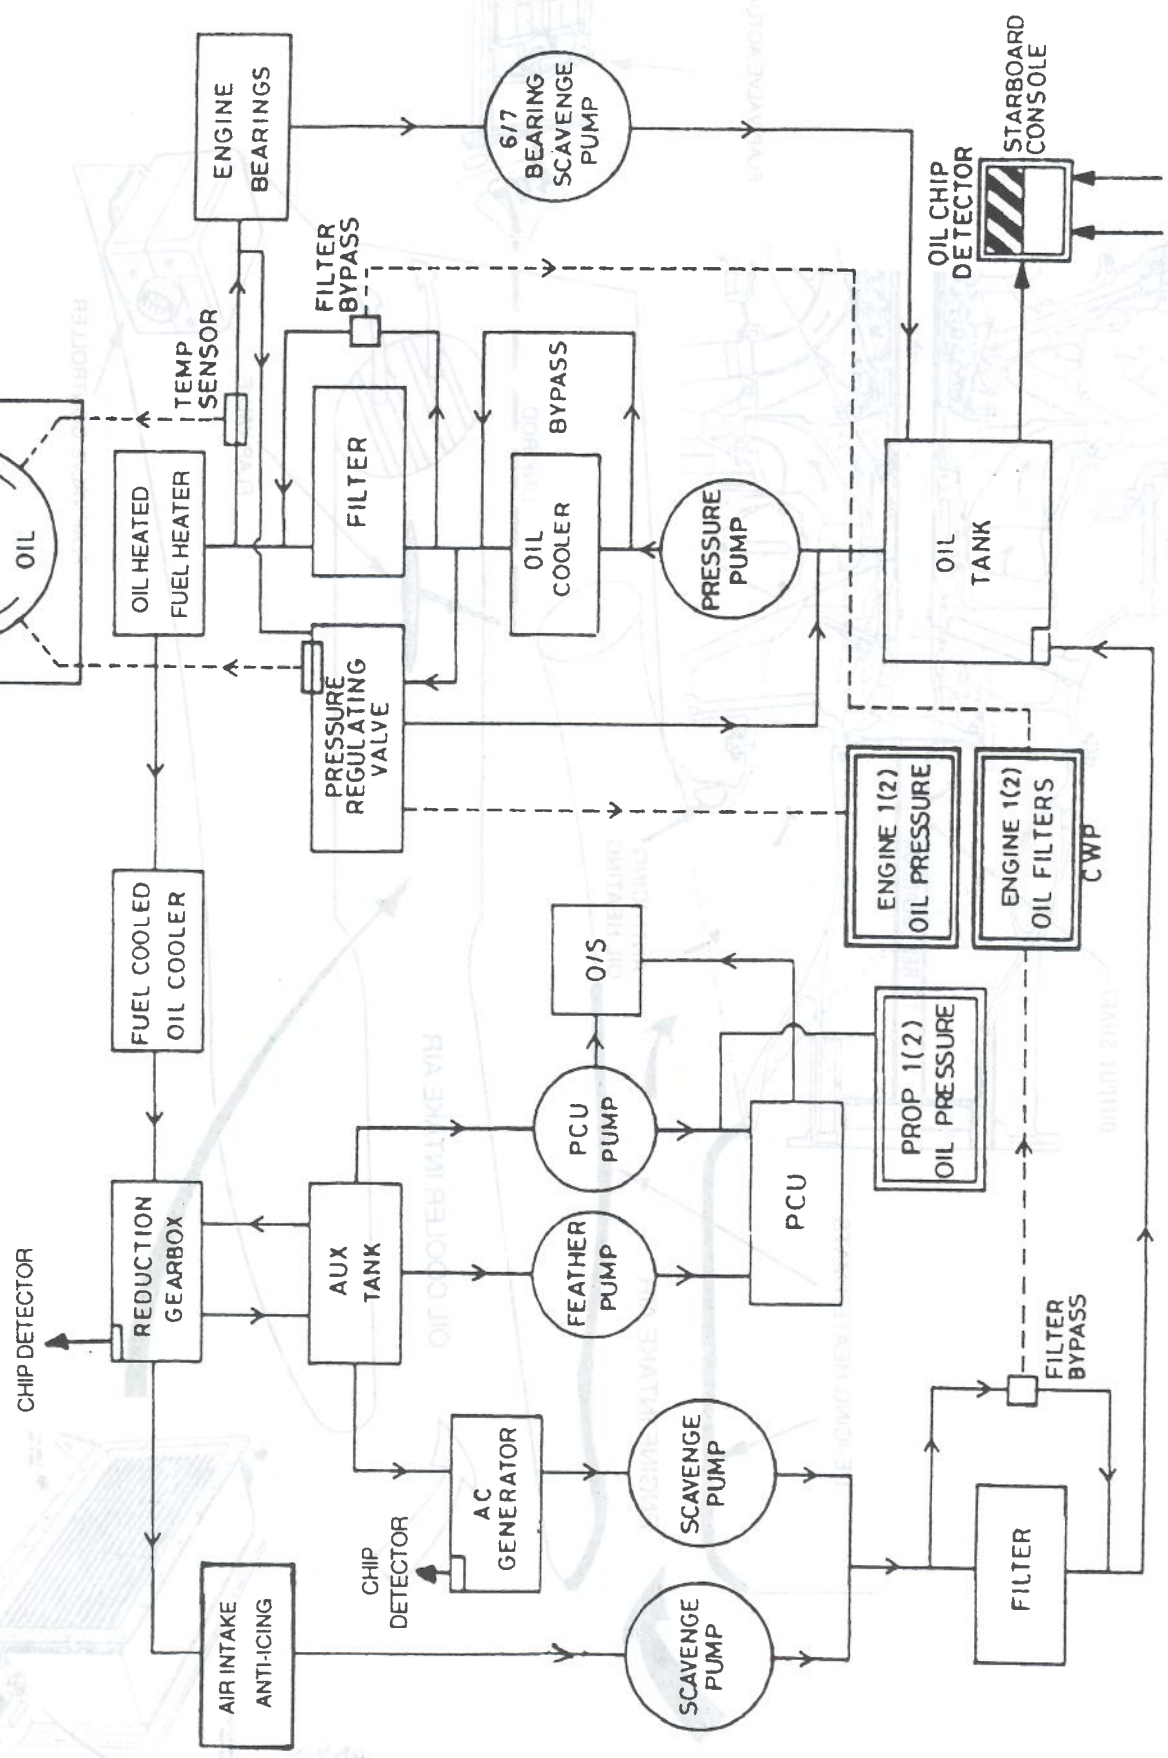
FIGURE 2 ENGINE OIL SYSTEM SCHEMATIC

It may be noted from Figure 2, the engine oil system schematic, that the engine oil temperature sensor is located in an area of the oil system that is not directly associated with the oil that provides the engine compressor air intake anti-icing. It may also be noted that between the oil system temperature sensor and the compressor air intake anti-icing there is an Oil Heated Fuel Heater and a Fuel Cooled Oil Cooler. Both of these units have a direct effect on the temperature of the engine oil that supplies the compressor air intake anti-icing. Mounted within both of these units are temperature dependent bypass thermal control valves.

The engine oil cooler was removed and sent to the manufacturer for examination and test. It was found during testing that the bypass thermal control valve had failed in the bypass closed position which would have had the effect of directing all the engine oil through the cooler matrix, regardless of the oil temperature. The bypass thermal control valve was sent to the manufacturer for examination where it was found that the PTFCE plug within the valve had absorbed enough engine oil to cause the valve to extend permanently to the fully closed position. The reason for this appeared to be that the plug material absorbs engine oil at a slow rate whenever it is in contact with the oil. Since there is no control over the amount of internal leakage, some valves will be more susceptible than others. It was determined that this valve had been manufactured approximately 8 years prior to the incident. Due to the greater awareness of the significance of engine oil temperatures following this incident, another operator of the aircraft type found a similar failed engine oil cooler bypass thermal control valve which had been manufactured approximately 5 years previously.

- a) The imposition of a 6 year life, from manufacture, on the oil cooler bypass thermal control valve.
- b) Changing the plug material from PTFCE to viton, to reduce oil absorption.
- c) Introduction of a viton seal at the top of the valve to prevent oil ingress into the plug.
- d) Introduction of instructions in the Aircraft Maintenance Manual to permit operators to remove and replace the oil cooler bypass thermal control valve.

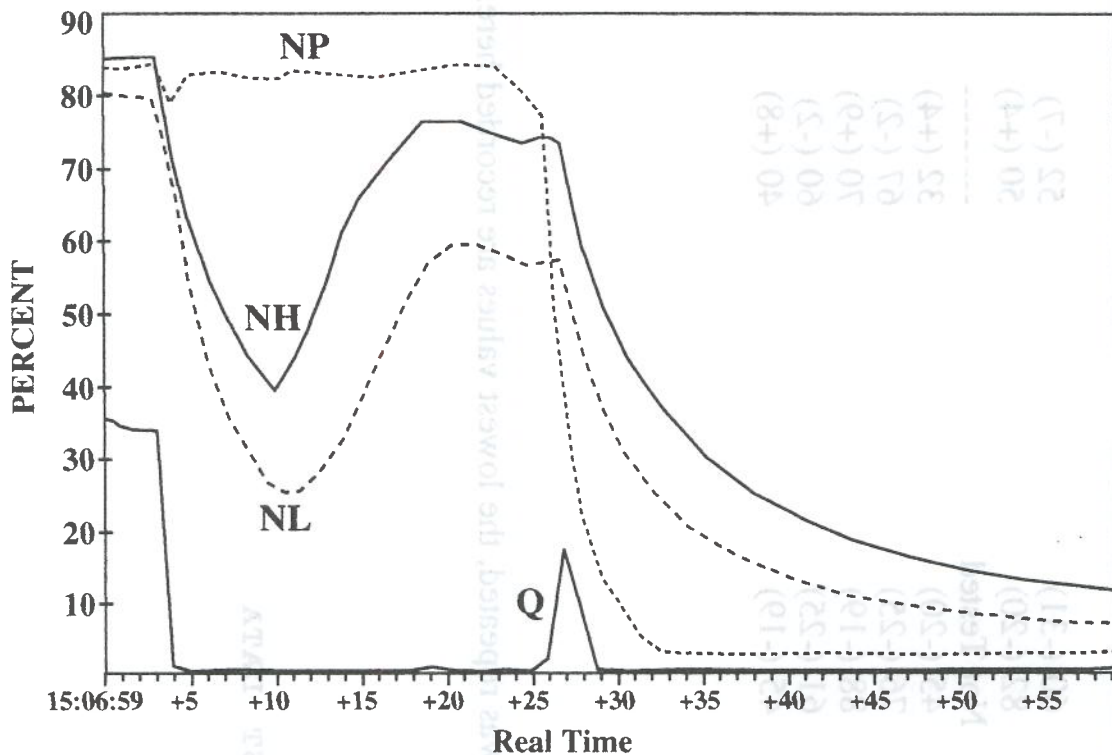
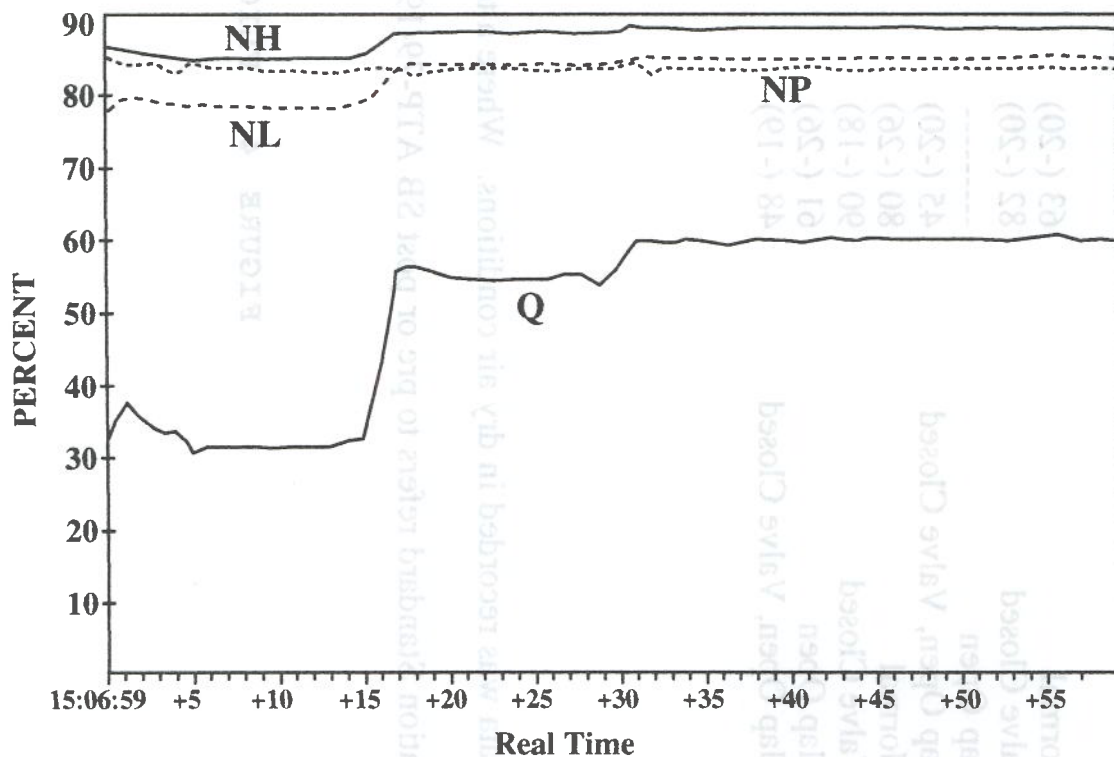
FIGURE 3 FDR TRACES FOR BOTH ENGINES

The torque record showed No 1 engine torque reducing from 34% to 0.9% in one second (one sample period) and it did not recover prior to engine shutdown. A short 3 second 'spike' present some 20 seconds after the rundown was consistent with propeller feathering. No torque discrepancies were apparent on the No 2 engine torque record.

The start of torque reduction on the No 1 engine was concurrent with a reduction in NH from 84.3% to 38.7% over a 7 second period. NH started to recover from its low of 38.7%, however recovery did not run to completion. Sixteen seconds following the initiation of rundown the NH levelled off at approximately 74%, and 8 seconds following this NH started to decay to windmilling speeds. This characteristic was consistent with the pilot having carried out the engine shutdown drill at 16 seconds following rundown (ie power lever reduction, condition lever to feather and fuel off). The propeller feathering spike on the torque trace was consistent with the fuel shut-off having occurred at this point. The FDR trace was consistent with No 1 engine power reduction as a result of flameout, followed by re-ignition and the start of a recovery.
