Gill SA Pulsar, G-BSFA

AAIB Bulletin No: 5/2003	Ref: EW/G2002/08/13	Category: 1.3
Aircraft Type and Registration:	Gill SA Pulsar, G-BSFA	
No & Type of Engines:	1 Rotax 582 piston engine	
Year of Manufacture:	1992	
Date & Time (UTC):	14 August 2002 at 1845 hrs	
Location:	Gloucestershire Aerodrome, Staverton	
Type of Flight:	Private	
Persons on Board:	Crew - 1	Passengers - 1
Injuries:	Crew - None	Passengers - None
Nature of Damage:	Damage to nose leg and floor aft of firewall	
Commander's Licence:	Private Pilot's Licence	
Commander's Age:	40 years	
Commander's Flying Experience:	526 hours (of which 34 were on type) Last 90 days - 26 hours Last 28 days - 11 hours	
Information Source:	Aircraft Accident Report Form submitted by the pilot and metallurgical examination of failed pin from the nose landing gear

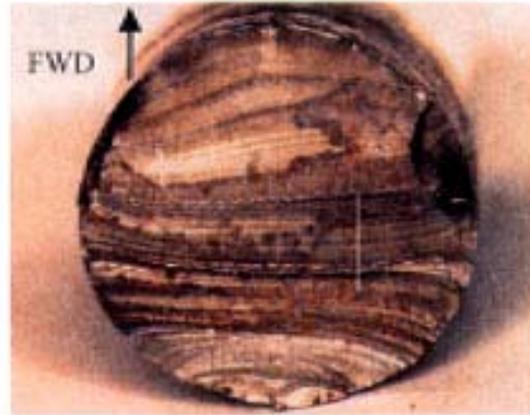
The nose leg components were subjected to a metallurgical examination. The lower end of the strut had a collar welded to it, apparently made from the same tubular steel. The nosewheel pivot pin passed through the collar and an additional weld bead joined the strut to the portion of the pin protruding above the collar. The pin was found to have suffered a fatigue fracture approximately in line with the upper face of the collar (see Figure 3). The failure occurred as a result of a reverse bending mechanism in the fore and aft direction (see Figure 2), with multiple initiation sites at the surface of the pin on the front and rear sections of the circumference. In addition, multiple secondary fatigue initiation sites were present either side of the fore-aft direction, just below the main plane of separation. This indicated the application of reverse bending loads had occurred either side of the longitudinal axis, ie when the nosewheel was pointing away from the straight-ahead position.

Fig 2. View of fracture face

Examination of the failed pin indicated that the failure was the result of a fatigue process, with multiple initiation sites. There was thus no evidence to suggest that a single event, such as a heavy landing had been responsible for the initiation. The examination of the intact strut and pin provided corroborative evidence, for despite the fact that the pin had been subjected to an overload sufficient to produce plastic deformation, fatigue damage was already present.

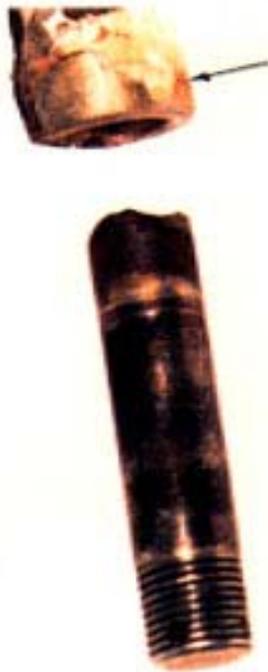
Fig 3. Pivot pin and bottom of strut: separation plane within collar is arrowed. (Photo: HT Consultants)

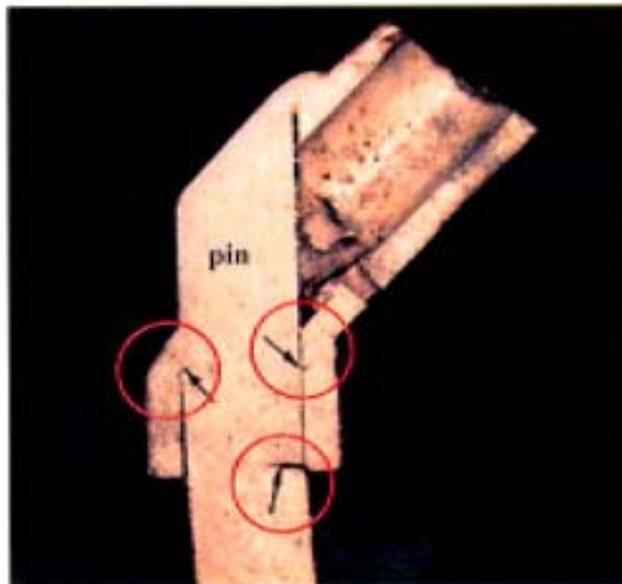
The intact strut with the bent pin was sectioned along the length of the pin, and three discontinuities were apparent, as shown in Figure 4. Additional metallurgical examination revealed that crack 'A' had occurred as a result of a tension fatigue mechanism, with initiation being in the root of the weld. This was approximately in line with the top surface of the collar and so was in a position very similar to the plane of separation in the pin from G-BSFA.

Crack 'B' had initially occurred by a forward bending fatigue mechanism, although this had been followed by a short overload tear with associated plastic deformation. Additional crack growth had then occurred as a result of fatigue.

The discontinuity at 'C' was found to be the result of a complete lack of fusion in one side of the weld at this position. It probably had little influence on the development of cracks 'A' and 'B'.

Fig 4. Section through intact strut, showing cracks in pin (A&B) and lack of fusion between collar and tube (C). (Photo: HT Consultants)
