No: 11/92

Ref: EW/G92/09/13

Aircraft Type and Registration: Steen Skybolt, G-BRIS
No & Type of Engines: 1 Lycoming IO-360-A1A piston engine
Year of Manufacture: 1988
Date & Time (UTC): 12 September 1992 at 1600 hrs
Location: Netherthorpe Airfield, Yorkshire
Type of Flight: Private
Persons on Board: Crew - 1 Passengers - None
Injuries: Crew - None Passengers - N/A
Nature of Damage: Landing gear collapsed and engine shock loaded
Commander's Licence: Private Pilot's Licence with Instrument Rating
Commander's Age: 40 years
Commander's Flying Experience: 779 hours (of which 4 were on type)
Last 90 days - 63 hours
Last 28 days - 25 hours
Information Source: Aircraft Accident Report Form submitted by the pilot

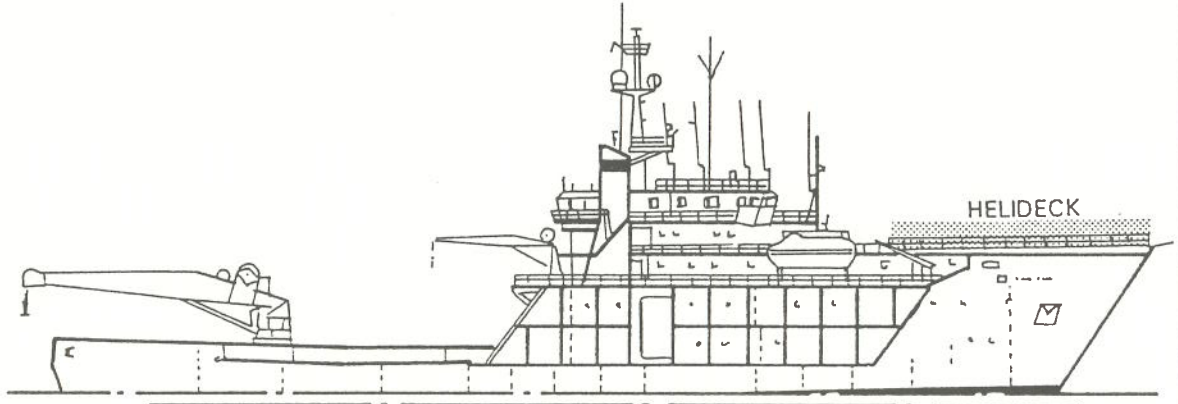
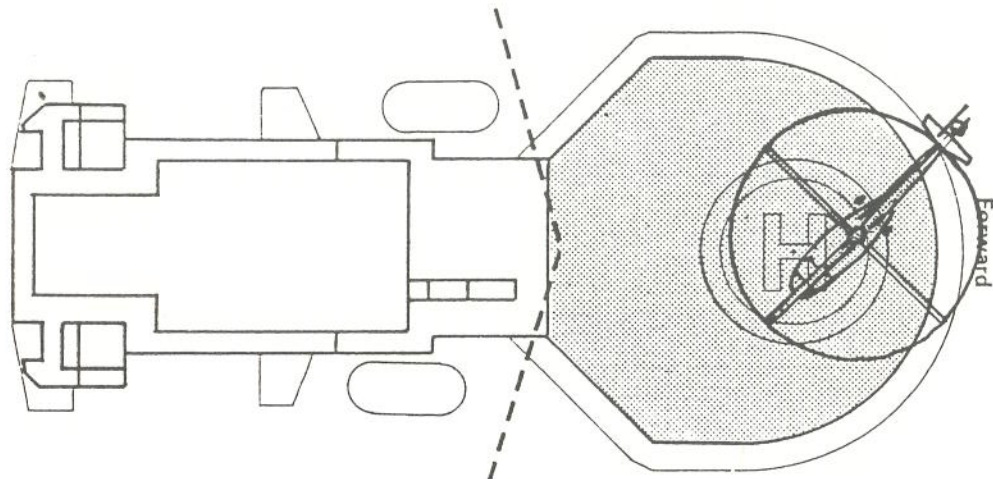
FIGURE 1 - LAYOUT OF HELIDECK AND HELICOPTER POSITION

was initially positioned on the helideck slightly towards the bow rather than on the central position of the aiming circle, one or both of the main wheels would have been very close to the bow edge of the deck netting as the movement occurred.

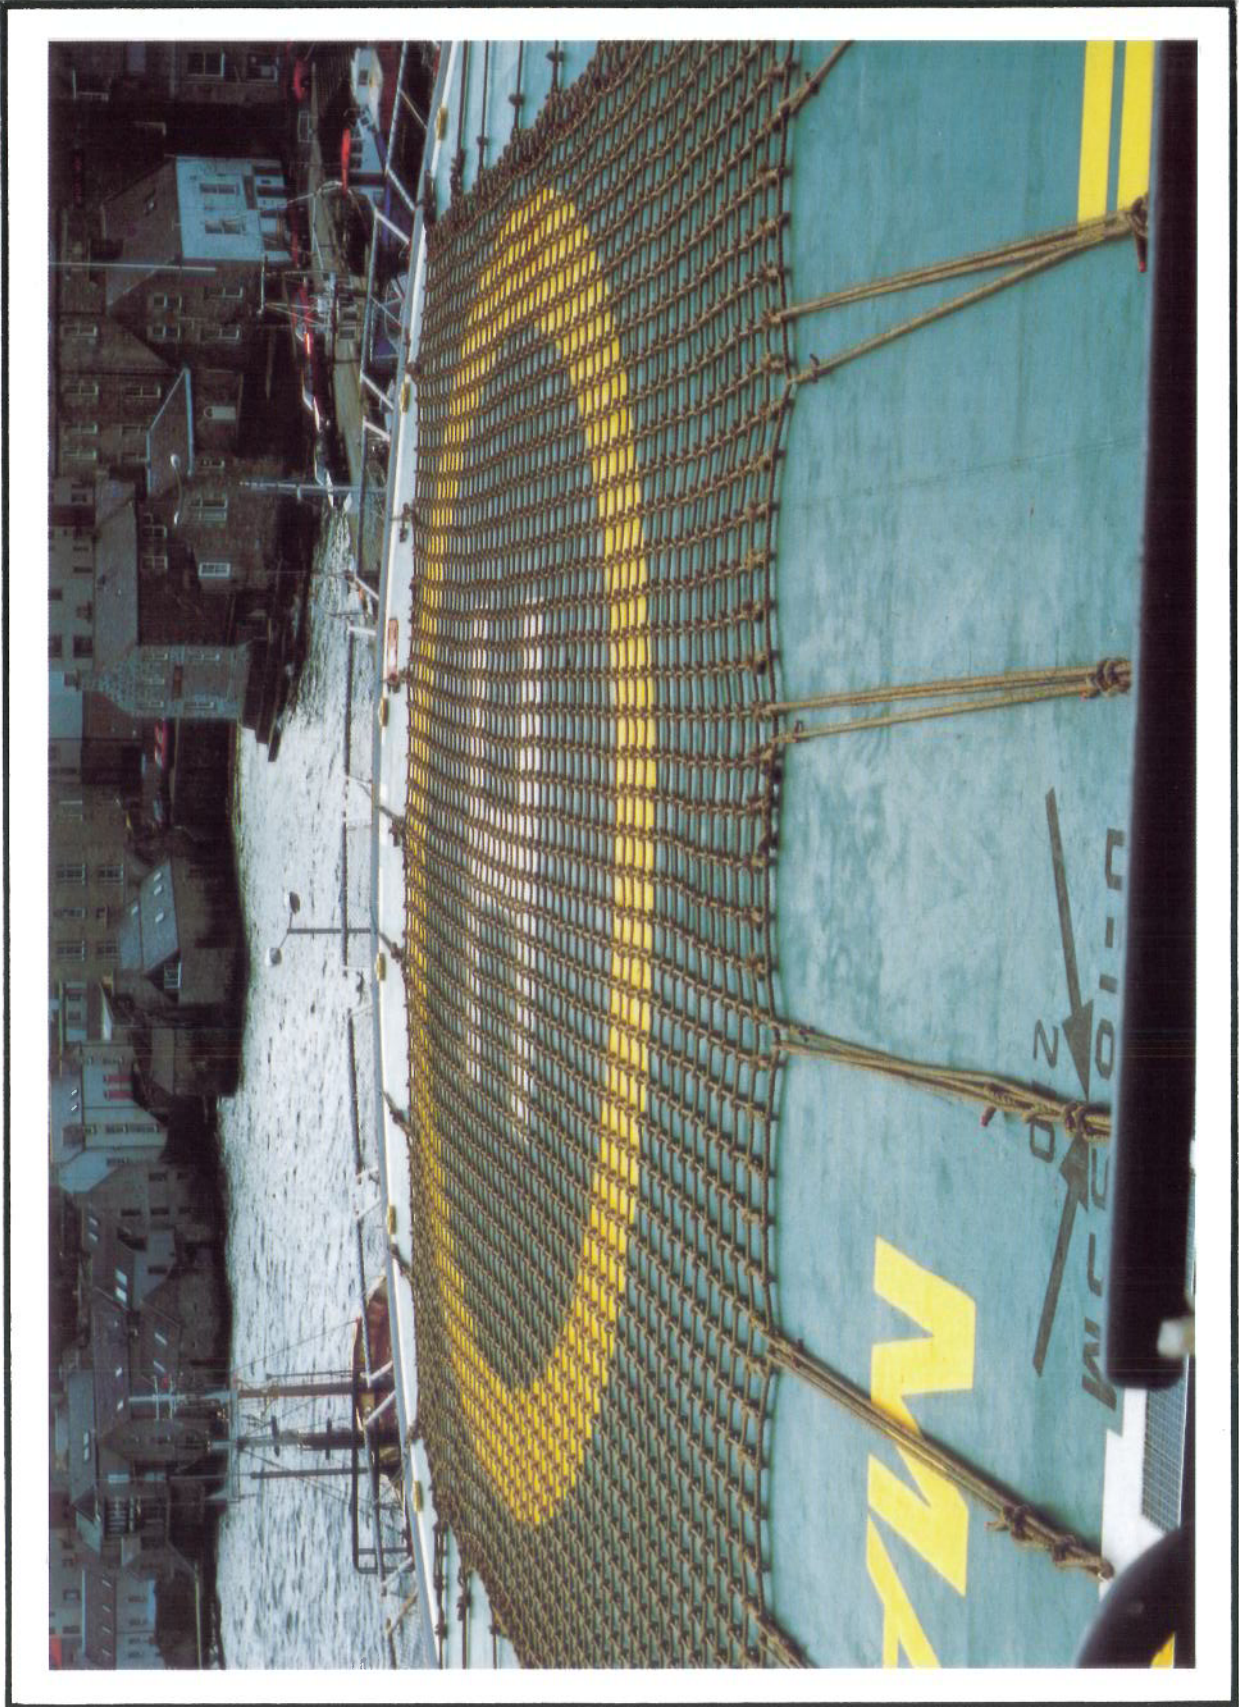
FIGURE 2 - VIEW OF DSV 'MAYO' HELIDECK FROM THE SHIP'S BRIDGE, FACING FORWARD

The 'Mayo' was equipped with an 18.95 metre diameter helideck, and was approved by both the Netherlands Department of Civil Aviation and UK CAA for operations by helicopters up to the size of the Bell 214ST and AS332L Super Puma, both of which are longer than the S76A. The surface of the helideck was finished with an anti-slip coating. The deck markings were in accordance with the guidance given in CAP 437 for Offshore helicopter landing areas. The aiming circle was of 10 metre outside diameter, with the 'H' centrally positioned in the circle aligned across the helideck. Over the aiming circle was positioned a medium sized (12 metre square) deck net, secured at appropriate intervals around the periphery, and tensioned in accordance with the recommendations. The deck net was made up of a mesh of 20 mm diameter sisal rope, knotted at each corner of the mesh. Because of limited deck space, the net was not centrally positioned over the aiming circle, the forward edge of the deck net being almost tangential to the outer edge of the aiming circle at the bow end (Figure 2). The wheelbase of the S76A from the nosewheel to the main wheel axis is 5.0 metres. As the helicopter
