**No:** 7/92

**Ref:** EW/C92/3/5

**Aircraft Type and Registration:** Rotorway Executive, G-BMYH  
**No & Type of Engines:** 1 Rotorway RW 152 piston engine  
**Year of Manufacture:** 1986  
**Date & Time (UTC):** 28 March 1992 at 1520 hours  
**Location:** Coalport, Shropshire  
**Type of Flight:** Private  
**Persons on Board:** Crew - 1                      Passengers - Nil  
**Injuries:** Crew - Fatal                      Passengers - N/A  
**Nature of Damage:** Aircraft destroyed  
**Commander's Licence:** PPL (Helicopters)  
**Commander's Age:** 61  
**Commander's Flying Experience:** 3747 hrs, including 447 on helicopters  
(of which 14 were on type)  
**Information Source:** AAIB Field Investigation

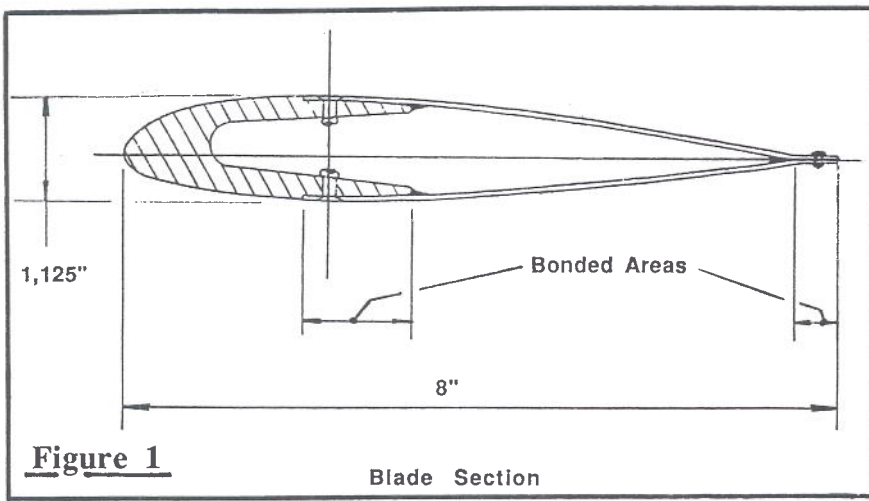
The asymmetrical section of the main rotor blades on this helicopter consists of a constant section extruded aluminium alloy spar, to which is bonded an upper and lower aluminium alloy trailing edge skin, as illustrated in Figure 1. These skins are also blind-riveted to the spar over the outer 50% of its span. The trailing edge is both bonded and riveted together. There is no honeycomb or other filler within the blade interior. The blades are vented by holes drilled through the root end and tip closure blocks. The blades are supplied to the builder, as in this case, with most of the basic bonding and rivetting operations already carried out, the builder then being required to add the root end straps, doubler plates, tip weights and closure blocks. If necessary, the builder is also allowed to apply a

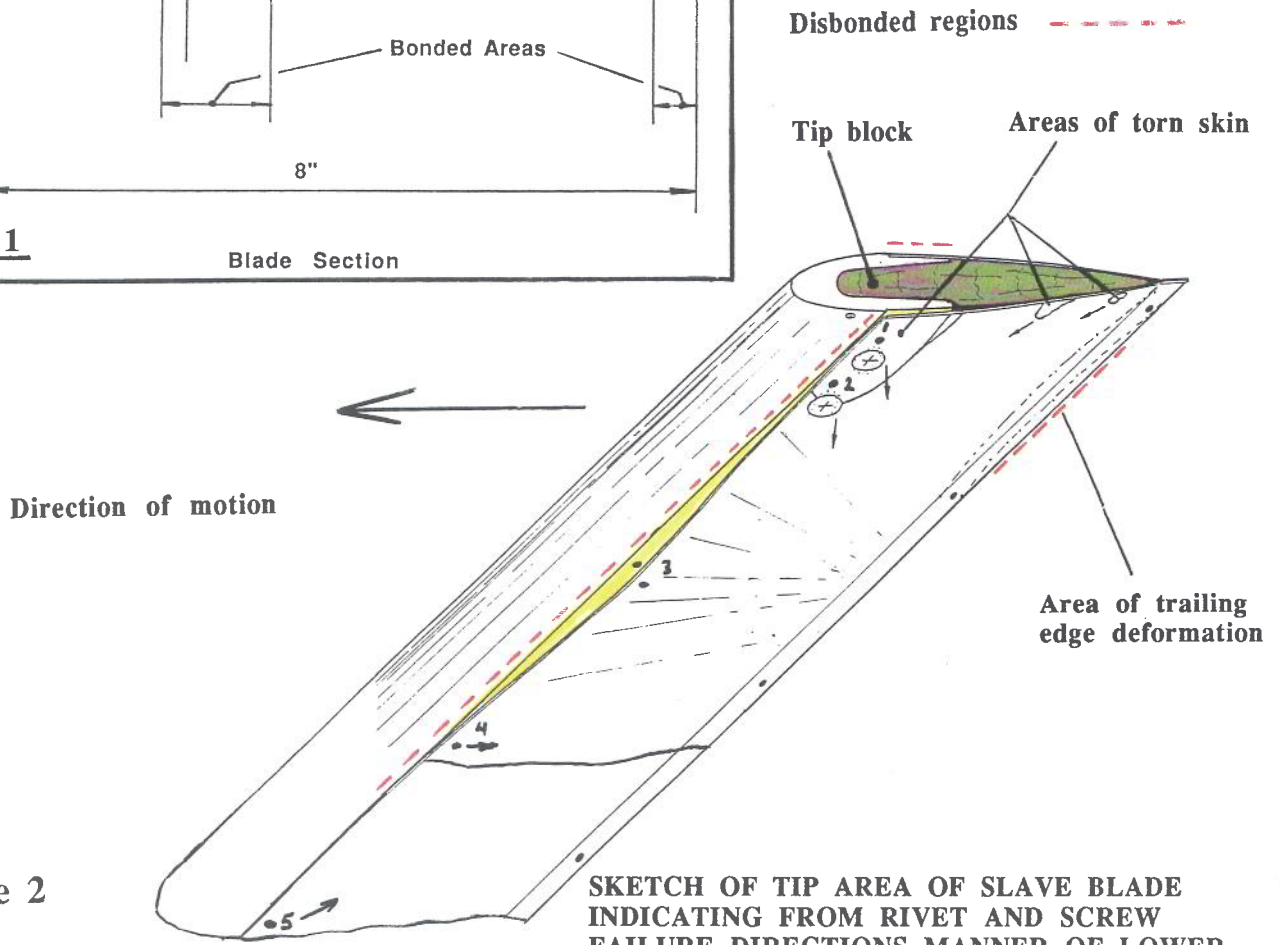
Figure 2

The failure directions of the rivets attaching the lower skin to the spar in this region were also examined. This indicated that that the skin had separated by lifting initially between rivets 2 and 4, as indicated in Figure 2, pulling the skin rearwards over the rivet heads in the case of rivets 4 and 5 and failing the head in tension in the case of rivet 3. The skin had then pulled over rivet heads 1 and 2 in a

direction which was approximately 45° inboard/rearwards and that retained by rivet 6 had pulled from this rivet in a direction that was approximately 70° outboard/rearwards. The screws which had attached the end of the lower skin to the wooden tip block had also pulled through the skin due to displacement of the skin in a direction which was approximately 45° forwards/inboard, indicating that the end of the lower skin had pivoted inboard about its outermost trailing-edge point. Examination of the remaining portions of the rivets that had attached the lower skin to the spar indicated that this area of skin had peeled off in an inboard direction. It was apparent from this, and a tightly curled section of the lower skin which had remained attached at the blade root, that most of the lower skin had peeled off the spar inboard and rearwards, in a rapid manner.

SKETCH OF TIP AREA OF SLAVE BLADE INDICATING FROM RIVET AND SCREW FAILURE DIRECTIONS MANNER OF LOWER SKIN DETACHMENT

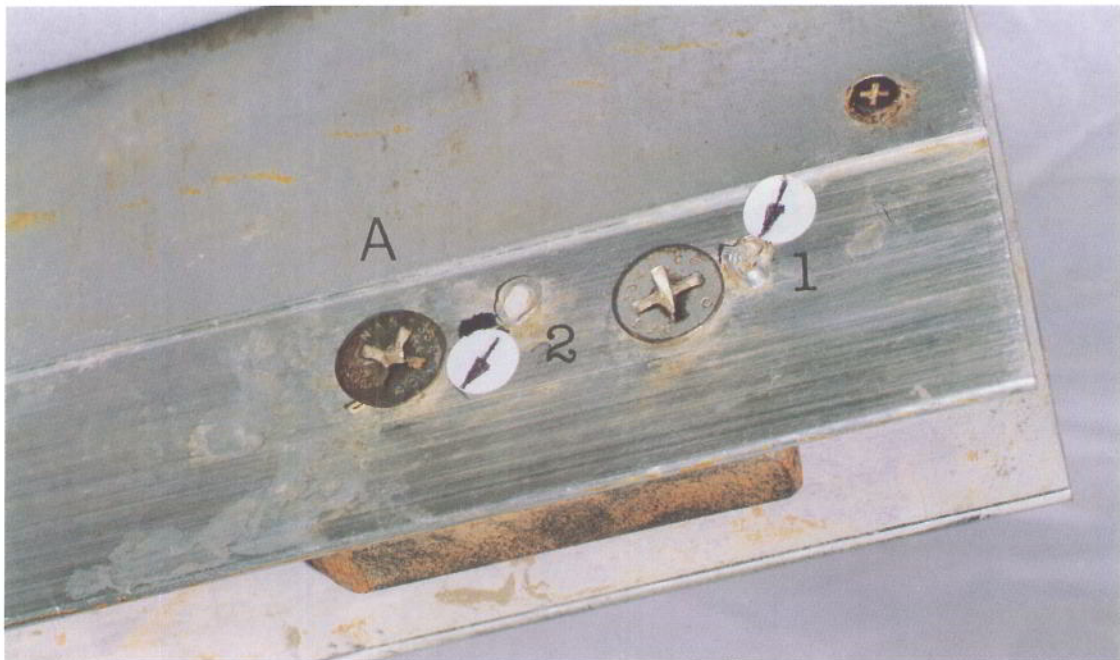
The areas of bonding were also examined and, in the main, exhibited no signs of any significant pre-existing defect. However, examination of the bonded regions between the spars and skins at the tip of the 'slave' blade revealed that disbonding had occurred due to the ingress of water (aqueous disbonding) over a length of approximately 4 inches inboard from the tip on the upper surface, and over a length of 12 inches on the lower surface. An area of disbond was also present up to 4 inches in from the tip on the upper surface of the 'master' blade. The limit of the disbond was equi-spaced between rivets 2 and 3 on the upper surface and centered on rivet 3 on the lower surface (Figures 2 and 3). Another area of aqueous disbonding was present at the trailing edge join between the upper and lower skins between the outermost two rivet locations. This was of particular interest since it was coincident with a region of pre-existing upwards deformation/separation of the skins which was evident at the trailing edge on one of the blades on a photograph (Figure 4) taken of the helicopter shortly before it departed on the accident flight. Figure 5 shows a computer-enhanced enlargement of this area. Examination of the skins of both blades at this point showed nothing of interest on the 'master' blade, but on the 'slave' blade both skins exhibited a nearly identical upward distortion in this area. Additionally, there were a series of spanwise witness marks on the outer surface of the lower skin in the affected area, the appearance of which suggested that they existed prior to the accident. Similar marks, however, were present at other locations along the trailing edge, although not to quite the same extent, and may have been associated with the manufacture of the blade skins.

It therefore appeared likely that the primary reason for the detachment of the bottom skin from the 'slave' blade was because an area of adhesive disbond had developed between the skin and the spar, extending approximately 12 inches inboard from the blade tip. If, as was reported, this helicopter had been exposed to the elements for the whole of the preceding winter period, the effect of ingress of water between the spar and layer of adhesive would have been accelerated by freezing of the contained water film. It was not established whether or not this failure had been influenced by the pre-existing distortion and disbond of the skins which was apparent at the trailing-edge in this region.

Tip section of blade lower surface showing evidence of aqueous disbonding

**92-43** The CAA consider the requirement for an appropriate calendar time inspection of the main rotor blades on Rotorway Executive and Executive 90 helicopters, by a suitably qualified person, and require that all such blades should be painted.

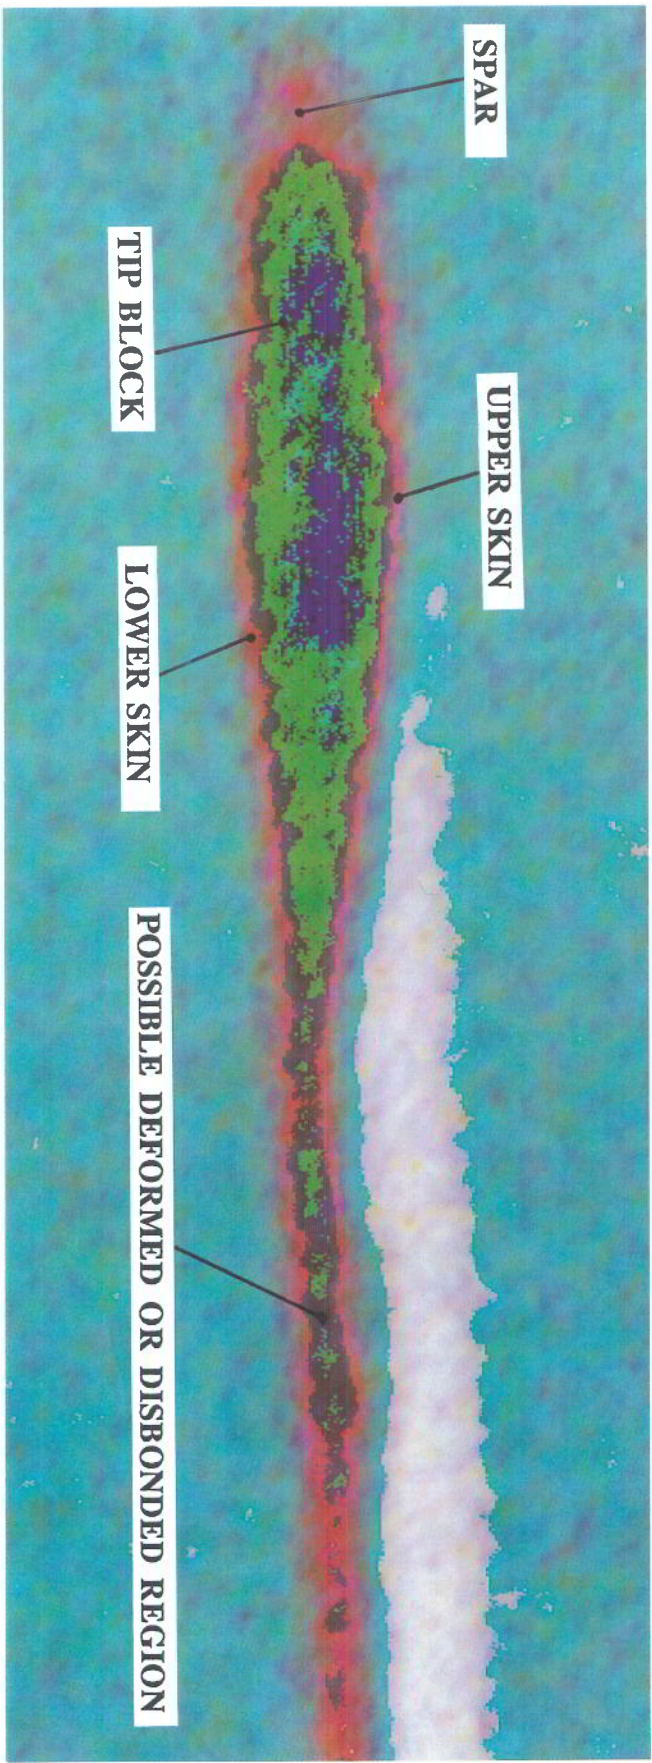
Figure 5

Computer Contrast Enhancement of tip area
