Aircraft Type and Registration:	Folland Gnat T Mk 1, G-BVPP	
No & Type of Engines:	1 Rolls-Royce Orpheus Mk 10101 jet engine	
Year of Manufacture:	1963	
Date & Time (UTC):	17 September 2004 at approximately 1240 hrs	
Location:	Near to the A414 road, 1 nm north-west of North Weald Airfield, Essex	
Type of Flight:	Private	
Persons on Board:	Crew - 1	Passengers - 1
Injuries:	Crew - None	Passengers - None
Nature of Damage:	Damage to underside of aircraft	
Commander's Licence:	Basic Commercial Pilot's Licence	
Commander's Age:	36 years	
Commander's Flying Experience:	1,250 hours (of which 40 were on type) Last 90 days - 15 hours Last 28 days - 5 hours	
Information Source:	AAIB Field Investigation

Synopsis

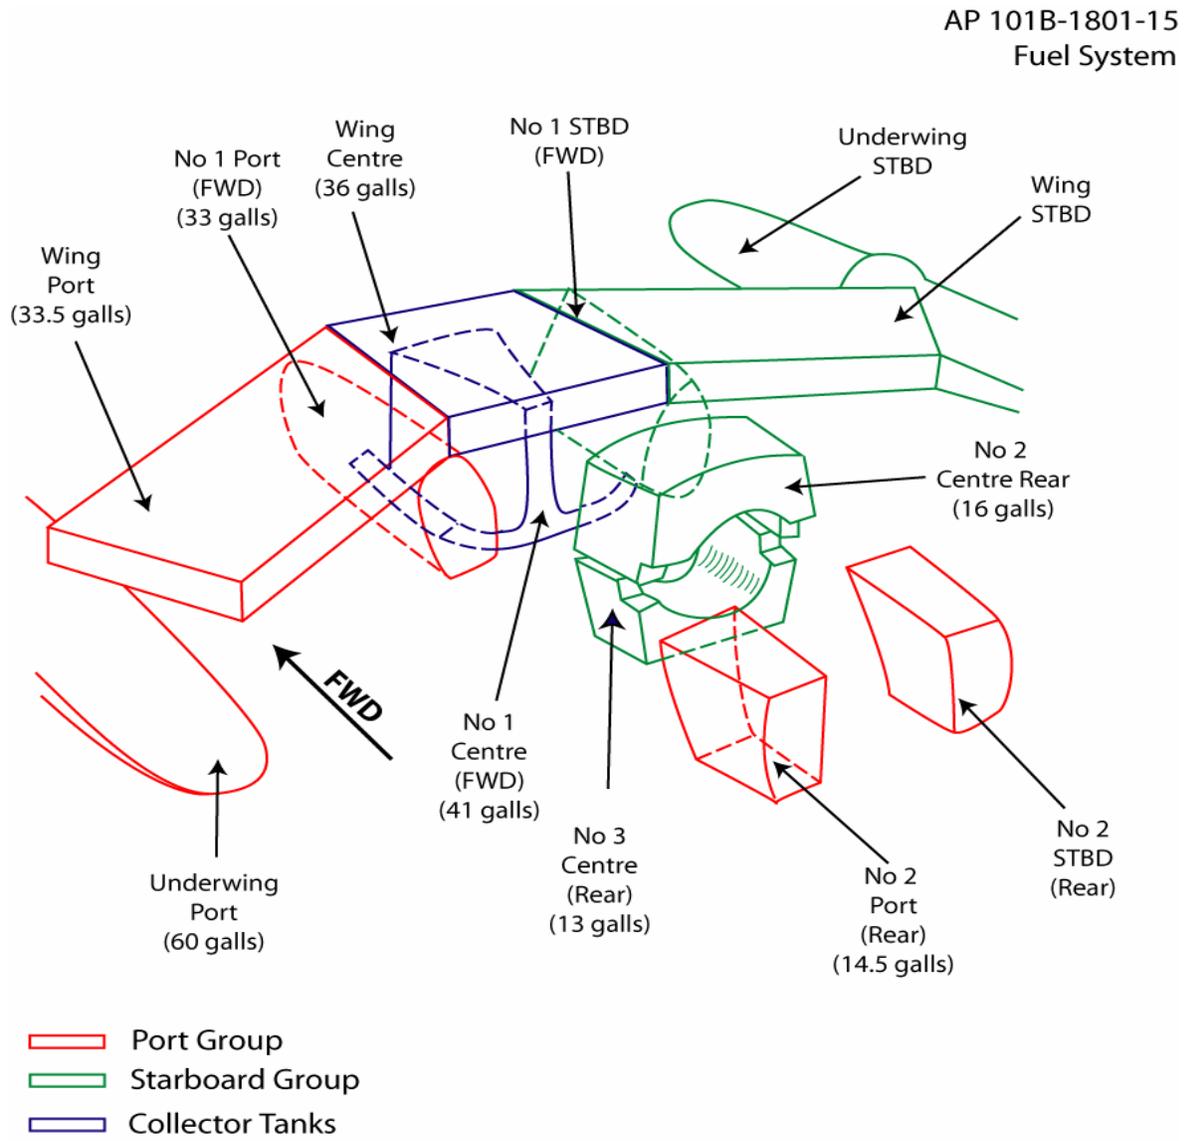
Figure 1

At the time of the accident, G-BVPP was fitted with two under-wing slipper tanks and eight airframe fuel tanks were in use, Figures 1 and 2. (The two rearmost fuselage tanks were reportedly isolated.) Pneumatic pressure, bled from the engine compressor, is supplied to each slipper tank and causes the fuel to be transferred to the associated wing tank, from where it subsequently transfers into two pannier tanks, one located each side of the fuselage. From there, the fuel transfers to the fuselage centre tank group. All fuel tanks on the aircraft eventually feed into the No 1 centre tank in the fuselage, which contains a boost pump, from where the engine is supplied via the low pressure fuel cock (LPC). A flow proportioner ensures that equal volumes of fuel are taken from each tank group (left and right) to prevent any imbalance across the aircraft. A fuel low pressure switch, downstream of the engine low pressure filter, operates the FUEL warning light on both pilots instrument panels should the boost pump pressure be lost or the filter become blocked. Additionally, a fuel low level float switch triggers a warning light when the contents of the No 1 centre tank become depleted to a level that only assures sufficient fuel for a missed approach, a go-around and a landing.

Fuel Tank Layout Diagram

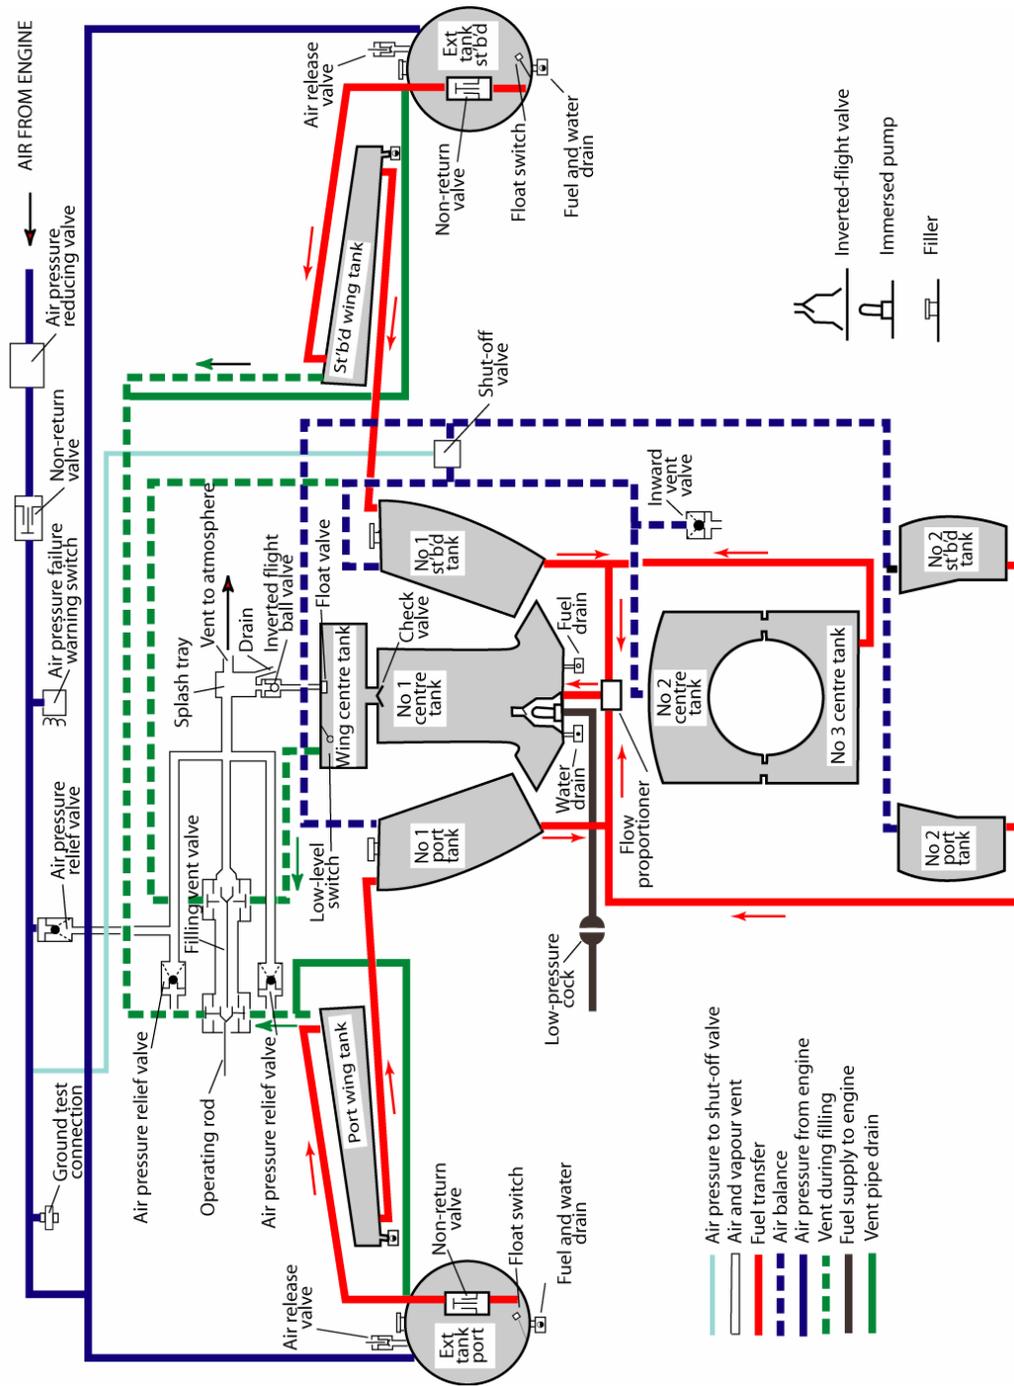
Figure 2

Fuel System Diagram
