<b>Aircraft Type and Registration:</b>	X'Air V2(2), G-CBTY	
<b>No &amp; Type of Engines:</b>	1 Simonini Victor II piston engine	
<b>Year of Manufacture:</b>	2002	
<b>Date &amp; Time (UTC):</b>	27 June 2004 at 1620 hrs	
<b>Location:</b>	Newtownards, Northern Ireland	
<b>Type of Flight:</b>	Training	
<b>Persons on Board:</b>	Crew - 2	Passengers - None
<b>Injuries:</b>	Crew - None	Passengers - N/A
<b>Nature of Damage:</b>	Damage to fibre glass pod, propeller blades and nose landing gear	
<b>Commander's Licence:</b>	Private Pilot's License with Instructor Rating	
<b>Commander's Age:</b>	55 years	
<b>Commander's Flying Experience:</b>	1,550 hours (of which 30 were on type) Last 90 days - 140 hours Last 28 days - 50 hours	
<b>Information Source:</b>	Aircraft Accident Report Form submitted by the pilot and examination of the aircraft engine by the AAIB

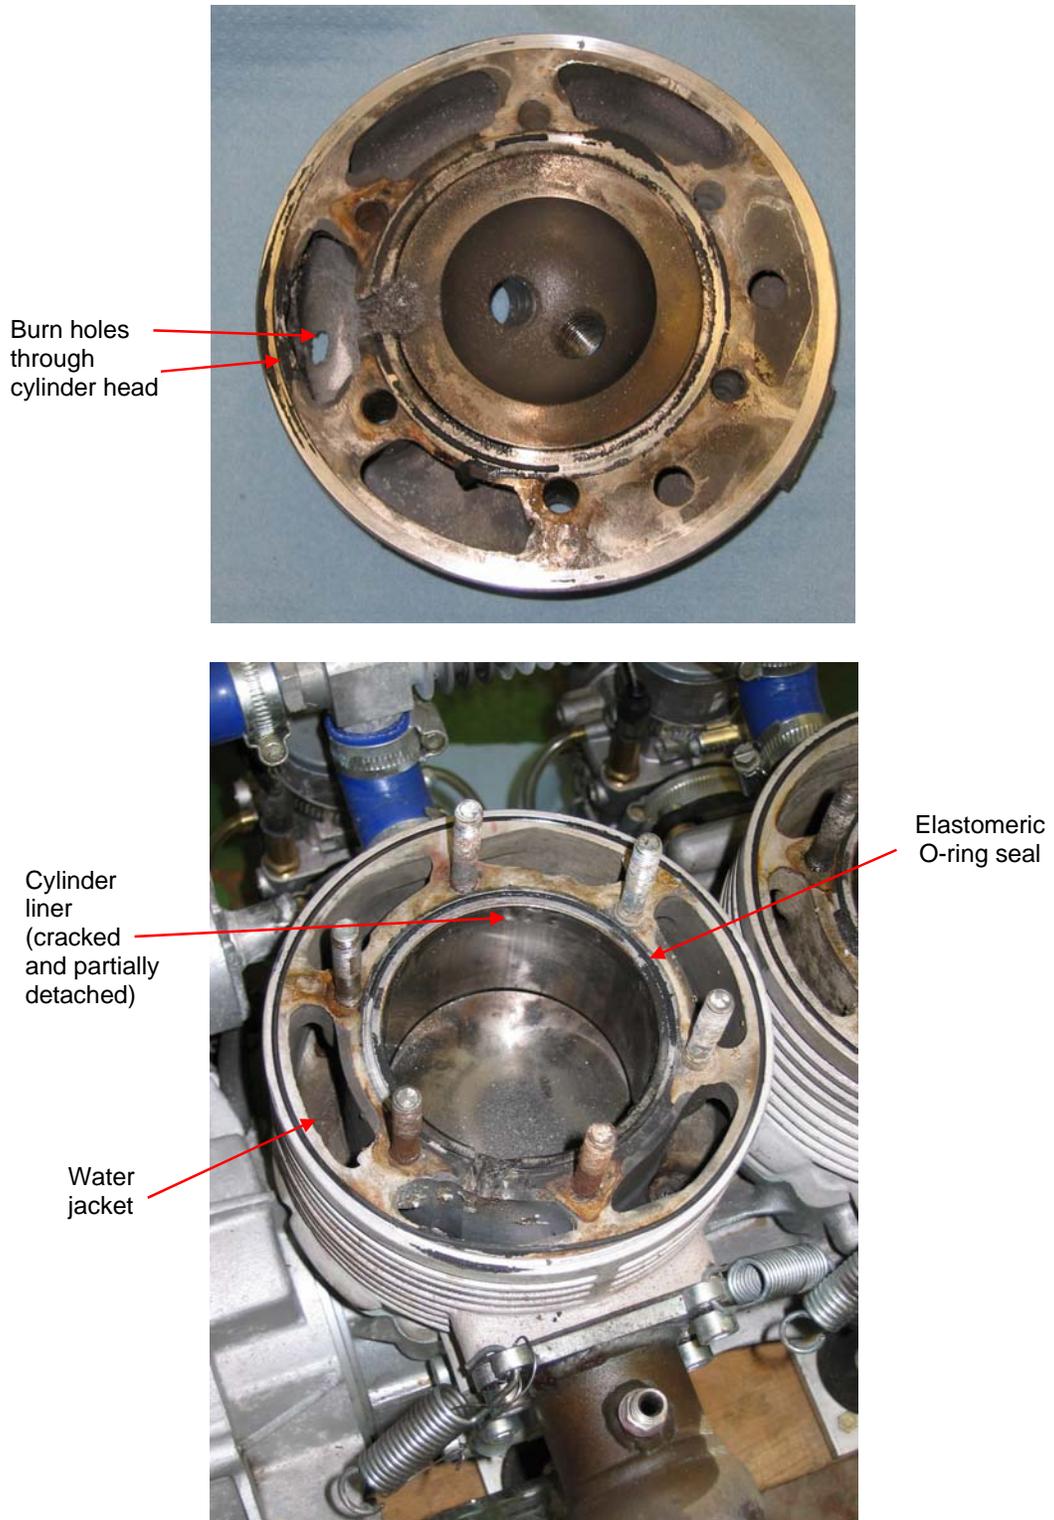
The engine without the cooling system and the propeller was returned to the AAIB in August 2004 for further examination. Two burn holes were observed in the side wall of the rear cylinder head (see Figure 1). The engine could not be rotated by hand. The plating on the top end of the inner

walls of both cylinders was cracked and partially detached in places. The burn holes passed through both walls of the liquid cooling jacket and the seal between the head and the block. The seal, an elastomeric O-ring, had suffered thermal degeneration. The front cylinder seal had suffered similar degeneration although no gas leaks from the cylinder had apparently occurred.

It was considered that the engine failure was caused by the loss of coolant allowing hot gases to burn through the cylinder casing. The evidence of corrosion in the bearings indicated that liquid had been present in the crankcase for some time. The accumulation of liquid in the crankcase probably resulted from a leak past one or both of the cylinder head elastomeric seals.

**Figure 1** Rear cylinder with cylinder head removed (shown above)
