ACCIDENT

Aircraft Type and Registration:	Piper PA-34-200T Seneca II, G-JDBC	
No & Type of Engines:	2 Continental Motors Corp LTSIO-360-E piston engines	
Year of Manufacture:	1975	
Date & Time (UTC):	30 June 2008 at 1458 hrs	
Location:	Runway 23L, Manchester International Airport, Greater Manchester	
Type of Flight:	Training	
Persons on Board:	Crew - 3	Passengers - None
Injuries:	Crew - None	Passengers - N/A
Nature of Damage:	Failed left main landing gear attachments, damage to left flap, aileron, propeller and pitot head and horizontal stabiliser tip	
Commander's Licence:	Commercial Pilot's Licence	
Commander's Age:	47 years	
Commander's Flying Experience:	1,975 hours (of which 302 were on type) Last 90 days - 28 hours Last 28 days - 4 hours	
Information Source:	Aircraft Accident Report Form submitted by the pilot and metallurgical examination of landing gear trunnion fitting

Synopsis

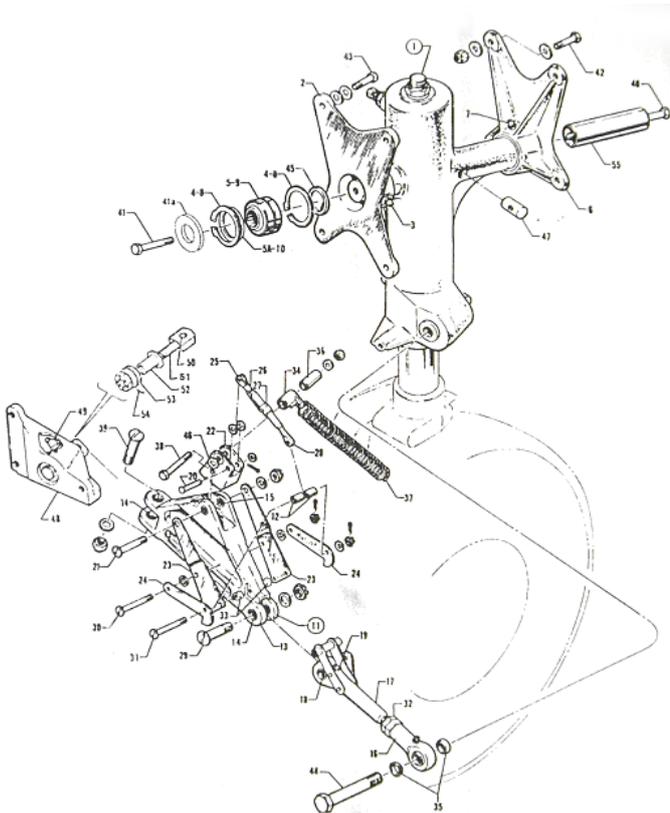
The aircraft was recovered to the maintenance organisation's hangar, where an inspection revealed that the left landing gear forward trunnion fitting had broken into several pieces. Parts of the component were missing, although one piece was later recovered from the runway at Tatenhill. Figure 1 shows an illustration from the Illustrated Parts Catalogue, which shows details of the installation.

Drawing illustrating installation of the main landing gear trunnion fittings
