ACCIDENT

Gyroplane Type and Registration:	Ken Brock KB-2, G-BUYT	
No & Type of Engines:	1 Rotax 582 piston engine	
Category:	2.3	
Year of Manufacture:	1993	
Date & Time (UTC):	15 December 2004 at 1410 hrs	
Location:	Sutton Bank, Thirsk, North Yorkshire	
Type of Flight:	Private	
Persons on Board:	Crew - 1	Passengers - None
Injuries:	Crew - 1 (Fatal)	Passengers - N/A
Nature of Damage:	Extensive	
Commander's Licence:	Private Pilot's Licence	
Commander's Age:	61 years	
Commander's Flying Experience:	3,350 hours (of which 33 were on gyroplanes and 12 were on type) Last 90 days -12 hours (0 on type) Last 28 days - 3 hours (0 on type)	
Information Source:	AAIB Field Investigation

Synopsis

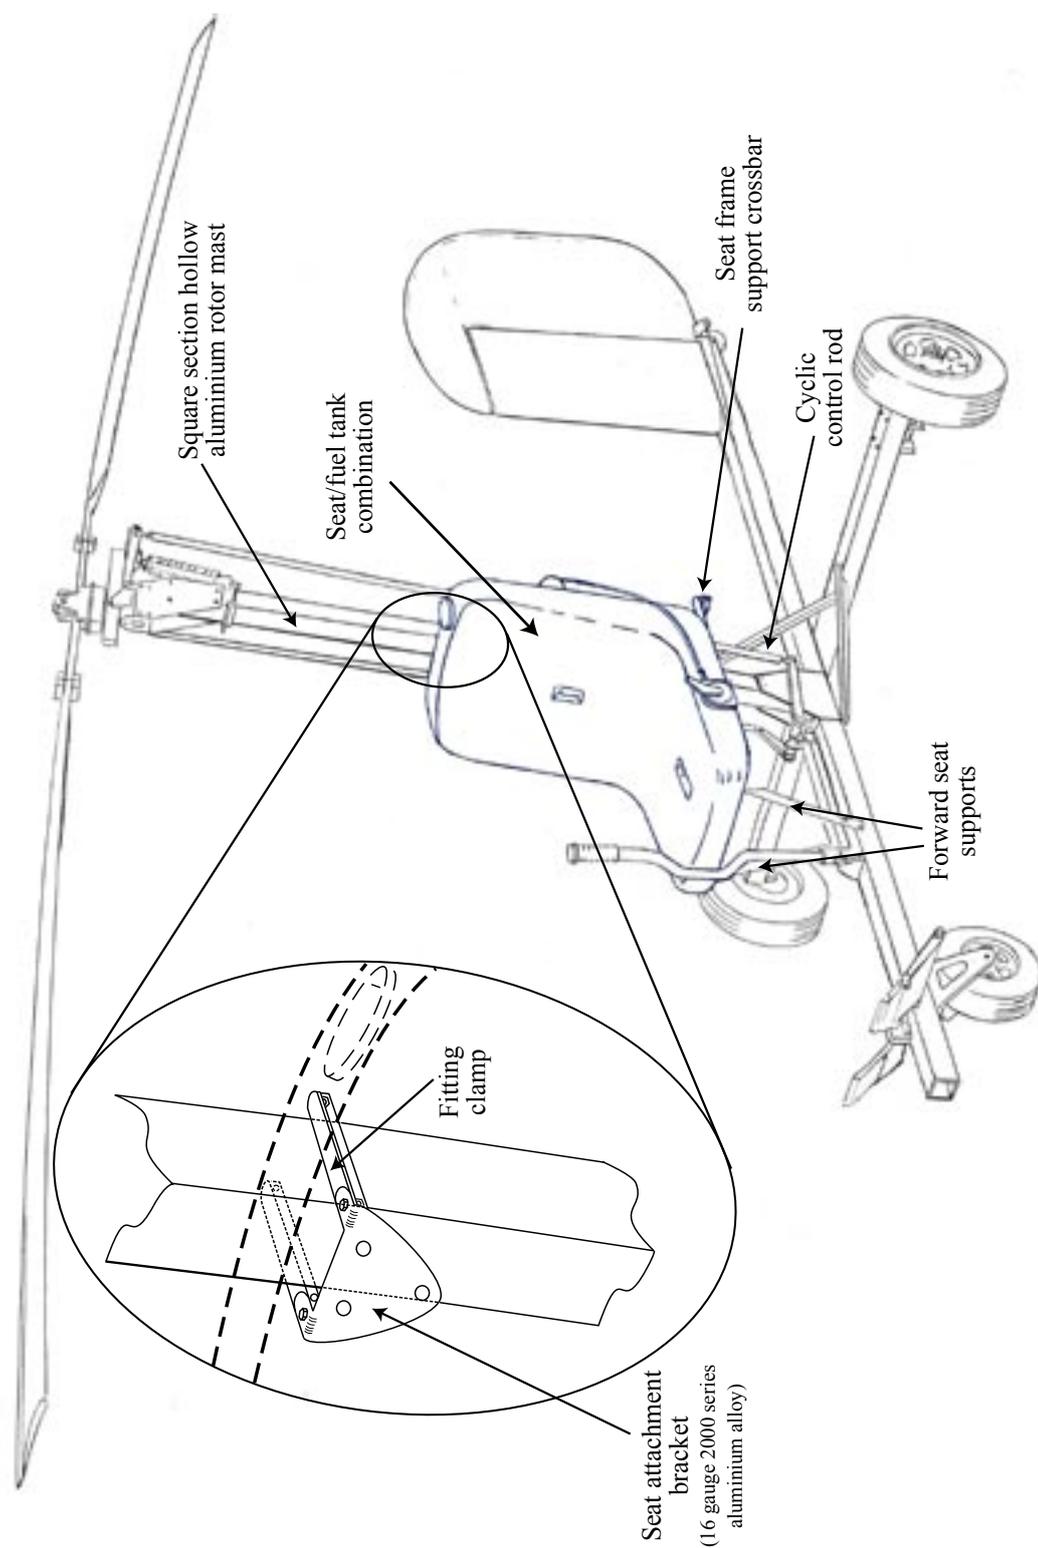
Figure 1

The pilot's seat on this gyroplane was a 31.4 ltr (7 imp gallons, 23 kg) capacity Ken Brock seat/fuel tank combination kit, empty weight 4.4 kg, made from a moulded plastic material. The weight of the seat/fuel/pilot is supported by a horizontally mounted U shaped tubular frame bolted, at the rear, to a support crossbar which itself is attached by two bolts to the aluminium alloy square section tube rotor mast. The frame is supported at the front by two simple struts to the longitudinal structural beam. The top of the seat is also attached to the mast by a 16 gauge aluminium alloy bracket, which was supplied

with the seat kit, designed to restrain or stabilise the seat in the fore/aft and lateral planes. This bracket does not transmit any significant vertical loads between the seat and the mast. It is secured to the top of the seat back by three bolts, and to a fitting clamped around the mast by two bolts (left and right) through two integral lugs.

Examination of the seat revealed that the left side lug of the attachment bracket at the top of the seat, at its connection to the clamp around the mast, had failed by a fatigue cracking mechanism, prior to the first impact with the trees. The right side lug had also partially failed in fatigue and then failed completely in a one-off overload mechanism. It was not possible to determine if the overload failure had occurred before the first impact or during the impact sequence. There was very good evidence of fretting between the attachment bolt washers and both the left and right lugs of the attachment bracket, indicating that there had been relative movement between the attachment bracket and the mast clamp over a period of time. Examination of the seat frame support crossbar, at its attachment to the rotor mast, found it to be loose and able to be 'rocked' laterally. There was very good evidence of fretting of the crossbar steel attachment bolts and ovalisation, in a downward direction, of the bolt holes in the aluminium rotor mast, indicating that this damage had occurred over a period of time. It was also found that the cross section of the hollow square section rotor mast had reduced in the immediate area of the attachment bolt holes, deformation being present on both the front and rear faces, in a manner consistent with excessive torque tightening of these attachment bolts. It was not established when this deformation occurred.

Diagram of the combined seat/fuel tank fixture

The only significant evidence found during the examination of damage that was inconsistent with having occurred during the accident, was the failure of the seat top attachment bracket. The left side lug of this bracket was found to have failed by fatigue cracking prior to the first impact with the trees. The right side had partially failed in fatigue. It was not possible to determine if the final overload failure of the right side occurred prior to, or as a consequence of, the impact. There was good evidence of long term fretting in a number of areas of the seat attachment points, looseness of the main load bearing rear crossbar for the seat, and vertical ovalisation of the crossbar attachment holes in the rotor mast.

It is recommended that the Popular Flying Association (PFA) emphasise to all PFA Inspectors, and owners of Brock KB-2 and similar gyroplanes, the particular importance of checking the security of all seat attachments and fittings and, where looseness is found, that no cracking or deformation of the airframe or seat attachments is present.
