INCIDENT

Aircraft Type and Registration:	Britten-Norman BN2A Mk III-2 Trislander, G-BEDP	
No & Type of Engines:	3	Lycoming O-540-E4C5 piston engines
Year of Manufacture:	1976	
Date & Time (UTC):	14 April 2007 at 0710 hrs	
Location:	Stand 8, Jersey Airport, Channel Islands	
Type of Flight:	Commercial Air Transport (Passenger)	
Persons on Board:	Crew - 1	Passengers - 3
Injuries:	Crew - None	Passengers - None
Nature of Damage:	G-BEDP: left wing tip paint scraped and a small dent Jetstream: right wing tip strobe light lens and upper cover broken	
Commander's Licence:	Commercial Pilot's Licence	
Commander's Age:	29 years	
Commander's Flying Experience:	836 hours (of which 36 were on type) Last 90 days - 67 hours Last 28 days - 36 hours	
Information Source:	Aircraft Accident Report Form submitted by the pilot and further enquiries by the AAIB

Synopsis

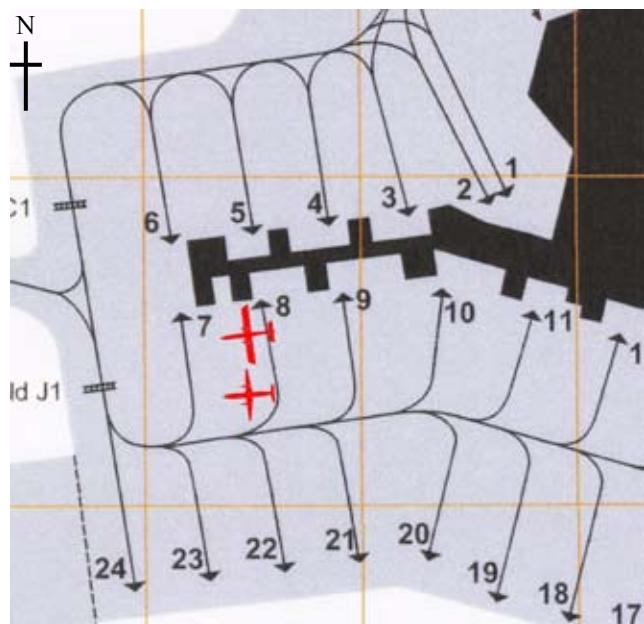
**Figure 1**

The operating company's parking arrangement on Stand 8 at Jersey Airport meant that G-BEDP and the Jetstream were parked parallel to each other and the terminal building, facing west (see Figure 1). This had been the arrangements on Stands 8 and 9 since February 2007; prior to this Stand 7 was also available but was then closed due to conflicts with traffic from an adjacent roadway.

The operating company’s station manager stated that as a result of this incident the company’s parking arrangements on Stands 8 and 9 have, in consultation with the airport authorities, been changed. Wing tip clearance requirements between adjacent aircraft have been increased and the aircraft are now parked facing south, away from the terminal. Yellow arrows have been painted on the ground to assist company pilots with the new arrangements.
