INCIDENT

Aircraft Type and Registration:	De Havilland Canada DHC-8 Series 311, G-NVSB
No & Type of Engines:	2 Pratt & Whitney Canada PW123 turboprop engines
Year of Manufacture:	1998
Date & Time (UTC):	9 August 2005 at 0830 hrs
Location:	On departure from Manchester Airport
Type of Flight:	Public Transport (Passenger)
Persons on Board:	Crew - 4 Passengers - 33
Injuries:	Crew - None Passengers - None
Nature of Damage:	Damage to right engine and propeller assembly
Commander's Licence:	Airline Transport Pilot's Licence
Commander's Age:	62 years
Commander's Flying Experience:	15,735 hours (of which 3,634 were on type) Last 90 days - 205 hours Last 28 days - 81 hours
Information Source:	AAIB Field Investigation

Synopsis

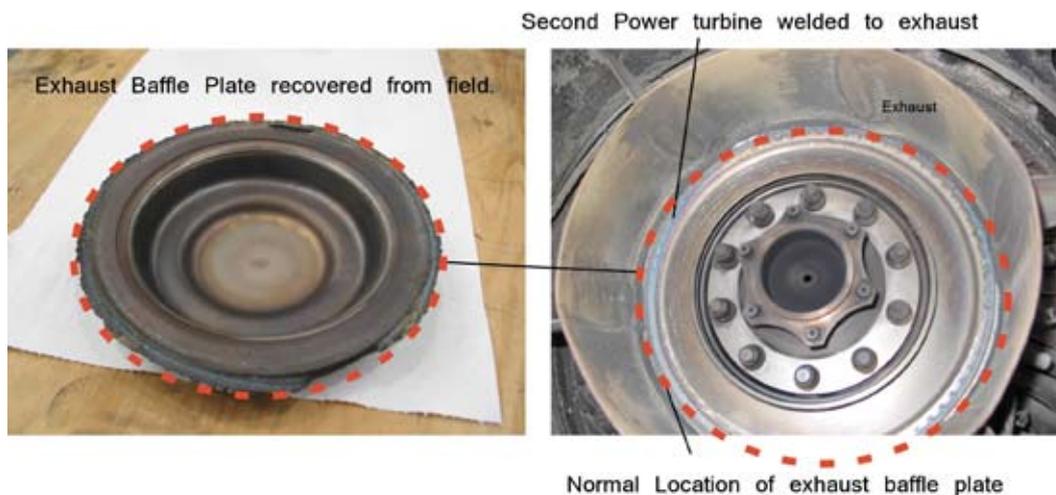
Figure 5

Damage to the exhaust components

come into contact with the exhaust duct and, in the process, had 'machined' into the baffle plate, causing it to depart from the rear of the engine. This disc had then friction welded itself to the remains of the exhaust duct, Figure 5.

resulting in a large torsional load in the PT shaft and its eventual fracture. This disconnected the two PT stages, which very quickly oversped, moving aft in the process, and shedding their blades from the engine exhaust. The 2nd stage PT disc had also come into contact with, and welded itself to, the exhaust assembly, which removed enough material to allow the rear exhaust baffle plate to become detached.
