**AAIB Bulletin No: 11/95**

**Ref: EW/G95/08/01**

**Aircraft Type and Registration:** Piper PA-34-200 Seneca, G-BVEV

**Nature of Damage:** Damage to nose underside, nose landing gear doors and propellers

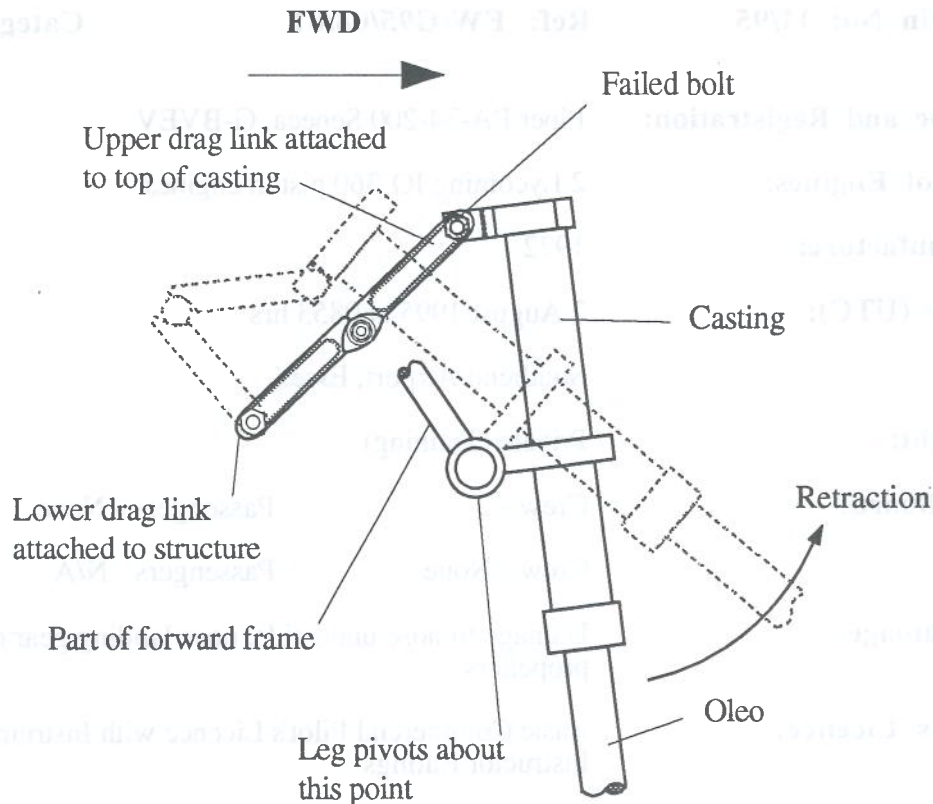
### SCHEMATIC OF PA34 NOSELEG

It was subsequently found that the nose gear collapse had been caused by failure of the AN7-35 bolt that attached the drag linkage to the top of the leg. The locations of these components are shown in the following diagram, and in the accompanying photographs.

With reference to the above diagram, it can be seen that the nose leg on the PA34 is attached to the horizontal member of the fuselage forward frame, which is of tubular steel construction. The leg pivots about this horizontal member such that the nosewheel retracts in a forwards direction. The installation is such that vertical loads are reacted by the frame. Fore and aft loads, the magnitude of which are largely dependant on the nature of the runway surface, are reacted by the drag linkage. It was considered possible that any free play (caused in this instance by the wear in the lower drag link bolt) could have resulted in a 'hammering' action on rough runways, which in turn may have initiated the fatigue process in the upper bolt. It can be seen from the photographs that this bolt is used in a single shear application compared with the smaller diameter lower bolt (not shown) which, as the lower link is located between two airframe mounted lugs, is in double shear.

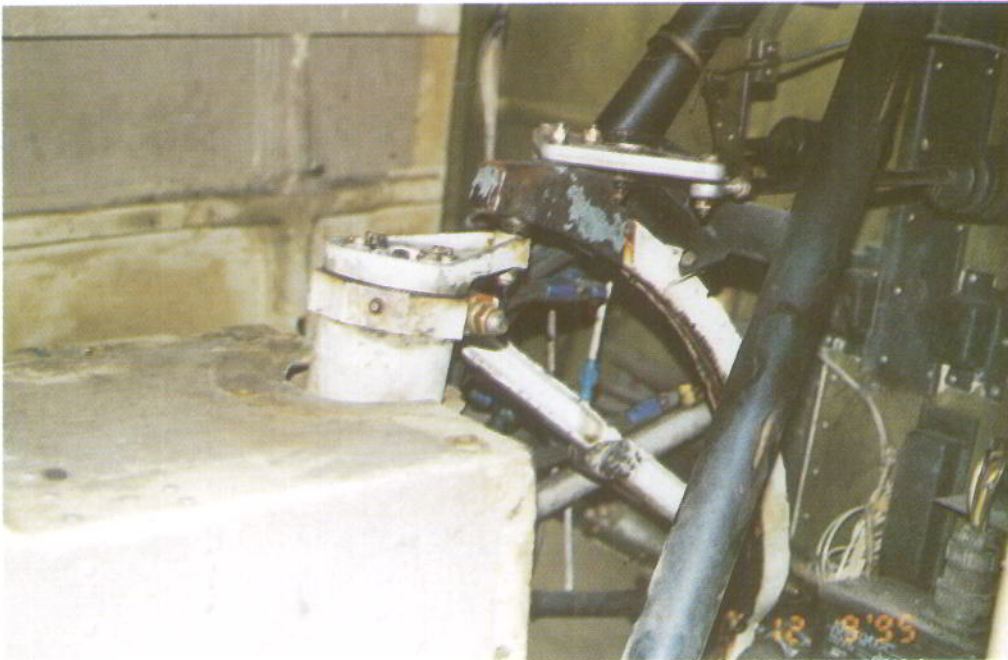
General view of nose landing gear bay

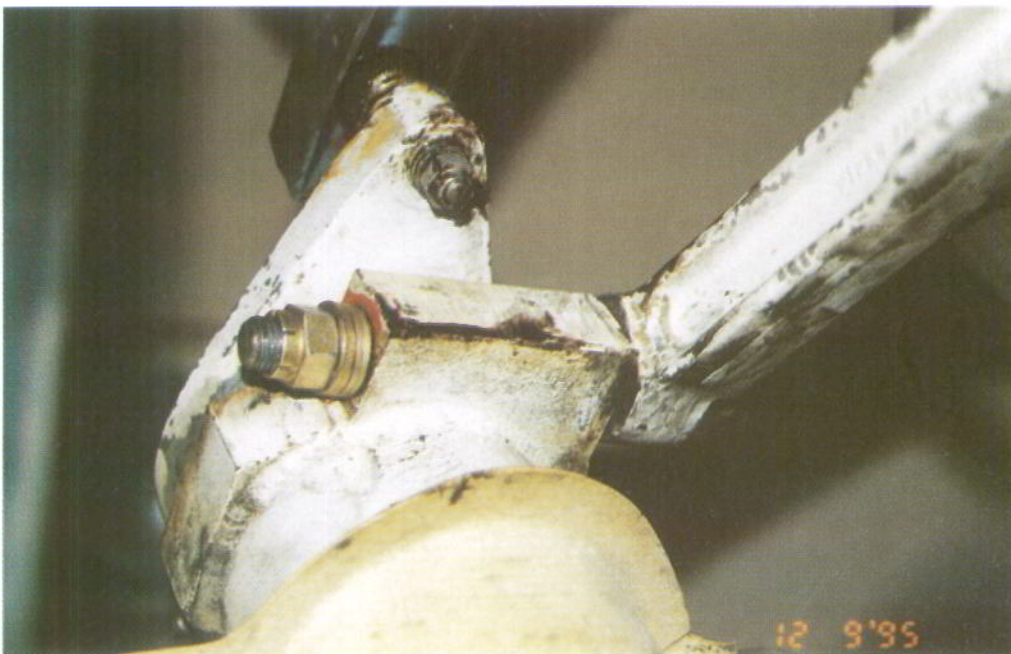
View of top of nose leg of G-BVEV, showing how upper drag link is attached to RHS of leg

*(NB. Bolt shown is non-standard "slave" item; hence washer stack)*

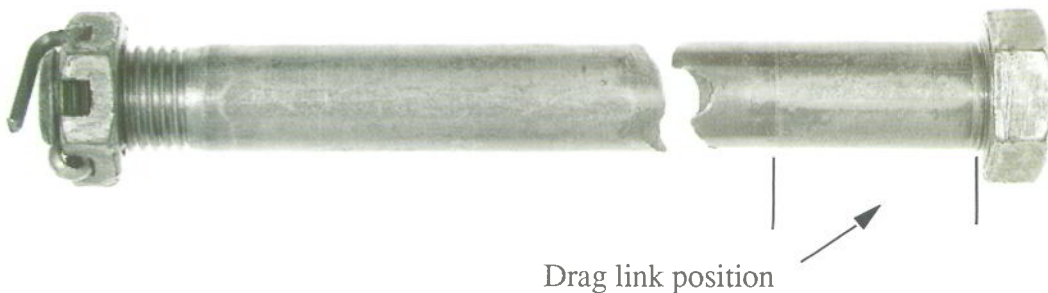
Metallurgical examination of the bolt revealed that it had cracked in bending fatigue across approximately 90% of its section before finally failing in overload. The fatigue origin was not associated with any obvious corrosion or metallurgical defect in the bolt material.

Failed drag link attachment bolt (Photo: DRA)
