ACCIDENT

Aircraft Type and Registration:	Bellanca 7GCBC Citabria, G-HUNI	
No & Type of Engines:	1 Lycoming O-320-A2B piston engine	
Year of Manufacture:	1973	
Date & Time (UTC):	31 May 2010 at 1330 hrs	
Location:	Henstridge Airfield, Somerset	
Type of Flight:	Private	
Persons on Board:	Crew - 1	Passengers - 1
Injuries:	Crew - None	Passengers - None
Nature of Damage:	Landing gear, underside of fuselage, propeller and right wingtip damaged	
Commander's Licence:	Private Pilot's Licence	
Commander's Age:	46 years	
Commander's Flying Experience:	284 hours (of which 10 were on type) Last 90 days - 6 hours Last 28 days - 1 hour	
Information Source:	Aircraft Accident Report Form submitted by the pilot

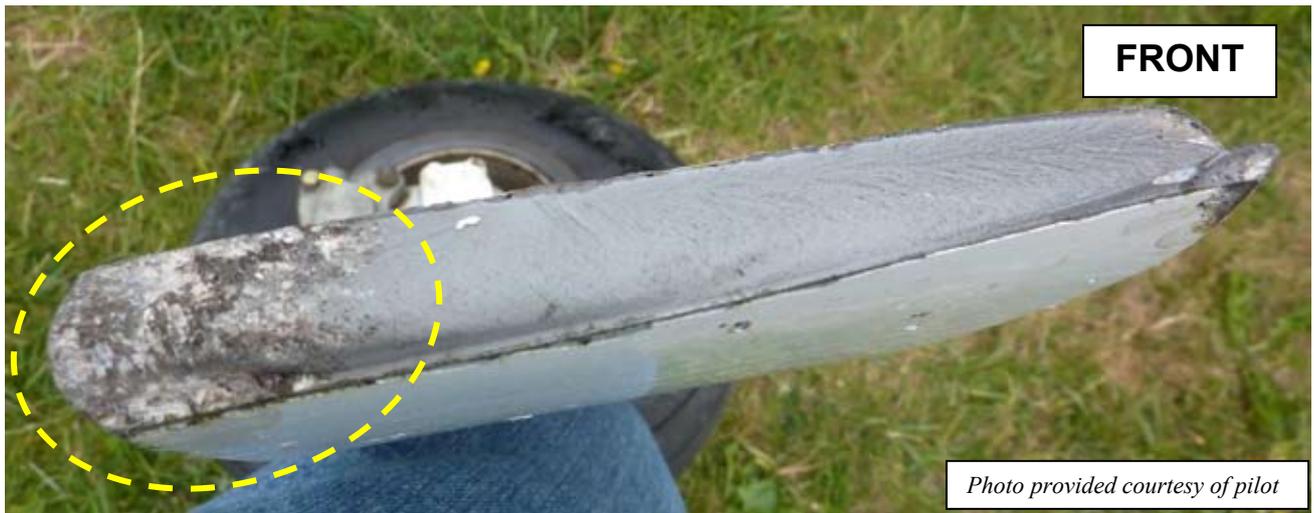
Figure 1

fracture surfaces revealed evidence of an approximately 15 mm deep pre-existing crack propagating from the rear edge of the gear leg. The crack surfaces in this region were heavily corroded (Figure 1), indicating that the crack had been present for some time prior to the failure.

Fracture surface of landing gear leg showing location of pre-existing crack (circled)
