ACCIDENT

Aircraft Type and Registration:	Socata TB9 Tampico, G-BIZE	
No & Type of Engines:	1 Lycoming O-320-D2A piston engine	
Year of Manufacture:	1981	
Date & Time (UTC):	4 May 2008 at 1730 hrs	
Location:	1 nm north of Gloucestershire Airport (formerly Staverton)	
Type of Flight:	Private	
Persons on Board:	Crew - 2	Passengers - None
Injuries:	Crew - None	Passengers - N/A
Nature of Damage:	Main wheel spats detached, damage to the tailplane leading edge and aircraft step	
Commander's Licence:	Private Pilot's Licence	
Commander's Age:	56 years	
Commander's Flying Experience:	2,500 hours (of which 1 was on type) Last 90 days - 8 hours Last 28 days - 3 hours	
Information Source:	Aircraft Accident Report Forms submitted by both the pilots

Synopsis

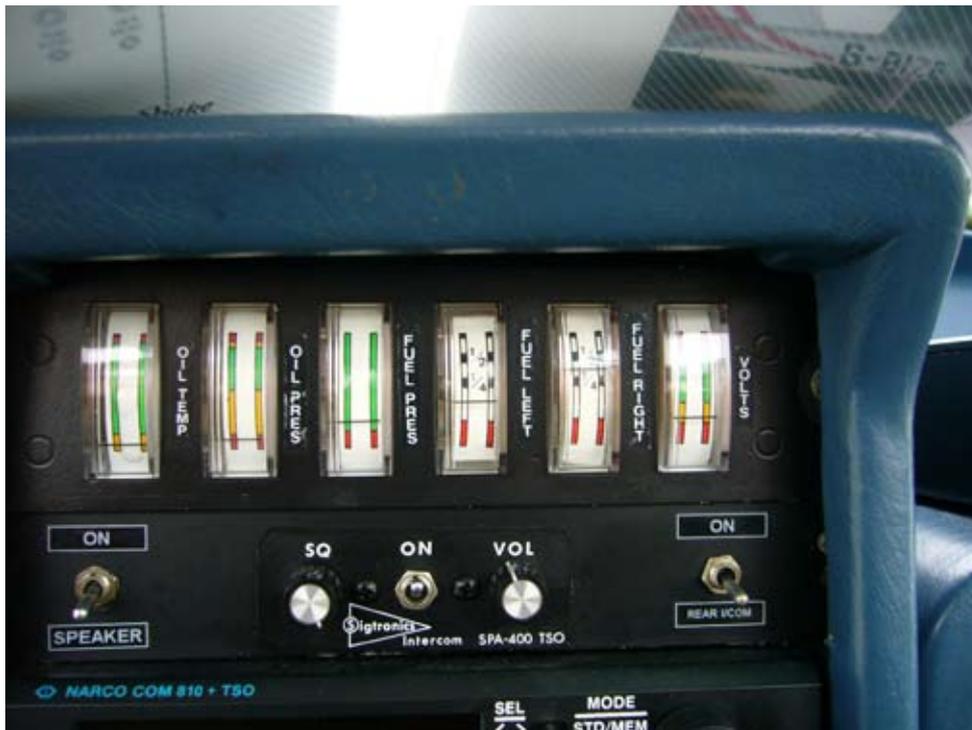
Figure 1

The TB9 Pilot Information Manual quotes a figure of 79 litres total and 76 litres usable fuel quantity per tank. After the accident the left tank was drained recovering about one litre of fuel, despite the gauge reading just under a quarter full, between 15 and 20 litres of fuel were later recovered from the right tank, which had indicated just less than half full (Figure 1). This does suggest both gauges were ‘over-reading’ by a similar amount. Airworthiness Directive 1999-062(A) was issued for the TB9 by the DGAC to highlight fuel gauges over-reading at low electrical power supply voltage. However, the maintenance facility repairing the aircraft confirmed the directive was not applicable to this aircraft because of the modification standard. Due to the level of disassembly required to recover the aircraft, it has not been possible to confirm whether any fault existed in the fuel quantity indication system at the time of the accident.

Whilst taking these issues into account, it is generally accepted that light aircraft fuel content gauges should not be relied upon, particularly at low tank quantities and with varying aircraft attitudes. The TB9 Pilot Information Manual reflects best practice in requiring a pre-flight inspection of the physical tank quantity. With knowledge of the approximate engine fuel burn rate this gives a secondary indication of remaining fuel in each tank. The CAA-published General Aviation Safety Information Leaflet (GASIL) Issue 2 of 2008 highlights the importance of this technique, particularly when converting to a new aircraft type.
