## ACCIDENT

<b>Aircraft Type and Registration:</b>	Rans S6-ES Coyote II, G-BZYL	
<b>No &amp; Type of Engines:</b>	1 Jabiru Aircraft Pty 2200A piston engine	
<b>Year of Manufacture:</b>	2002	
<b>Date &amp; Time (UTC):</b>	14 February 2009 at 1424 hrs	
<b>Location:</b>	Brimpton airstrip near Aldermaston, Berkshire	
<b>Type of Flight:</b>	Private	
<b>Persons on Board:</b>	Crew - 1	Passengers - None
<b>Injuries:</b>	Crew - 1 (Serious)	Passengers - None
<b>Nature of Damage:</b>	Aircraft destroyed	
<b>Commander's Licence:</b>	National Private Pilot's Licence	
<b>Commander's Age:</b>	65 years	
<b>Commander's Flying Experience:</b>	165 hours (of which 121 hours were on type) Last 90 days - 1:25 hours Last 28 days - 0:35 hours	
<b>Information Source:</b>	AAIB Field Investigation

## Synopsis

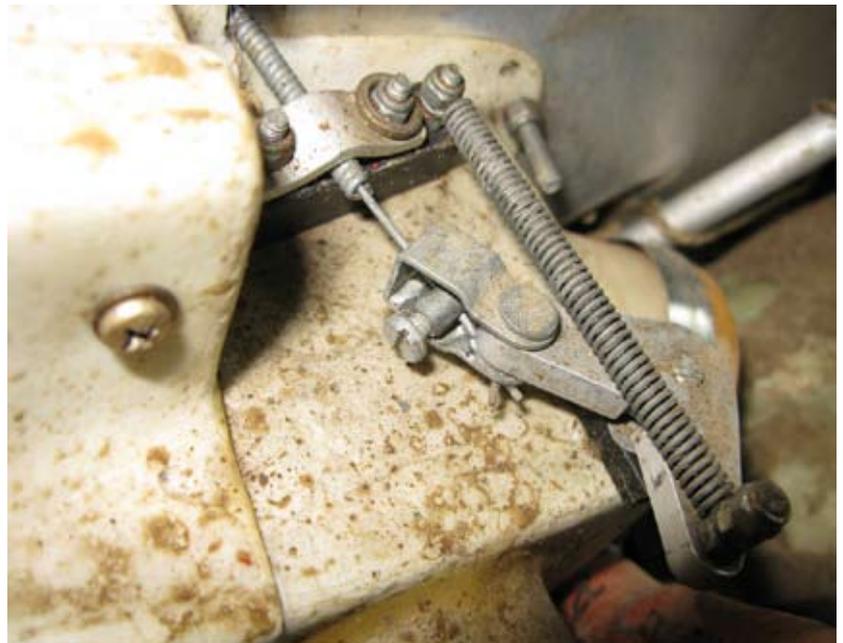
**Figure 1**

The control knob was found very close to the fully hot position. Its cable was intact and connected to the crank of the hot air valve, and the valve flap itself was fully seated in the HOT position. The valve-operating mechanism, and the related parts of the air-box, were undamaged and there was no evidence to suggest that the mechanism had been displaced during the impact. The nipple on the end of the operating cable at its connection to the crank was not fully in contact with the inner face of its clevis fitting, but its protruding end did abut the side face of the crank (Figure 1) consistent with

the crank being 'over-ridden' by the operating cable during the final stage of valve movement into the HOT position. This could have occurred due to the inherent tendency of the spring to snap the valve onto its seat in advance of the operating knob and cable becoming fully retracted. Alternatively, it could, possibly, have been due to impact forces driving the valve crank into the HOT position.

Analysis of the geometry of these components within the engine compartment, and bench operation of the mechanism showed that the position of the carburettor heat control at impact could not be established with certainty, but on a balance of probability, the evidence pointed to it having been in the HOT position.

Operating mechanism for engine carburettor heat
