ACCIDENT

Aircraft Type and Registration:	Cessna 750 Citation X, G-CDCX	
No & Type of Engines:	2 x Rolls-Royce AE 3007C1 turbofan engines	
Year of Manufacture:	2002	
Date & Time (UTC):	9 December 2010 at 1021 hrs	
Location:	Doncaster Airport, South Yorkshire	
Type of Flight:	Private	
Persons on Board:	Crew - 2	Passengers - None
Injuries:	Crew - None	Passengers - N/A
Nature of Damage:	Right mainwheels detached, damage to flaps and outboard wing skin, puncture of right elevator	
Commander's Licence:	Airline Transport Pilot's Licence	
Commander's Age:	34 years	
Commander's Flying Experience:	4,800 hours (of which 600 were on type) Last 90 days - 72 hours Last 28 days - 34 hours	
Information Source:	AAIB Field Investigation

Synopsis

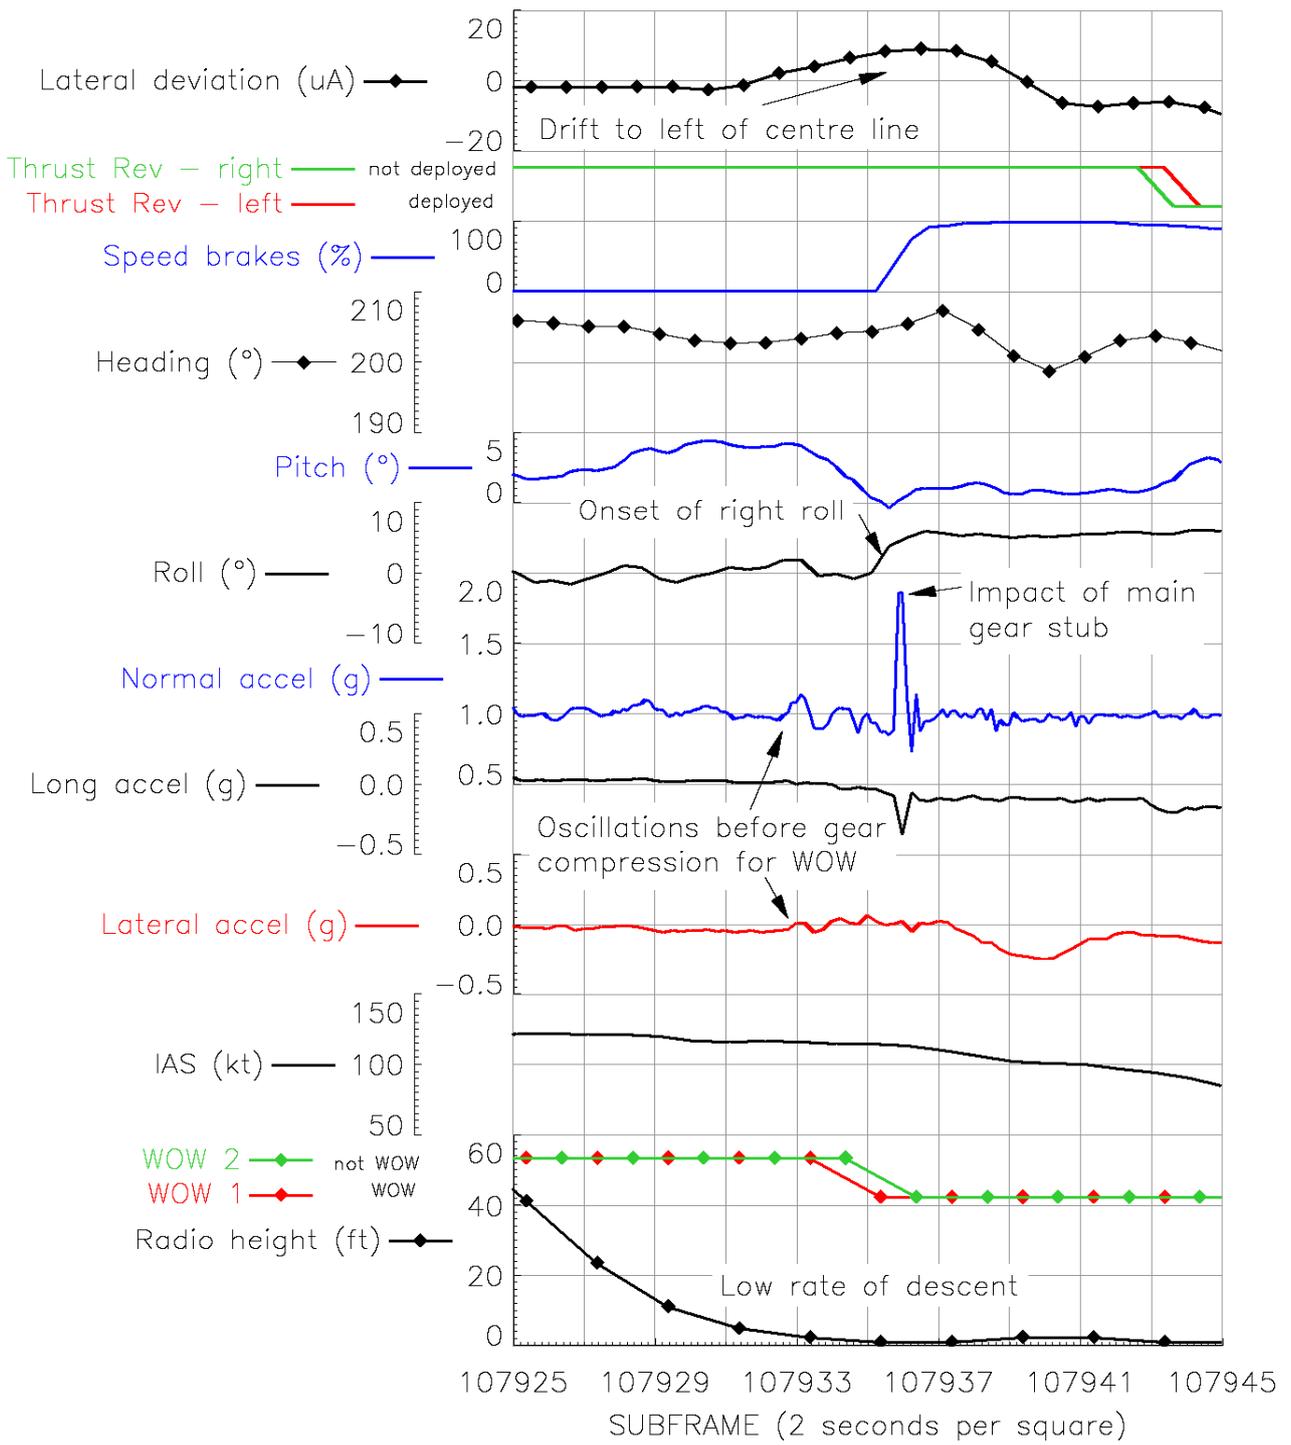
Figure 1
Pertinent FDR parameters from just before touchdown

From a height of 120 ft the pitch was increased and the rate of descent reduced. Figure 1 shows the pertinent FDR parameters from just before touchdown. The heading was gradually reduced and just before touchdown the aircraft started to drift left of the centreline.

The aircraft initially touched down with a descent rate of approximately 100 ft/min with a small amount of right roll and a small, but increasing, fly-right localizer deviation. The nose was lowered, during which small lateral acceleration oscillations were recorded. During the period when the Weight On Wheels (WOW) parameters became active, the aircraft started rolling right. The pitch reached zero and the speed brakes were deployed. When the roll reached approximately 5°, a 1.9 g spike in normal acceleration and a -0.35 g spike in longitudinal acceleration were recorded.

It is likely that the gear detachment occurred during the initial touchdown phase, with a low descent rate. Just prior to this, whilst drifting to the left, small oscillations in the normal and lateral acceleration parameters were recorded, possibly associated with intermittent contact with the runway or ridges of ice observed on the

runway. A right roll initiated with the failure of the gear component and the accelerometer spikes were the result of the aircraft rolling onto the remaining structure after the wheel assembly had detached.

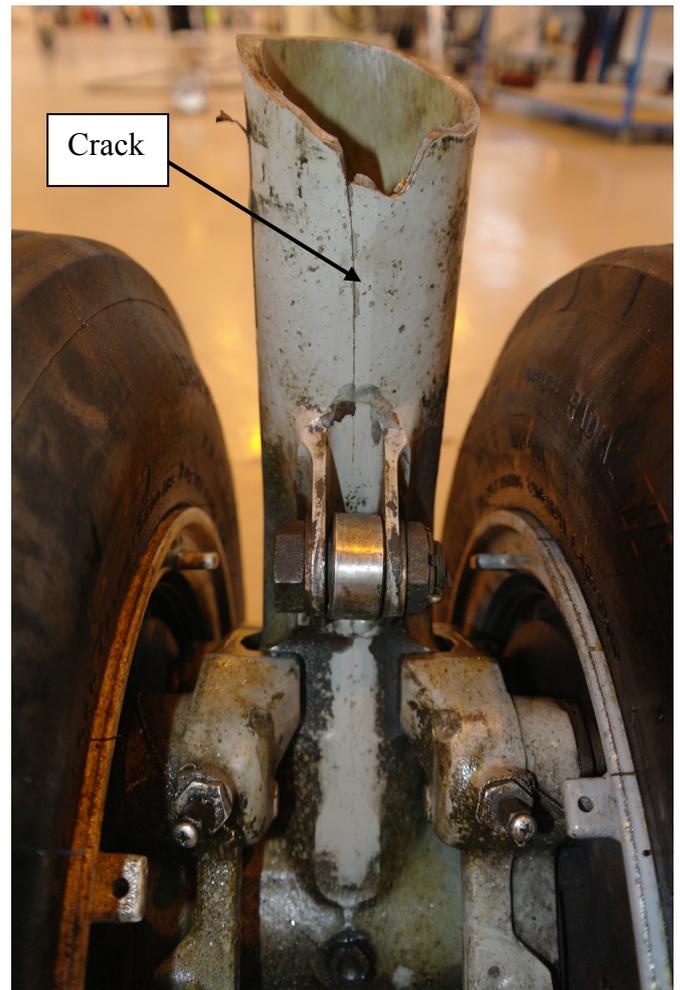
Figure 3

It was apparent that the trailing link had fractured in a roughly circumferential manner at its forward end although, at the upper surface, the fracture surface turned aft towards a longitudinal crack which ran for some 27 cm (Figure 3) along the top surface. Evidence of a darker area where the longitudinal crack met the circumferential fracture suggested that the crack pre-existed the final fracture and that it was responsible for an overload failure of the component. This was later confirmed by metallurgical examination.

Broken trailing link showing circumferential fracture and longitudinal crack on upper face

It is recommended that the Cessna Aircraft Company amends the Maintenance Schedule for the Model 750 Citation X aircraft to include a suitably frequent external visual inspection of the MLG trailing link upper surface for cracks.

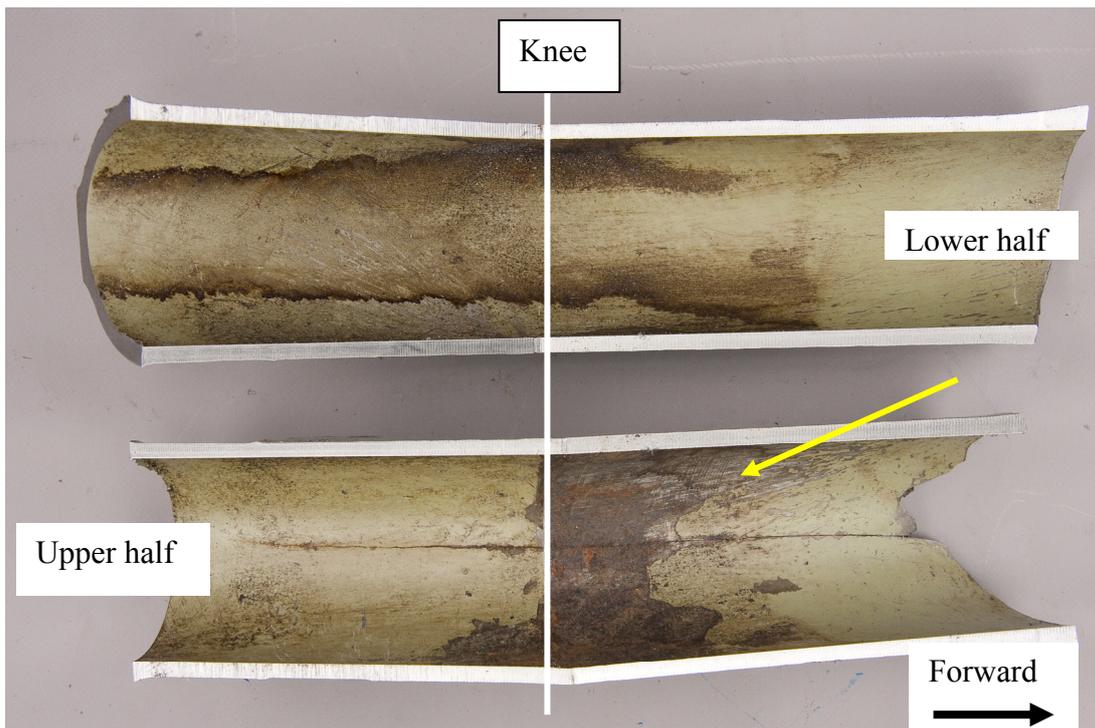
Figure 4

The failed link was transported to a metallurgical laboratory for expert examination in the presence of a specialist from Cessna Aircraft Company. One of the first actions was to section the link longitudinally, so that the interior of it could be examined (Figure 4). The crack on the upper face could clearly be seen, as could an extensive area of corrosion and loose paint in the vicinity of the knee, again on the upper surface. The lower half of the link appeared crack and corrosion-free with no loss of paint. However, there was an apparent black stain, suggesting long-term pooling of some liquid – this would later be examined to discover its nature.

Longitudinal section through failed link showing extent of crack and corrosion on upper half and staining on lower half. Note scratches (arrowed)

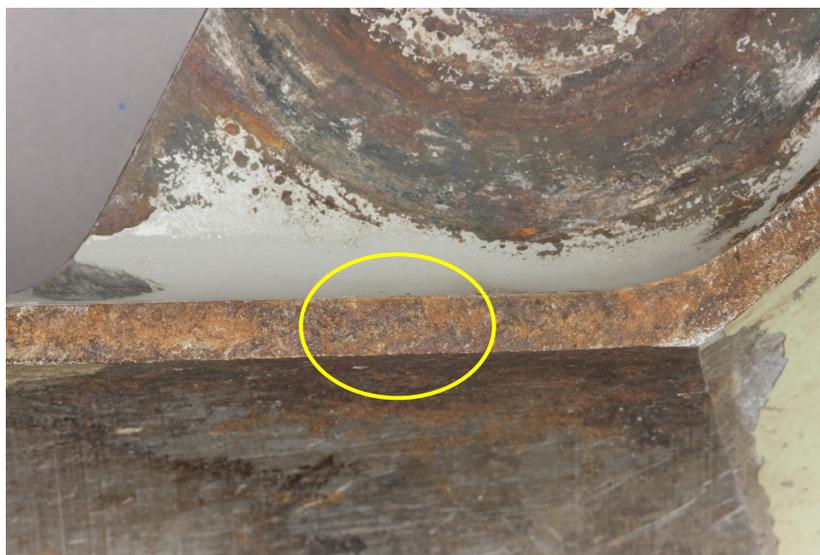
Figure 5

A few centimetres of uncracked material held the two halves of the upper segment together, so this had to be sawn and then broken apart in order to examine the crack faces. As can be seen in Figure 5, the faces were heavily corroded and it was not possible to identify

precisely the origin of the crack but, judging by the varying degrees of severity of the corrosion attack, it was judged to have been just forward of the knee on the inner surface, propagating forward and aft from this point simultaneously until the total crack length reached approximately 275 mm, at which point instantaneous rupture of the forward part of the link occurred in a circumferential direction. Sections placed in a Scanning Electron Microscope (SEM), showed that the crack had propagated through Stress Corrosion Cracking (SCC).

Picture of SCC showing probable area of origin

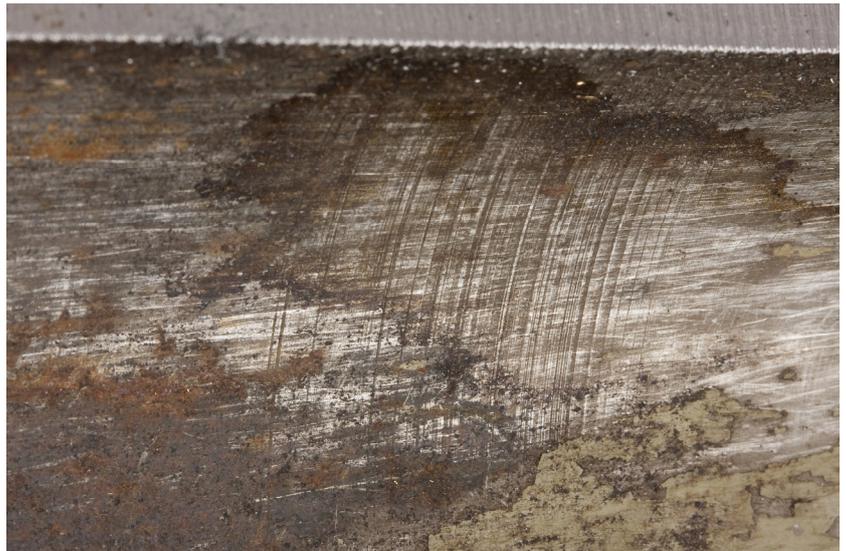
Figure 6

complete loss of the cadmium plating and deep pitting of the base metal. Also noted was a series of roughly longitudinal scratches in the paint (Figure 6), which appeared relatively fresh and were thought to have been caused post-failure of the link, possibly by scooping-up runway debris. However, microscopic examination showed that similar marks appeared in the heavily corroded region in a similar orientation, manifesting themselves as linear regions of deeper corrosion. Furthermore, the ‘fresh’ scratching appeared to run under a region of black staining, similar to that which was noted on the lower half of the link.

Close-up of longitudinal scratches

scratching damage found during this investigation was responsible for the initial development of corrosion. Two possibilities were considered, the first being that insertion of the borescope probe to inspect as prescribed by the ASLs and the AMM had damaged the paint and plating. This appeared unlikely given that the borescope recommended by Cessna had a relatively soft-coated probe head; the actual equipment used in the inspections is unknown. The second possibility arises from anecdotal evidence that if, for any reason, it becomes necessary to remove and replace the anti-skid wiring harness, it can be a difficult operation and some mechanics may resort to using metal wire to guide the coiled loom through the small apertures. Whatever the damage mechanism, the importance of taking precautions not to scratch the surface of the link interior must be stressed.

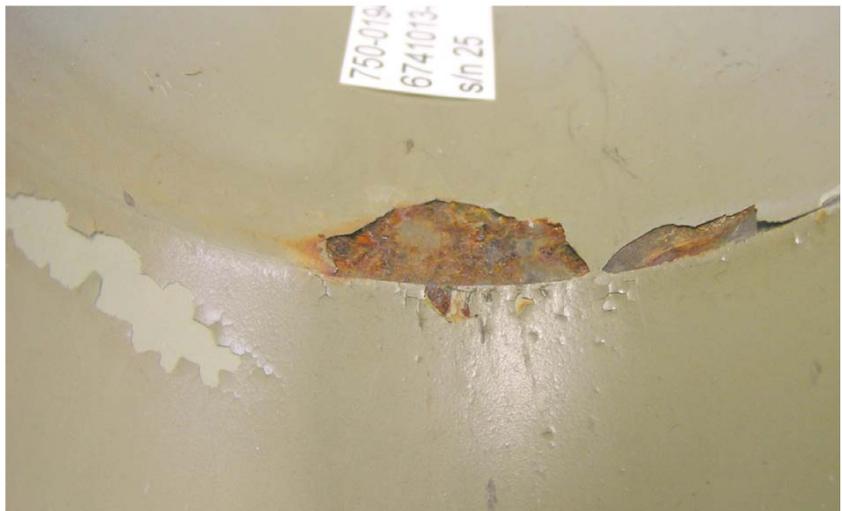
Figure 7

The left MLG trailing link was examined using a borescope and was found to have a patch of corrosion in the same area as the right link, but apparently not as severe or extensive, and with no obvious signs of cracking (Figure 7). It was despatched to Cessna for detailed examination, where it was prepared for examination in a similar manner to the right link.

When the corroded area was examined using an SEM, it could be seen that some micro cracks (identified as SCC) were growing from some of the deeper corrosion pits. There was also some external surface corrosion on the outside diameter of the link, between the oleo attachment lugs, but no cracking was present.

diameter of the link had been recoated with primer over a wide area around the area of corrosion, appearing to be a darker shade compared with the original paint. This was clearly a second coat applied after a corrosion repair which was performed in October 2004, after an inspection to comply with an Alert Service Letter (ASL) 750-32-19, but much of the chromate had leached out and adhesion was extremely patchy, despite it being of the correct type of primer. Little is known about this repair beyond the fact that it was found to be necessary and had been dressed-out with the correct grade of abrasive pad and primer re-applied.

Interior of left link at the knee, showing corrosion and flaking of re-applied primer

However, this link had had some removal of the primer to address corrosion in October 2004 – this might explain why it corroded again, due the possibility that the already sub-thickness plating was removed by the abrasive pad with no means of replacing it and given the difficulty inherent in trying to touch-in the primer by hand in the region of the knee. This 'repair' option does not form part of the current AMM procedure.
